Job #: 57950 /

VIN: 54DB4W1B9GS812813

14' LYNCOACH & TROJAN DRY VAN BODY, GAS 2016 - ISUZU NPR / NA

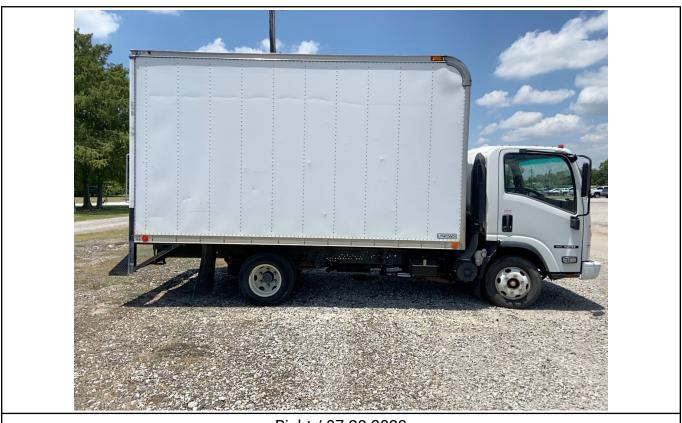
Right / 07-28-2023

The sheet metal on the right side of the box is dented and bent and the top right corner of the box is dented. The plastic face cover is cracked on the instrument cluster. The driver and passenger bottom seat cushions have holes in them. The left side cover is missing on the dash. The steering column plastics are separating. The floor mat cover is ripped and the material is loose under the seat. The paint is worn on the left grab iron and chipped in the the right grab iron in the cab. The cover is missing from the door panel. All tires are worn and the left steer tire has a split in its center. The rear right brake light lens is broken. The brakes sound squeaky when activated.
