## DIESEL 2019 - ISUZU FTR, CAB AND CHASSIS / LA127625

Job #: 58895 /

VIN: 54DK6S164KSG00273

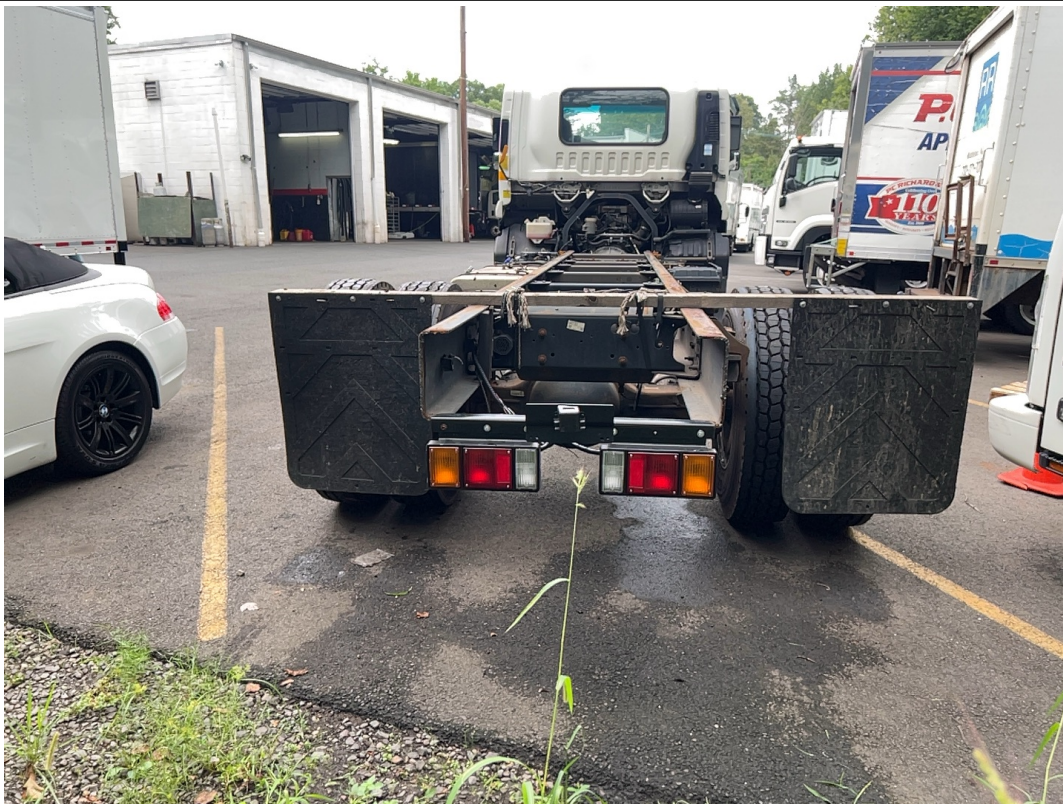
Rear / 08-17-2023

The unit has temporary mud flaps installed on it and aftermarket rear light bracket have been installed on the rear.

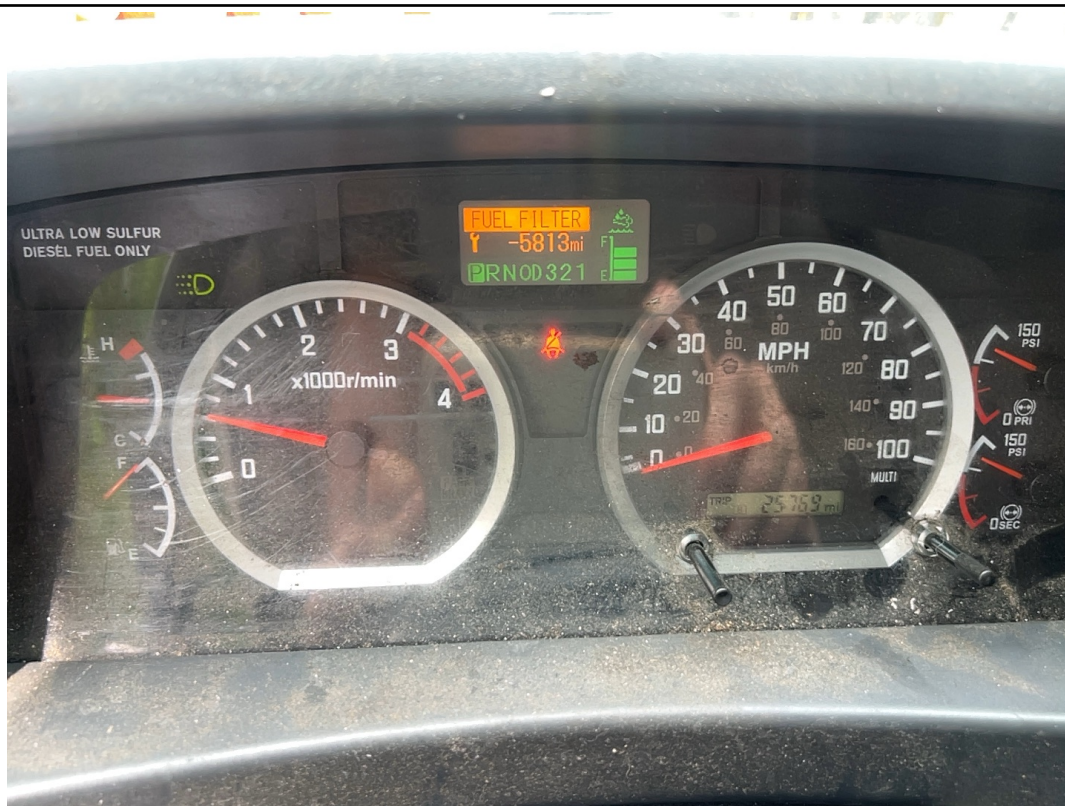
EMS Warning Lights / 08-17-2023

Front Bumper	The bumper is dented on the right.
Right Step	The step is bent outwards.
Frame	The rear crossmember support has been cut out and removed.
EMS Warning Lights	The dash is showing the fuel filter service is due.
Instrument Cluster	The cluster plastic face cover is scratched.
Fire Extinguisher	the fire extinguisher is missing from its mount.
Panel Cover	The cover is missing on the dash in the center.
Glove Box	The lid will not latch shut.
Exhaust Flange	The flange and bolts are rusty.
Coolant	The coolant is low in the reservoir.
Engine Oil	The oil is dark in color.
Oil Hub Caps	The front right wheel oil hub cap is leaking.
Shocks	The front shocks are leaking.
Differentail Seal	The pinion seal is leaking on the differential.
Rear Right Outer Wheel	The wheel is bent on the lip.
Pulley	A belt or pulley squeaks when the unit is started.
