20' TRANSIT BODY WITH RAMP, DIESEL 2019 ISUZU NRR / LA128159

Specifications	
Year	2019
Make	Isuzu
Model	NRR
Date of Inspection	08/15/2023
Location of Inspection	109 Lindberg Avenue, Methuen, MA, 01844
VIN	JALE5W165K7303765
GVWR	19,500 lbs
Odometer	133,791
Engine Hours	5,884
EMS Warning Lights	Active Warnings
Cab Interior	See Notes
Driver's Seat	See Notes
Passenger's Seat	See Notes
Transmission Type	Automatic
Pedals	No Damages Observed
Floorboard	No Damages Observed
Radio	Yes
A/C	Yes
Switches and Controls	No Damages Observed
Power Mirrors	No
Heated Mirrors	Yes
Steering Wheel	No Damages Observed
Mirrors	No Damages Observed
Steps	No Damages Observed
Handrails	See Notes
Exhaust Pipe	Single - No Damages Observed
Engine Compartment	No Damages Observed
Oil Dipstick	Good Level / Dark Color
Coolant Level	Low Level
Suspension	Leaf Spring - See Notes
Axles	No Damages Observed
Front Lights	No Damages Observed
Rear Lights	No Damages Observed
Left Steer Tire Condition	No Damages Observed
Left Steer Tire Brand	Roadmaster

Job #: 58878 /

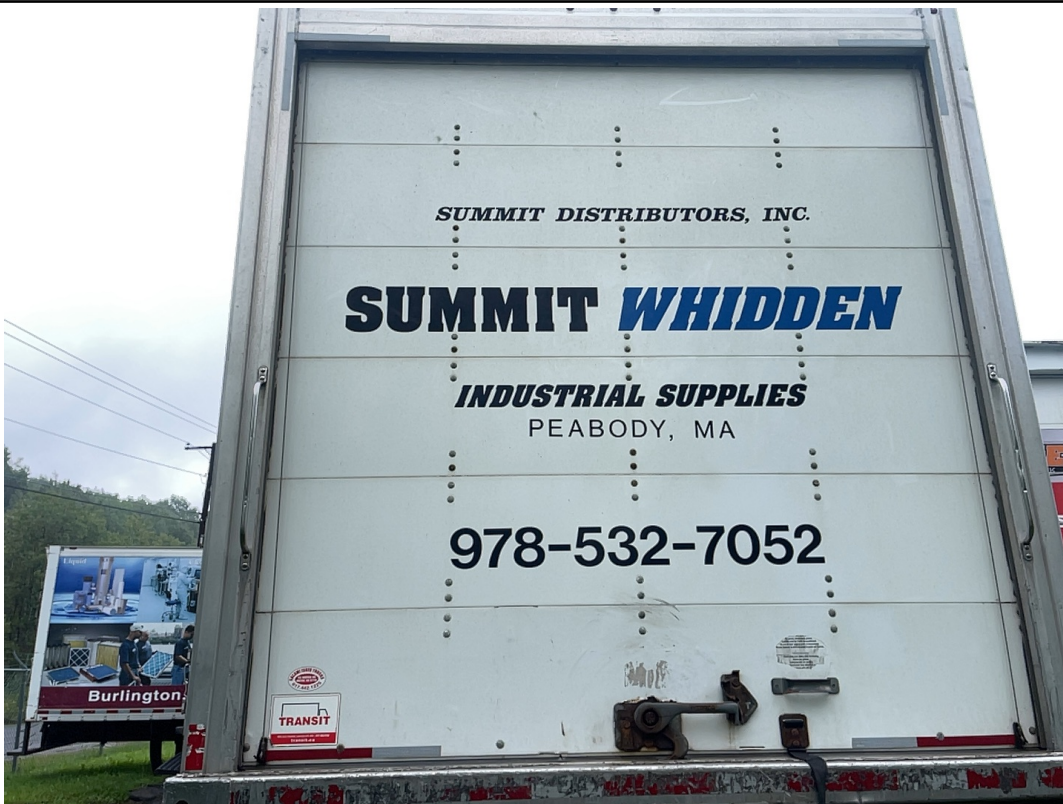
Rear / 08-15-2023

Ramp	The ramp is missing from the rear of the unit.
Rear Bumper	An aftermarket bumper has been installed onto this unit.
Pull Rope	The rear door's pull rope is damaged.

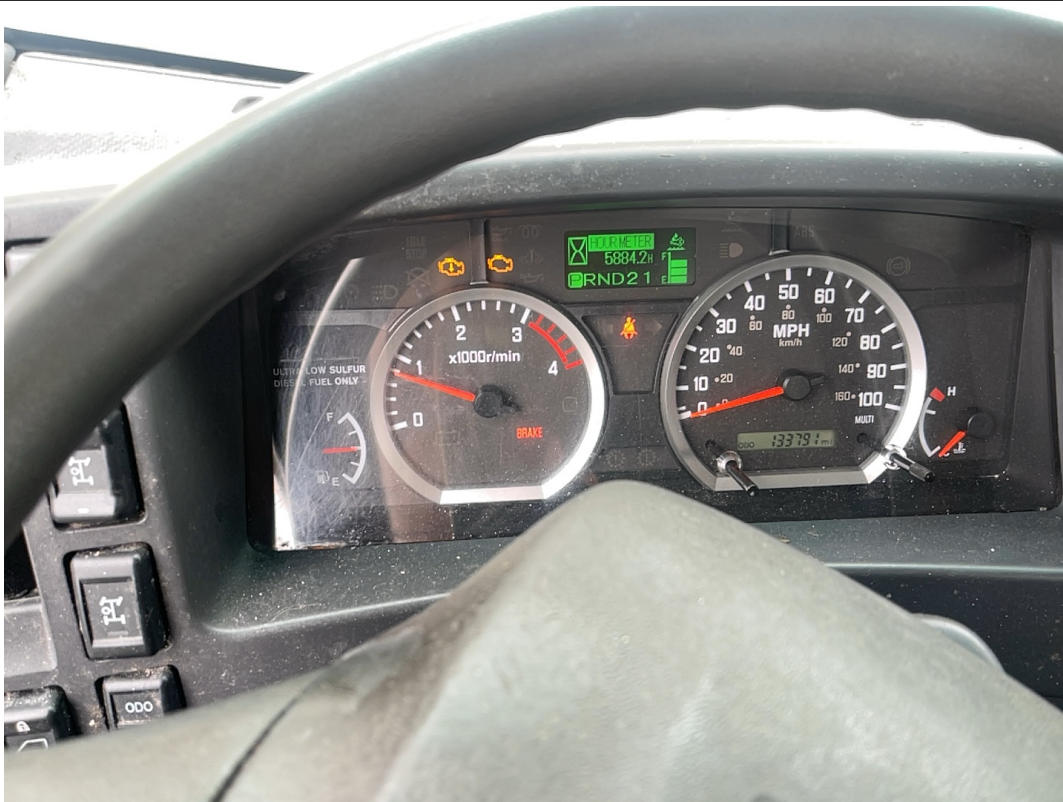
EMS Warning Lights / 08-15-2023

Wiper Blade	The front left wiper blade is torn.
Grab Iron	The rear grab irons are bent.
EMS Warning Lights	The "check engine" is lit on the EMS screen.
Seats Stained	The seats' cushions are stained.
Driver's Seat	The seat has small holes in the bottom cushion.
Cab Interior	The cab interior is dirty and there are stains on the rubber material under the seats.
Floor Mat	The rubber floor mat is torn.
Front Bumper	The front left bumper is damaged.
Coolant	The coolant is low in the reservoir.
Engine Oil	The engine oil is dark in color.
Frame Rails	The frame rails are rusty.
Air Cooler Tube	The charge air cooler tube is rusty in the engine compartment.
Right Outer Drive Tire	The tire has cuts in the sidewall.
Leaf Springs	The rear left leaf springs are not pilled straight.
Hangers	The leaf spring hangers are rusty.
Rubber Bumpers	The rear rubber bumpers are missing.
Reflective Tape	The reflective tape on the rear of the unit is missing and scratched off.
