Aspen Field Services

Job #: 58424 /

VIN: JALE5W168K7306126

2019 ISUZU NRR DIESEL WITH MORGAN 24' VAN BODY. / N/A

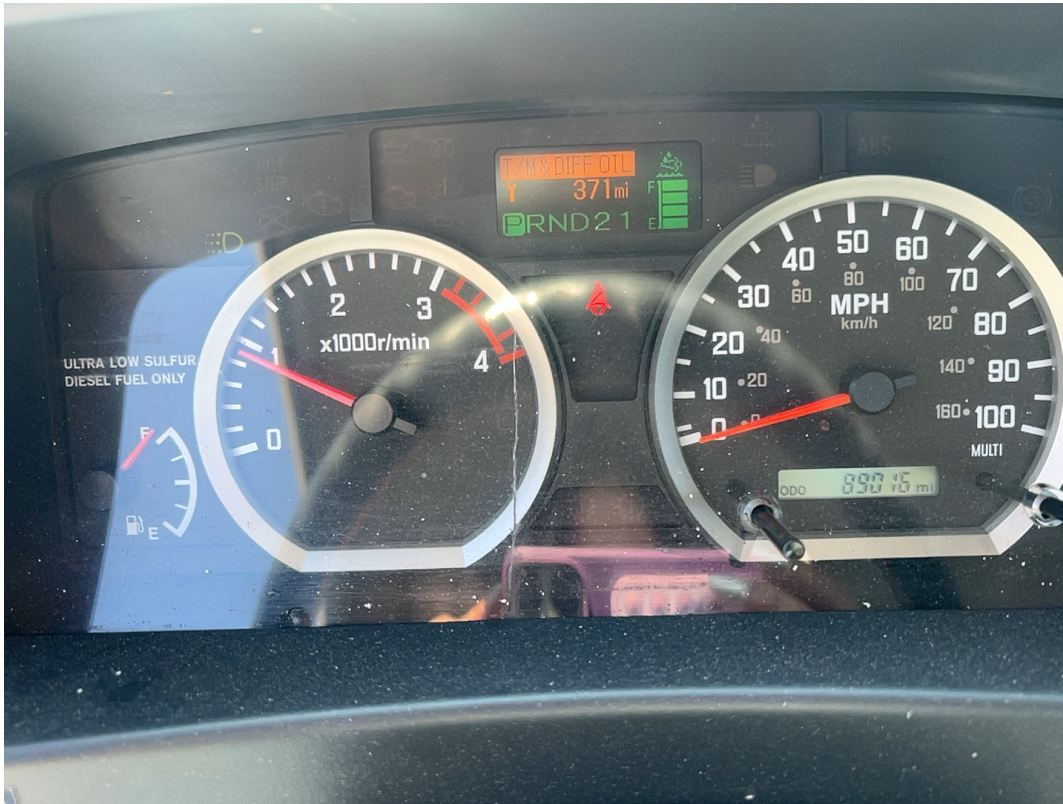
EMS Warning Lights / 08-10-2023

Visible Damages	
Active Warnings	The dash is showing a warning for services needed.
Instrument Cluster	The plastic face is cracked.
Windshield	The glass is cracked.
Wiring	There is wiring exposed under the dash on the driver side.
Coolant	The coolant is low in the reservoir.
Engine Oil	The engine oil is dark in color.
Coolers	The coolers are dirty.
Wheel	The front right wheel needs paint.
Left Inner Drive Tire	The tire's shoulder is worn. The tire is flat.
Right Inner Drive Tire	The tire's shoulder is worn.
