Aspen Field Services

Job #: 58880 /

VIN: 54DB4W1B2LS802618

14' MORGAN DRY VAN BODY, GAS 2020 - ISUZU NPR / LA133371

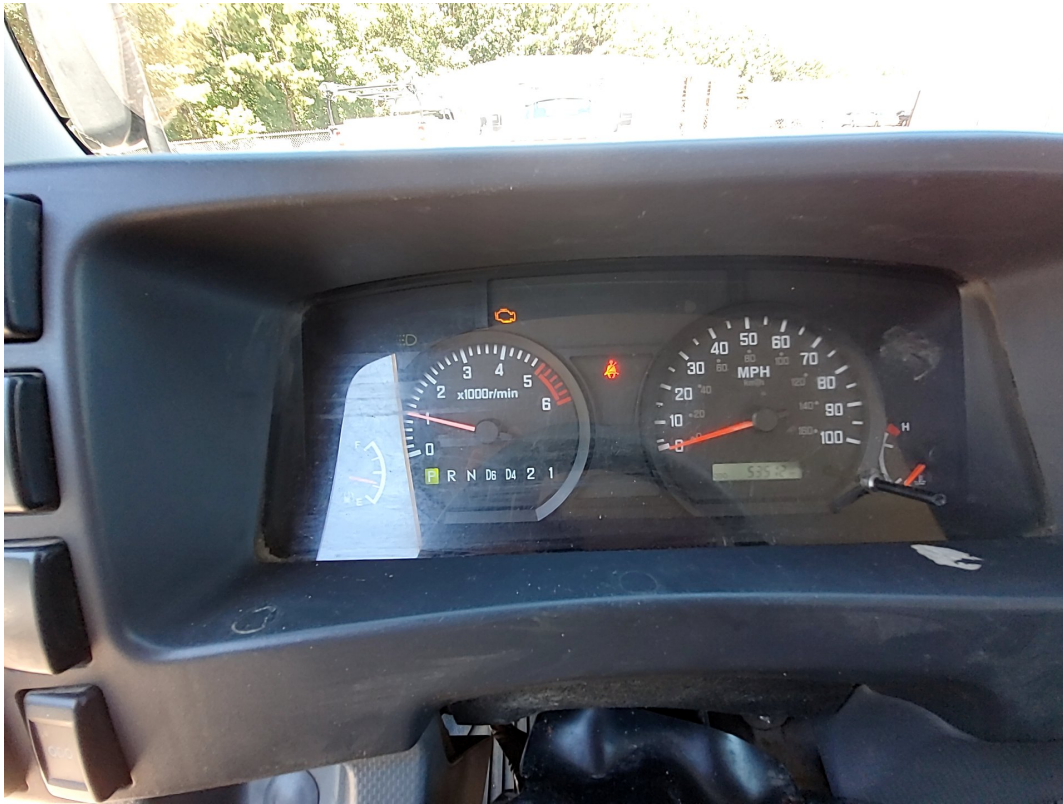
EMS Warning Lights / 08-16-2023

Visible Damages	
Sheet Metal Panels	The panels on the side of the box are dented.
Active Warnings	The check-engine warning is active on the EMS screen.
Driver's Seat	The bottom seat cushion has stains and the backrest has a small hole.
Passenger's Seat	The bottom seat cushion has stains and the backrest has a small hole.
Cover	The screw access cover is missing from the driver door.
Grab Iron	The rear right grab iron on the box is bent.
Right Steer Tire	The tire is low on air pressure and the outside shoulder is cupping.
Mud Flap	The front left mud flap is missing.
Shocks	The rear shocks are leaking.
Coolers	The coolers seem to be dirty.
Left Mirror	The mirror housing seems to be broken on the side.
Glove Box	The glove box is not staying closed.
