2014 ISUZU NPR-HD DIESEL WITH 18' DRY VAN BODY WITH MAXON LIFTGATE. / N/A

Aspen Field Services Job #: 58405 / VIN: JALC4W161E7002800

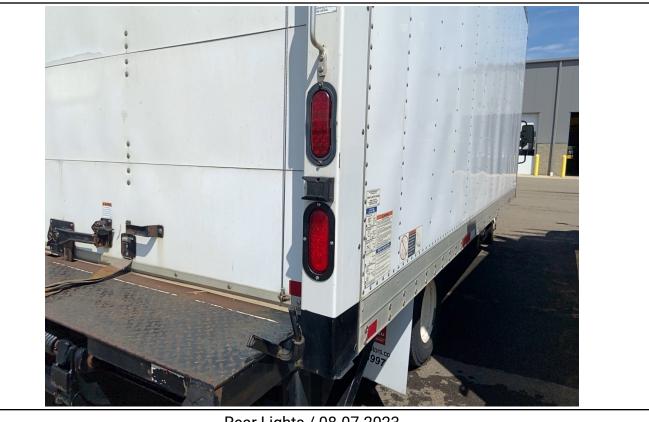
Rear Lights / 08-07-2023

The unit was not operational so the odometer, engine hours, EMS warning lights and the full operational video could not be captured. The lights' condition could not be determined due to the unit not being operational.
