Isuzu Finance
of America, Inc.

TRUCK INSPECTION SHEET

Dealership:	Hayes Truck Group
City / State:	Houston Texas
Lease #:	LA 126993
Vin #:	JALC4W161K7008463

Year:	2019
Make / Model:	Isuzu NPR

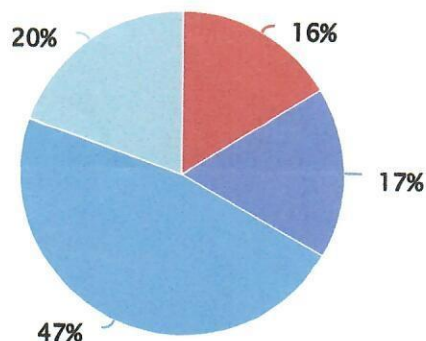
Breakdown of engine operation hours

City

Idling (5 min or more)	16 %
Congested traffic or slow driving	17 %
City	47 %
Highway	20 %

Total engine run time: 2,959 hrs

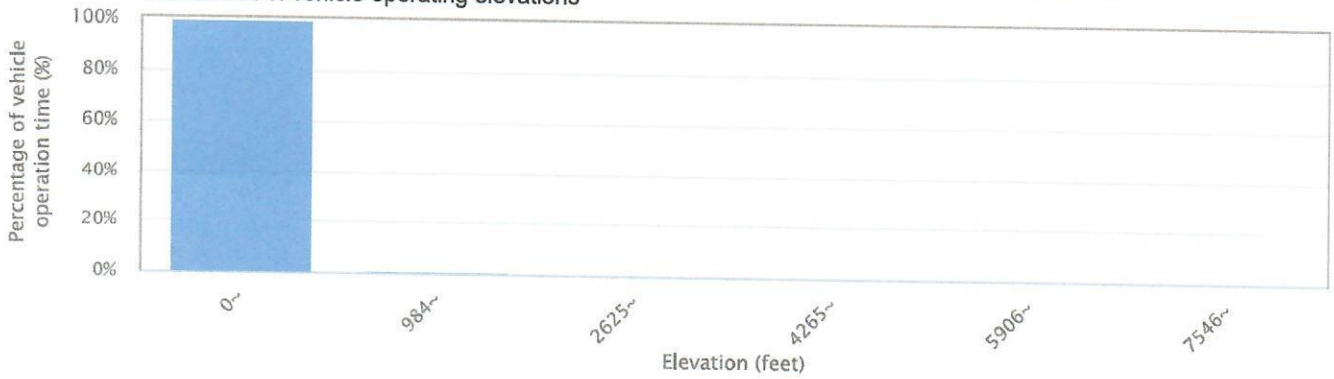
Distribution of vehicle operating elevations

Your vehicle doesn't appear to be regularly driven on mountain roads.

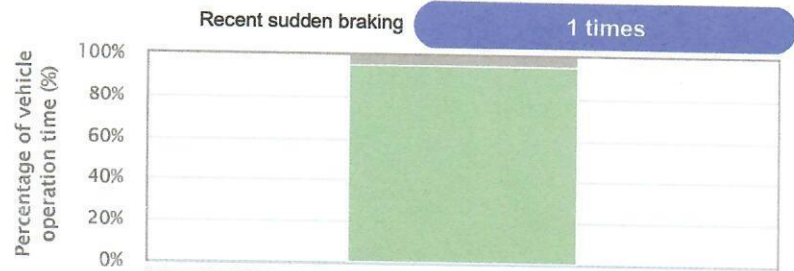
Your vehicle's braking operation falls within the normal range.

Type of braking	1st VHR
Depression of both brake and accelerator pedals during acceleration	4.97%
Normal braking	94.30%
Hard braking	0.71%
Sudden brake operation	0.01%

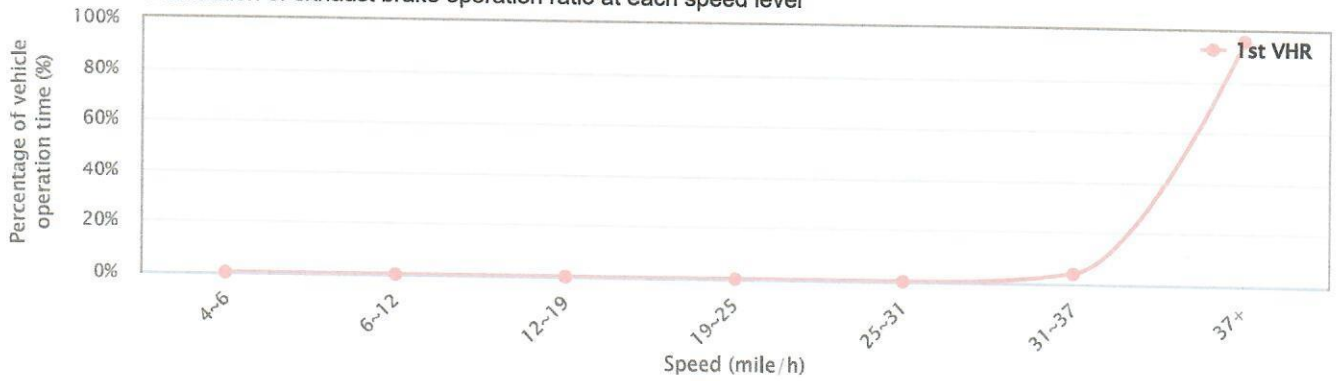
Distribution of exhaust brake operation ratio at each speed level

Your exhaust brake could be used to greater efficiency. Refer to your owners' manual on how to properly use the exhaust brake to reduce regular brake wear.

98223 times

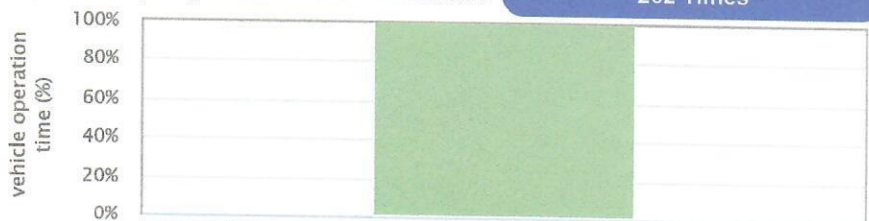
Frequency of recent sudden acceleration

Your accelerator pedal is being used in a way that is associated with normal operation.

262 Times

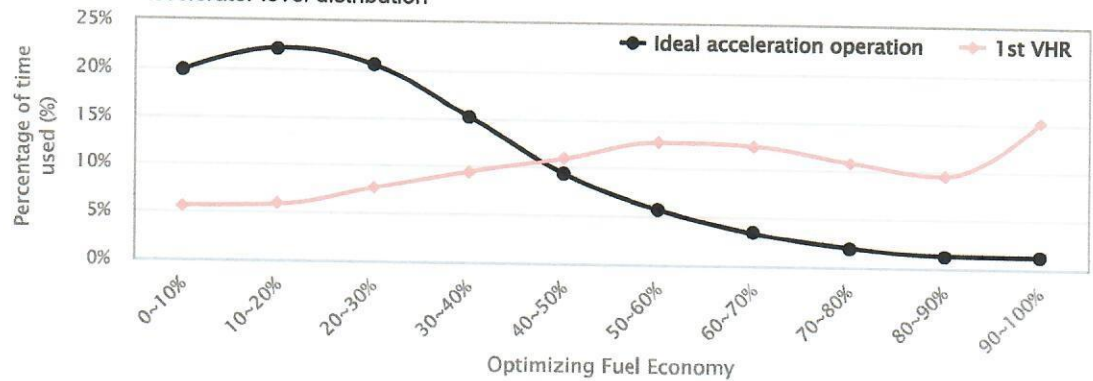
Accelerator level distribution

Your vehicle has been accelerated moderately. Follow the dotted line in the graph for optimal fuel efficiency.
