Aspen Field Services

Job #: 59575 /

VIN: JALC4W162J7009166

SUPREME 16' DRY VAN BODY, DIESEL 2018 - ISUZU NPR-HD / LA122588 DARREN ANDERSON INVESTMENTS CORP

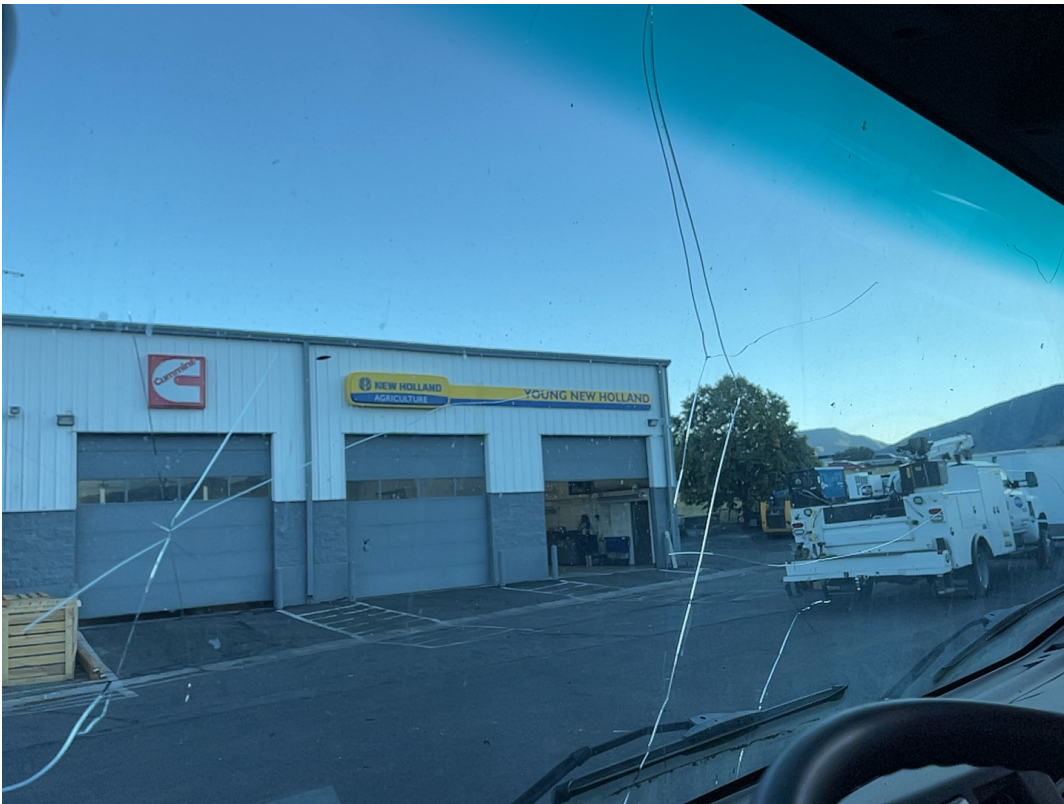
Damages / 08-29-2023

Visible Damages	
Windshield	The windshield is cracked.
Gasket	The windshield gasket is coming off.
Rear Top Lip	The lip is bent on the rear of the box.
Grab Iron	The rear left grab iron is missing on the box.
Rear Door Bolts	The bolts in the rear door are rusty.
Bumper	The rear bumper is bent.
Warnings	There are active warnings lit on the EMS Panel.
Seat Cushions	There are holes in the bottom seat cushions.
Plywood Panels	The wood panels inside the box has holes.
Coolant	The coolant is empty in the reservoir.
Engine Oil	There is no engine oil on the dipstick.
Front Wheels	The front wheels are rusty.
Left Inner Drive Tire	The tire's tread is worn out.
Left Lip	The left side lip of the box is bent down.
Back Up Alarm	The alarm did not sound when the unit was put in reverse.

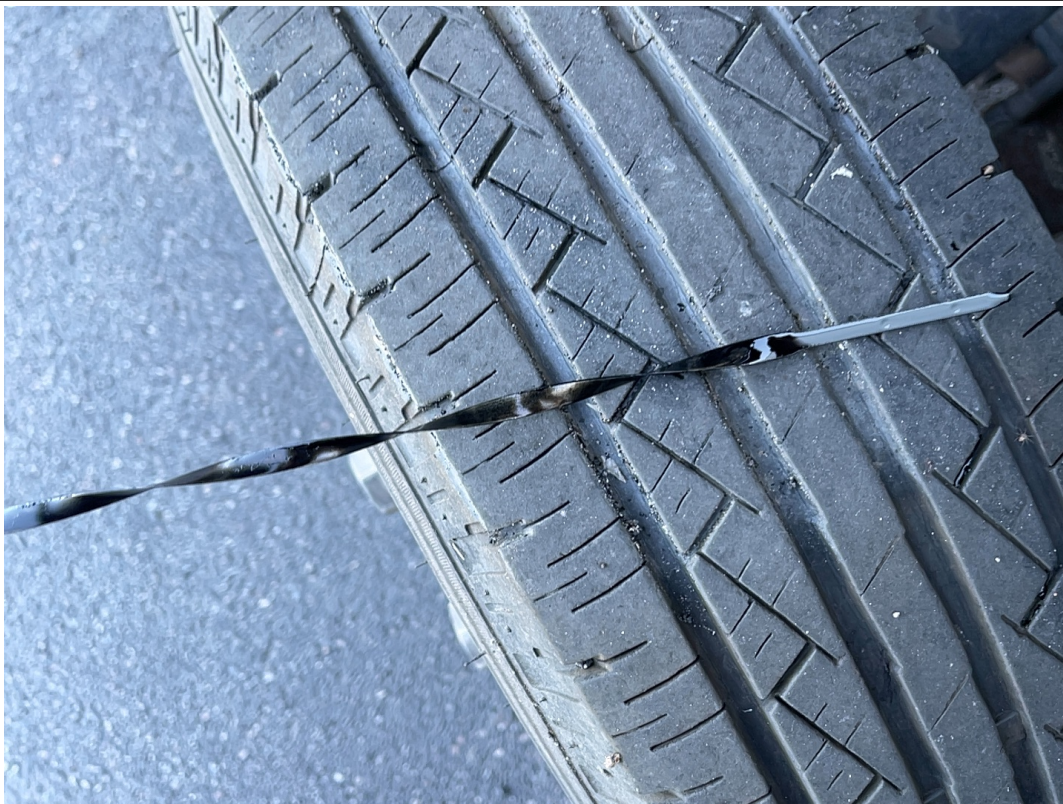
Oil Dipstick / 08-29-2023

Some of the engine information was obtained via a VIN-Decoding software. The engine oil is dry, indicating an empty reservoir or a very low engine oil level.
