20' GENERAL TRUCK BODY INC. DRY VAN BODY WITH PALFINGER ILK-22 LIFTGATE, DIESEL 2018 ISUZU NRR - LA125805 / LA125805

Job #: 59825 /

VIN: JALE5W169J7304352

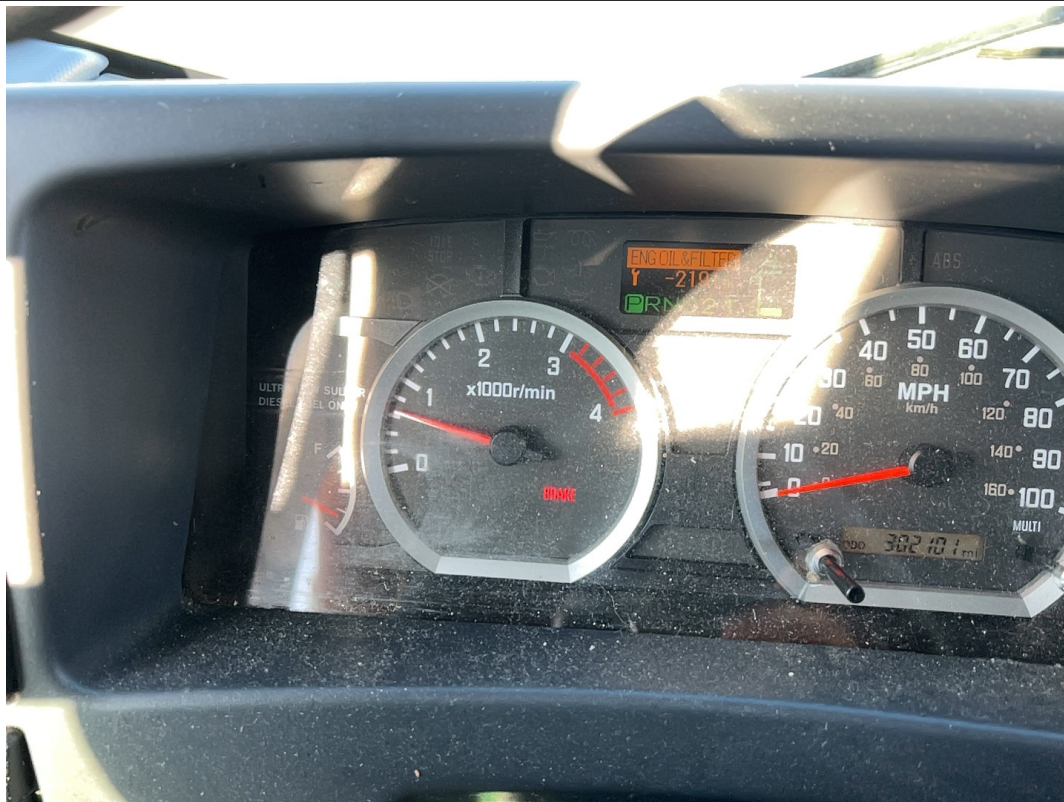
EMS Warning Lights / 09-07-2023

Visible Damages	
Sheet Metal Panels	The panels are scratched and have dents in them on the box.
Lip Bent	The rear right top lip on the box is bent.
Service Due	The engine oil and filter replacement warnings are active.
Floor Mat	The floor mat is torn and worn.
Door Rubber Strip	The rubber strip is falling off around the bottom of the right door.
Right Outer Drive Tire	The tire has a gouge in the tread.
Left Drive Tires	Both tires' treads seem to be worn.
Shocks	The front shocks are leaking.
Rear Left Bumper	The bumper is missing a plastic end cap.
Engine Belts	The belts are squeaking.
Warning Light	The left warning light on the lift gate platform is damaged and not working.

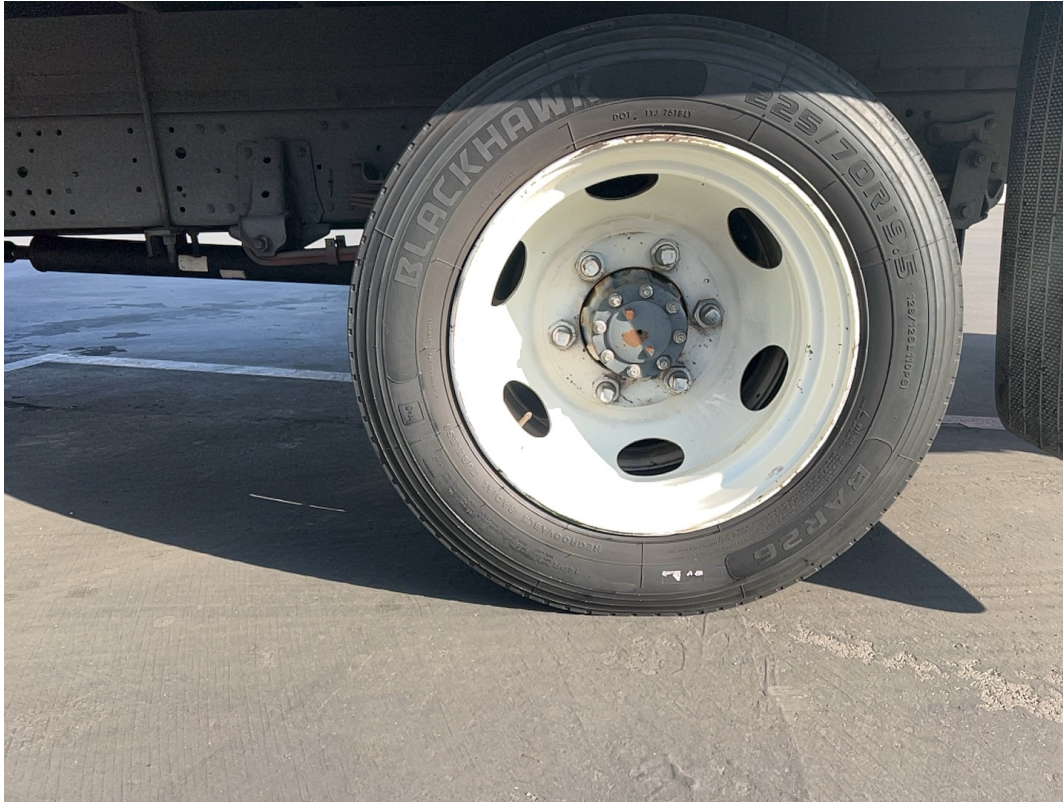
Left Outer Drive Tire Condition / 09-07-2023

Left Steer Tire Condition	No Damages Observed
Left Steer Tire Brand	Blackhawk
Left Steer Tire Size	225/70R19.5
Left Outer Drive Tire Condition	See Notes
Left Outer Drive Tire Brand	Blackhawk

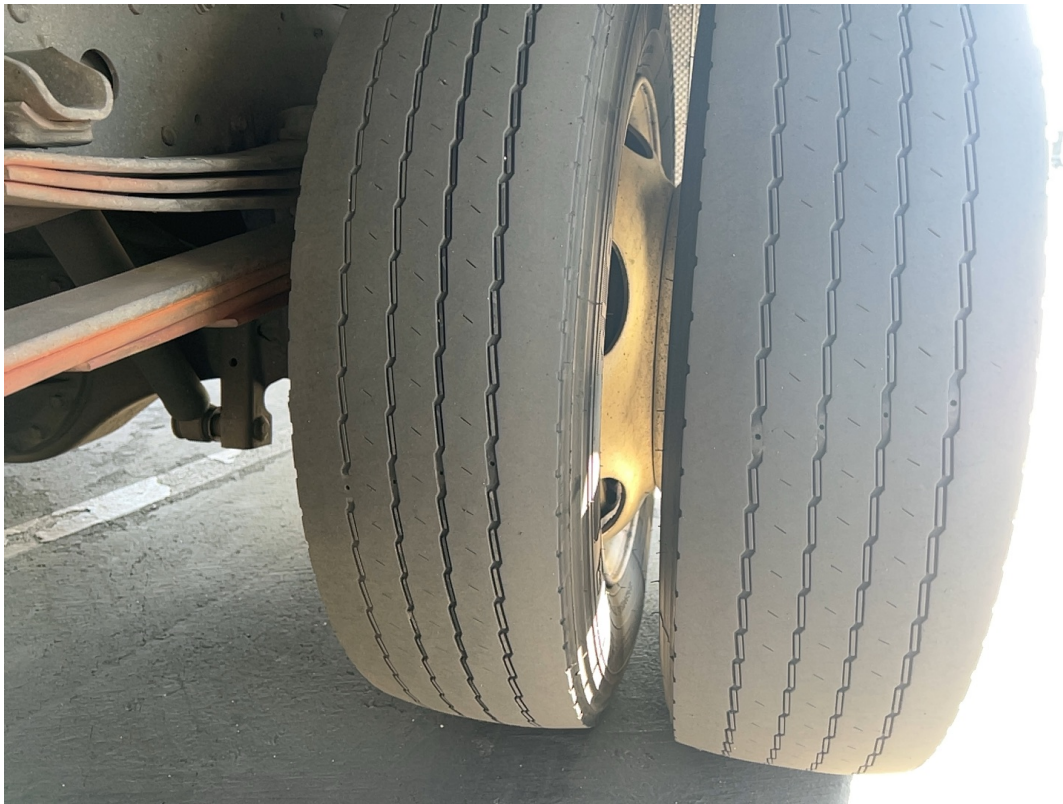
Left Outer Drive Tire Condition / Left Inner Drive Tire Condition / 09-07-2023

Left Outer Drive Tire Size	225/70R19.5
Left Inner Drive Tire Condition	See Notes
Right Steer Tire Condition	No Damages Observed
Right Steer Tire Brand	Blackhawk
Right Steer Tire Size	225/70R19.5
Right Outer Drive Tire Condition	See Notes
Right Outer Drive Tire Brand	Blackhawk
Right Outer Drive Tire Size	225/70R19.5
Right Inner Drive Tire Condition	No Damages Observed
Axle Information	F: 7,275 LBS / R: 13,660 LBS
Transmission Information	RSU
Engine Information	Isuzu 4HK1TC / 210 HP / 5.2L
