Aspen Field Services

Job #: 60605 /

20' DRY VAN BODY, DIESEL 2019 - ISUZU NPR-XD - LA130074 / LA130074

| Specifications | |
|---|--|
| Date of Inspection | 09/21/2023 |

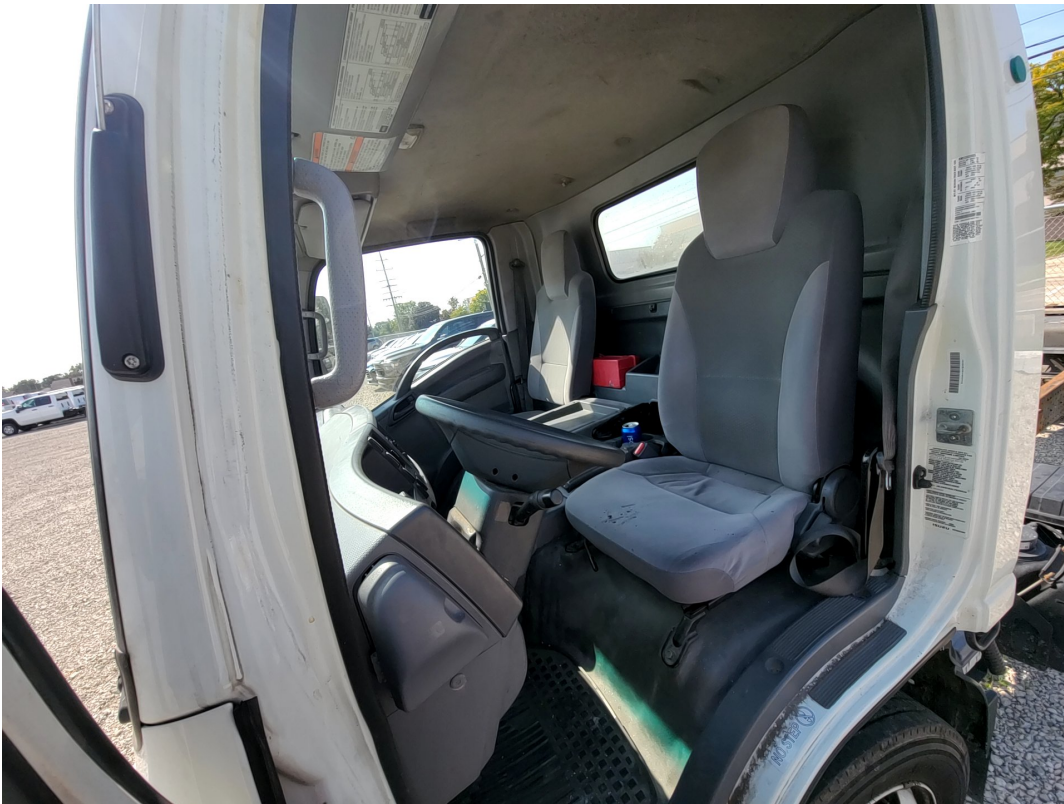
Driver's Seat / 09-21-2023

| Specifications | |
|---|--|
| Driver's Seat | See Notes |

| Visible Damages | |
|---|--|
| Driver's Seat | The bottom seat cushion has holes in it. |

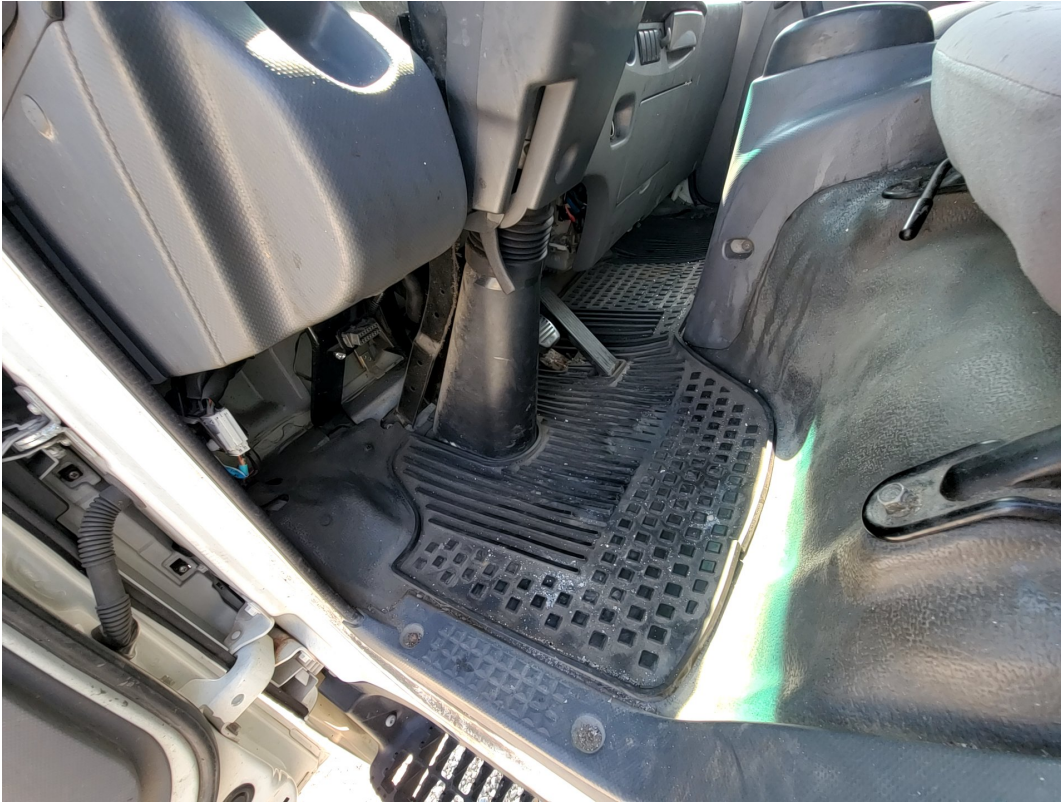
Floorboard / 09-21-2023

| Specifications | |
|---|--|
| Floorboard | See Notes |

| Visible Damages | |
|---|--|
| Floor Mat | The black rubber floor mat is worn through. |
| Gray Floor Cover | The cover is ripped on the passenger side. |

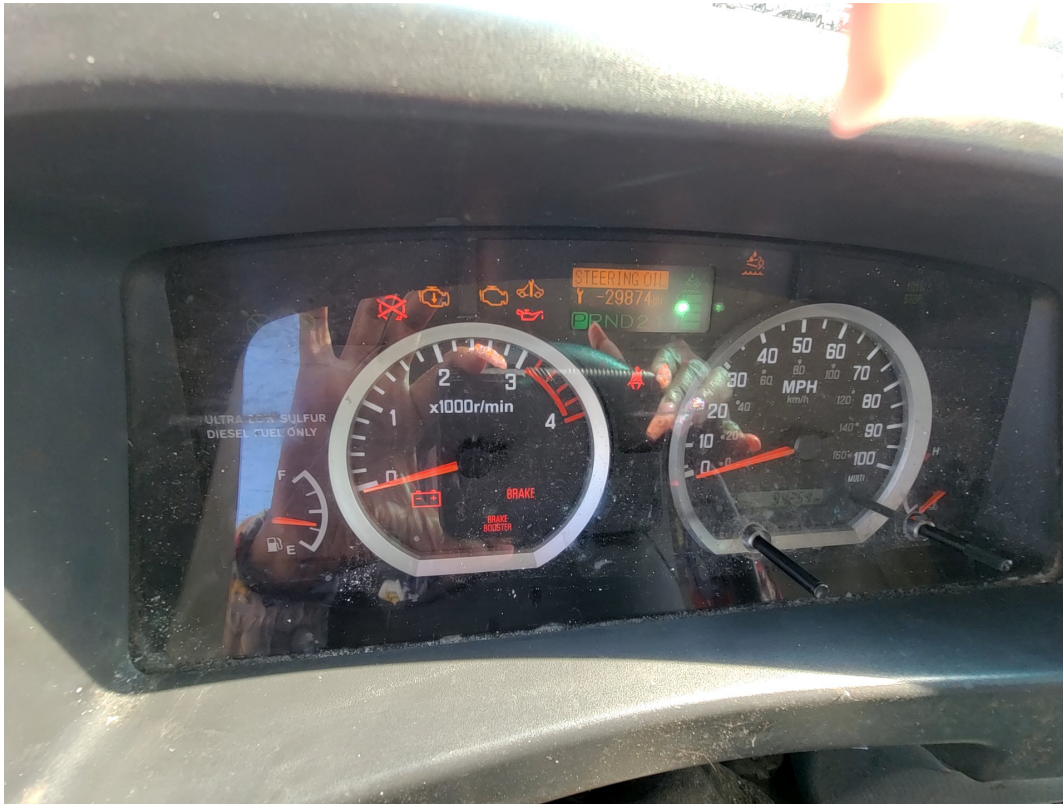
EMS Warning Lights / 09-21-2023

| Specifications | |
|---|--|
| EMS Warning Lights | Active Warnings |

| Visible Damages | |
|---|--|
| Steering Oil Service | The dash is showing that the steering oil service is past due. |

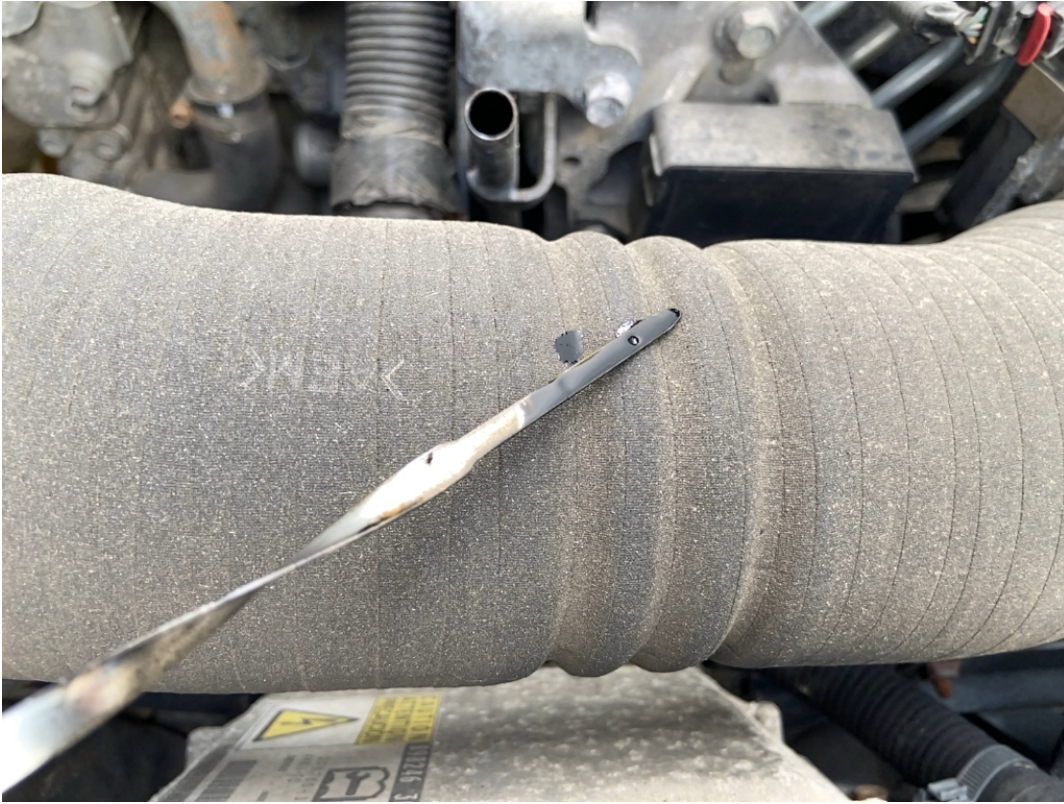
Oil Dipstick / 09-21-2023

| Specifications | |
|---|--|
| Oil Dipstick | Good Level / Dark Color |

| Visible Damages | |
|---|--|
| Engine Oil | The engine oil is dark in color. |

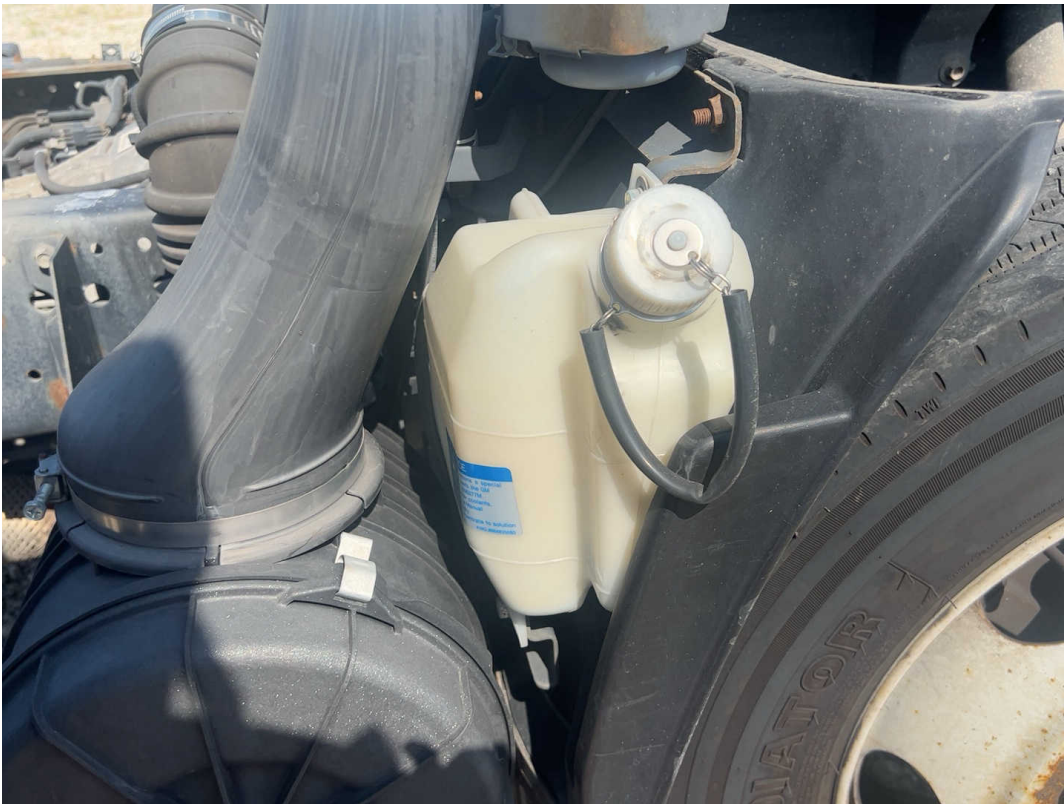
Coolant Level / 09-21-2023

| Specifications | |
|---|--|
| Coolant Level | Low Level |

| Visible Damages | |
|---|--|
| Coolant | The coolant is low in the reservoir. |

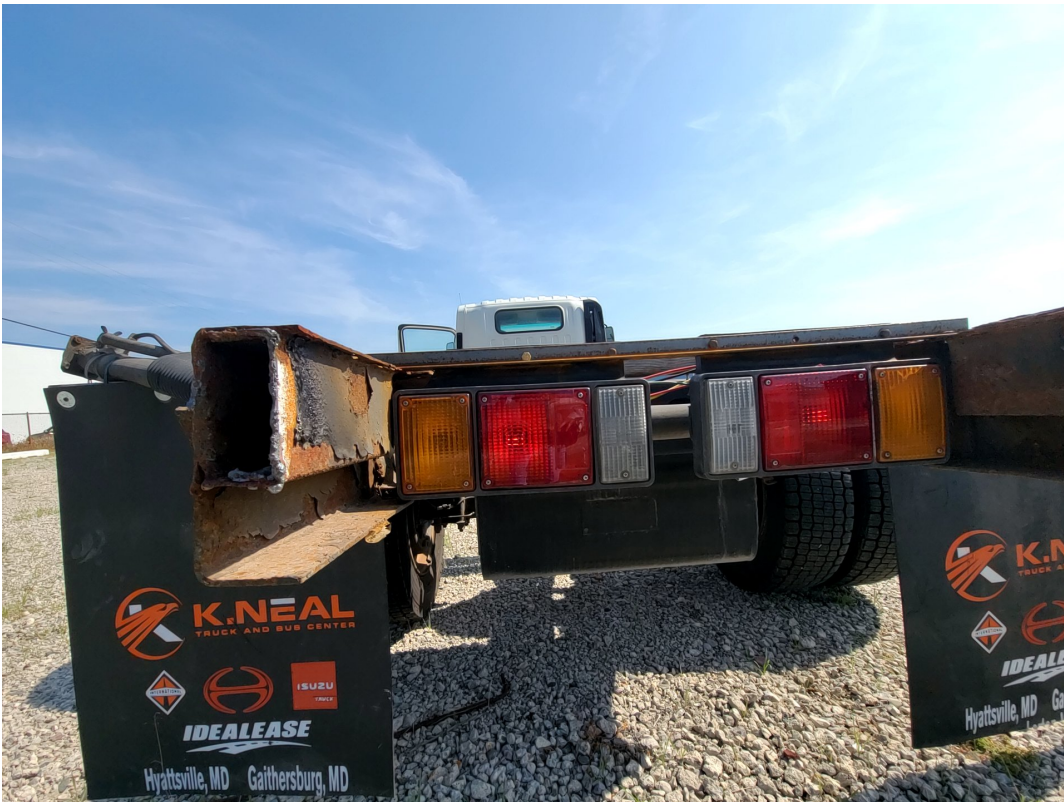
Rear Lights / 09-21-2023

| Specifications | |
|---|--|
| Rear Lights | See Notes |

| Visible Damages | |
|---|--|
| Signal Light Lens | The rear right signal light lens is cracked. |
