DIESEL 2020 - ISUZU FTR CHASSIS - LA130109 / LA130109

Specifications

Job #: 59616 /

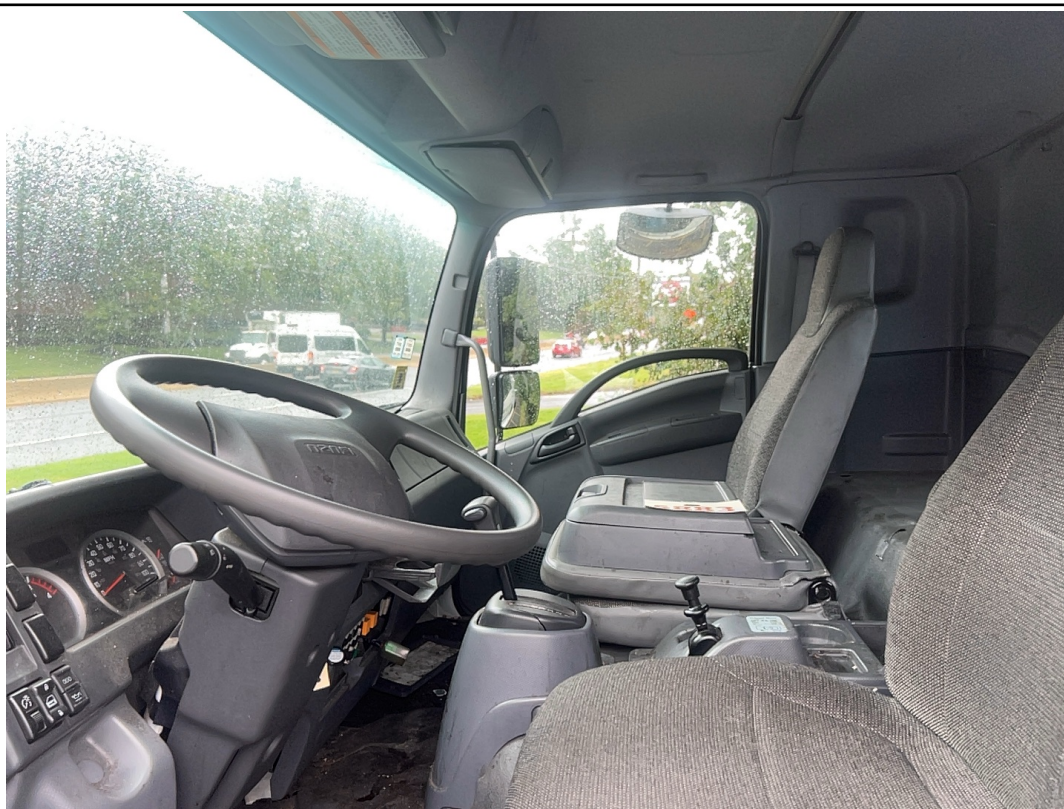
Cab Interior / 09-18-2023

Missing Panel	There is a panel missing from the dash below the cup holders and is laying on the passenger's floor.
Shift Lever Console	The plastic console is cracked on the shifter housing.
Front Bumper	The front bumper is bent.
Taillights	The taillights are missing.
Coolant	The coolant is low in the reservoir.
Engine Oil	The engine oil is dark in color.
Brake Chamber Spring	The spring in the brake chamber is possibly damaged. The spring is not centered in the chamber and the dirt plug is not installed in the hole.
Driver's Seat	The driver's seat is stained.
EMS Warnings	The dash is showing a Regen Required warning.
