Aspen Field Services

Job #: 60453 /

16' MORGAN DRY VAN BODY, DIESEL 2020 - ISUZU NPR-HD / LA130166

Specifications

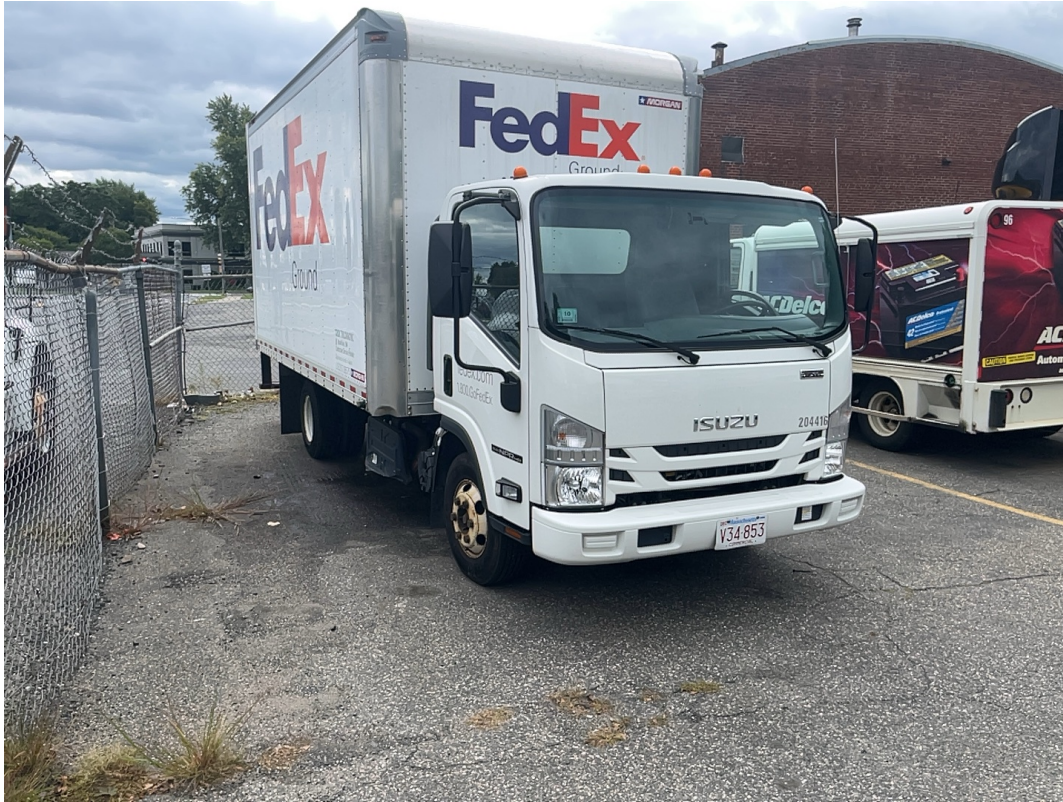
Front Right / 09-19-2023

Visible Damages	
Driver's Door	The driver's door is dented.
Clearance Light	The top left clearance light lens is missing.
Sheet Metal Panels	The panels on the truck box are scratched and some have dents.
Driver's Seat	The bottom seat cushion has a hole in the material.
Passenger's Seat	The seats are stained.
Interior	The interior is dirty.
Rubber Floor Mat	The rubber floor mat is worn through on the driver side..
Engine Oil	The engine oil and filter need to be changed.
Tail light	The rear right tail light bezel is cracked.
Wheel	The rear right outer wheel is bent on the lip.
Left Steer Tire	The tire is worn on the inside shoulder.
Rear Bumper	The rear bumper is rusty.
Front Right Corner	The corner of the box has a small dent.
