# 16' VAN BODY, GAS 2020 ISUZU NPR-HD (LA137591) / LA137591

## Aspen Field Services

Job #: 59439 /

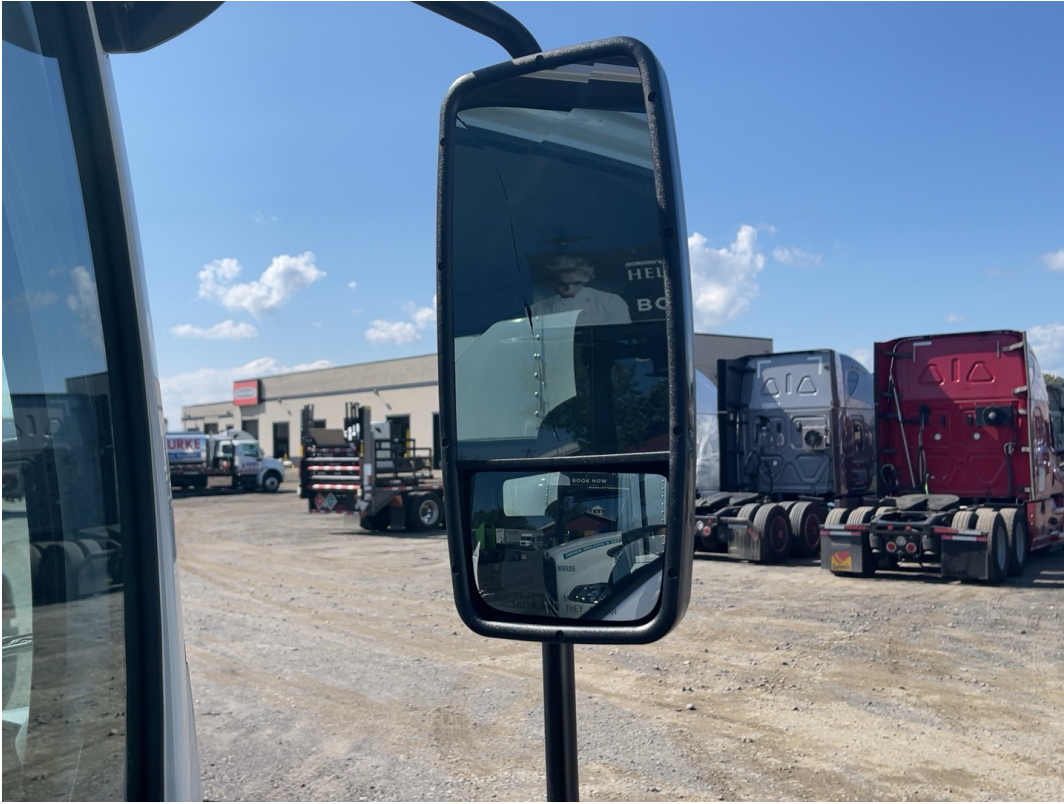
Mirrors / 08-30-2023

Catalytic Converters	Both of the catalytic converters are missing.
Mirror	The right mirror is cracked.
Plywood	The plywood panels in the box are damaged on the bottom.
Sheet Metal Panels	A couple of the metal panels on the front of the box are bent behind the cab.
Coolant Cap	The cap is missing.
Coolant	The coolant is low in the reservoir.
Engine Oil	The oil level on the dipstick is low.
Rear Right Platform	The aluminum strip is bent under the rear platform.

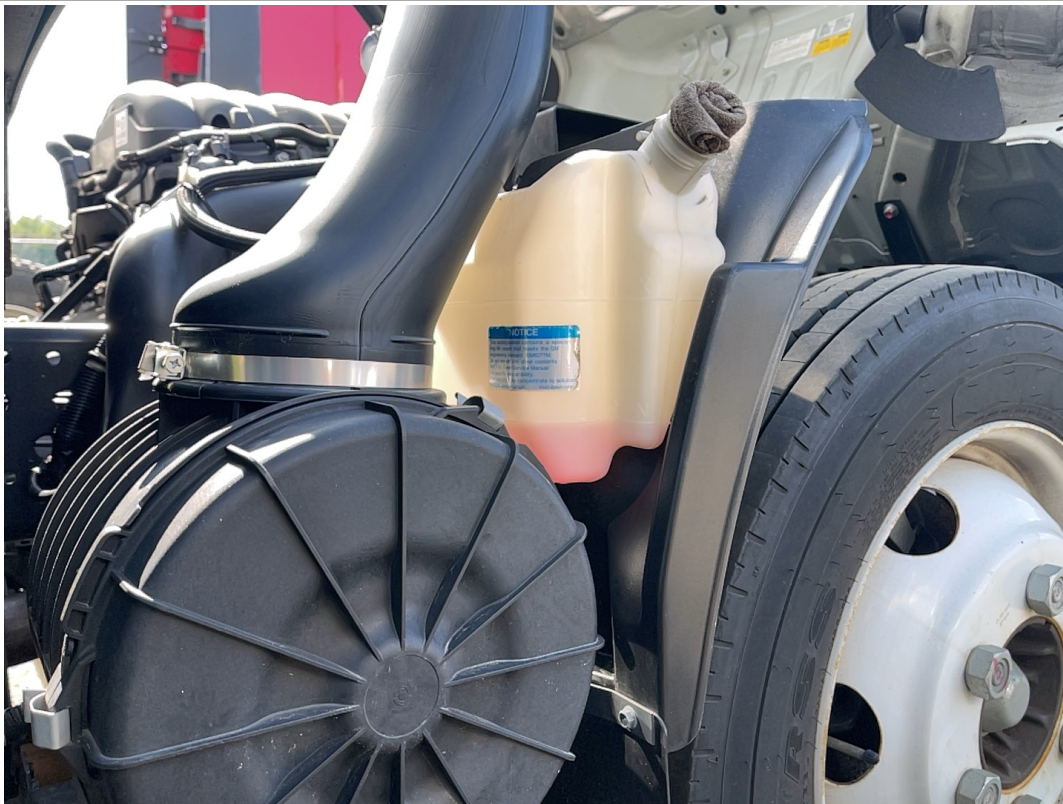
Coolant Level / 08-30-2023

The unit was left with a missing catalytic converter and a rag in place of a coolant cap. Therefore, the truck was not started during the time of the inspection, in order to avoid further damage to the engine. The Engine Information was obtained from a VIN-Decoding software.
