Inspection Detail

Client:	Isuzu Finance	
	Inspected by:	Victor Carreras	
	Location of Inspection:	64 Union St, Brooklyn, NY 11231, USA	
	Phone No / Email:	+1 201 954 4480 / dgenes@mileautogroup.com	
	Date of Inspection:	2/14/2025	Job#: 868ceqbt
	Year:	2019	Make: Isuzu
	Model:	NPR/NPR-HD	VIN: 54DC4W1B7KS811995

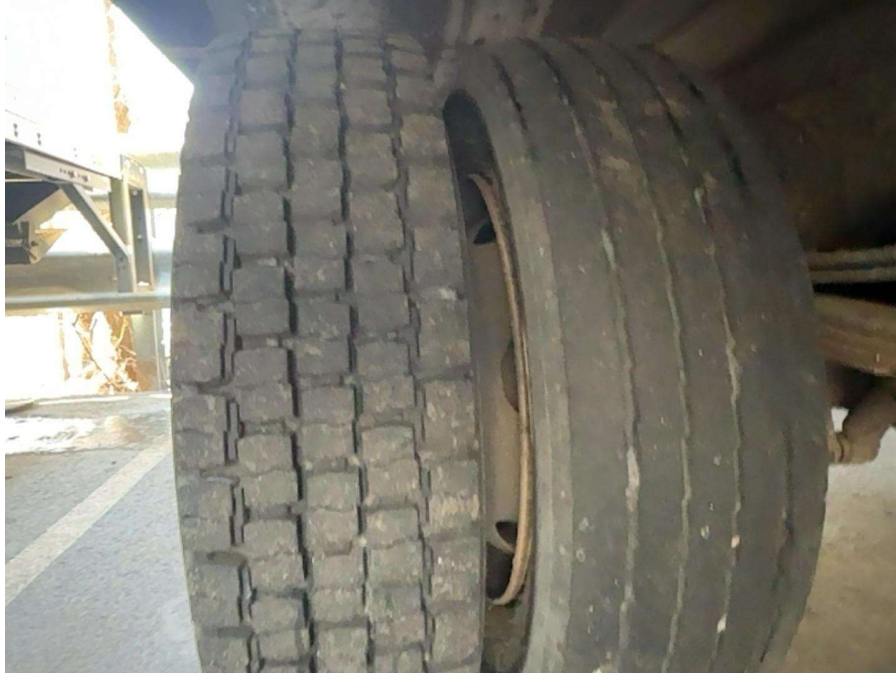
First Right Outer Drive Tire Condition / First Right Inner Drive Tire Condition

Wear and Tear Items	
Item Name	Item Comments
Decal Peeling	The decal is peeling on the front top of the box.
Corner Cover	The bottom edge of the right corner cover has a dent.
Sheetmetal Panels	The sheet metal panels on the box are spray-painted and damaged.
First Right Inner Drive Tire	The tire appears flat and coming off the wheel, and the tread shows wear on the outside shoulder.
Shocks	The front and rear shocks appear oily and leaking.
First Left Steer Tire	The steer tire is worn out on the inner shoulder.
Engine Oil	The engine oil appears to be above the full mark on the dipstick.
Left Door	The left door appears to be dented on the front corner.
Taillights	The left taillight is missing, and the housing is rusty.
Front Bumper	The bumper appears to have scratches on the front left side.
Driver's Seat Material	The material on the seat appears to be stained.
Climate Control Module	The selector knob on the module is missing, and the tip inside where the knob attaches appears to have been broken off.

Repair Items			
Item Name	Item Labor Cost	Item Part Cost	Total Cost
Decal Peeling	\$300.00	\$200.00	\$500.00
Corner Cover	\$300.00	\$250.00	\$550.00
Sheetmetal Panels	\$900.00	\$2,500.00	\$3,400.00
First Right Inner Drive Tire	\$150.00	\$400.00	\$550.00
Shocks	\$150.00	\$325.00	\$475.00
First Left Steer Tire	\$150.00	\$400.00	\$550.00
Left Door	\$150.00	\$780.00	\$930.00
Front Bumper	\$150.00	\$750.00	\$900.00
Climate Control Module	\$150.00	\$400.00	\$550.00
Dash Panels	\$300.00	\$300.00	\$600.00
Front Left Corner	\$150.00	\$350.00	\$500.00
Total Repairs:			\$9,505.00
