Inspection Detail

Client:		Isuzu Finance
	Inspected by:		Mearl Martin
	Location of Inspection:		909 N Grand Ave, Santa Ana, CA 92701, USA
	Phone No / Email:		+1 800 638 1015 / dvillafana@ttruck.com
	Date of Inspection:	Job#:	868c528fj
	Year:	Make:	Isuzu
	Model:	VIN:	JALE5W166L7302240

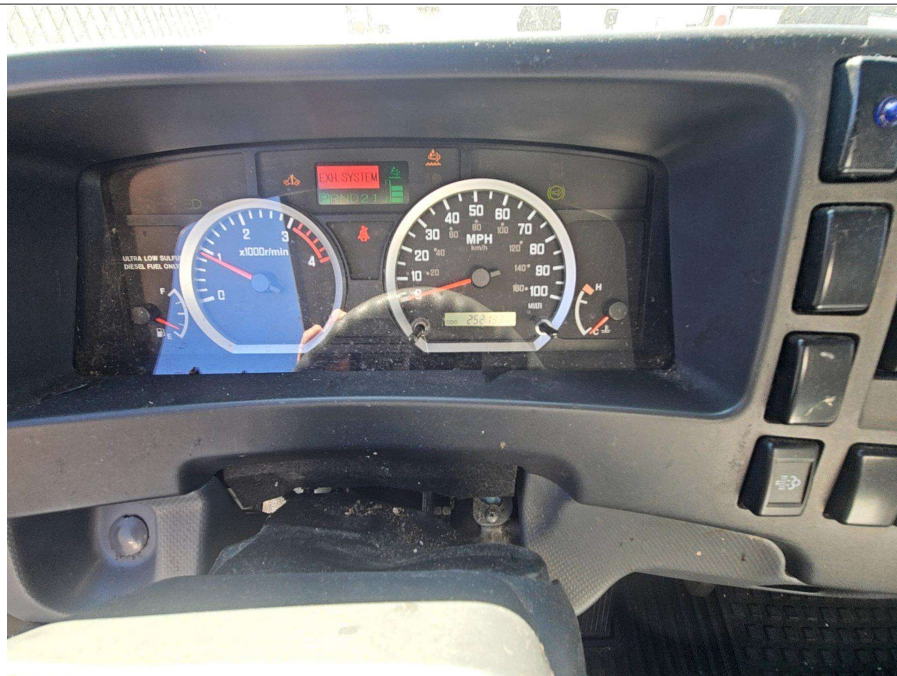
EMS Warning Lights

Wear and Tear Items	
Item Name	Item Comments
Taillight	The left taillight appears to be slightly bent downward.
Grab Handle	The grab handle is missing from the rear right door frame of the box.
Rubber Boots	The rubber boot protectors on the rear lift cylinders are torn.
Lift Platform Cylinder	The left cylinder for the lift platform appears to be leaking.
Mud Flap	The front left mud flap appears to be broken off at the bottom.
Front Shocks	The front shocks are leaking and appear to be oily.
First Right Inner Drive Tire	The drive tire treads are worn down
First Left Outer Drive Tire	The drive tire treads appear worn down.
Engine Oil	The engine oil is dark in color.
Backup Alarm	The backup alarm is not operational.
Floor Mat	The floor mat shows wear on both the driver's and passenger's sides.
Warnings	The unit has warning lights on the dash at the time of inspection.
Top Lip	The top lip on the right side of the box is dented.

Repair Items			
Item Name	Item Labor Cost	Item Part Cost	Total Cost
Lift Platform Cylinder	\$300.00	\$300.00	\$600.00
Floor Mat	\$150.00	\$250.00	\$400.00
Warnings	\$900.00	\$3,000.00	\$3,900.00
Top Lip	\$450.00	\$250.00	\$700.00
Sheetmetal Panels	\$1,200.00	\$2,500.00	\$3,700.00
Total Repairs:			\$9,300.00

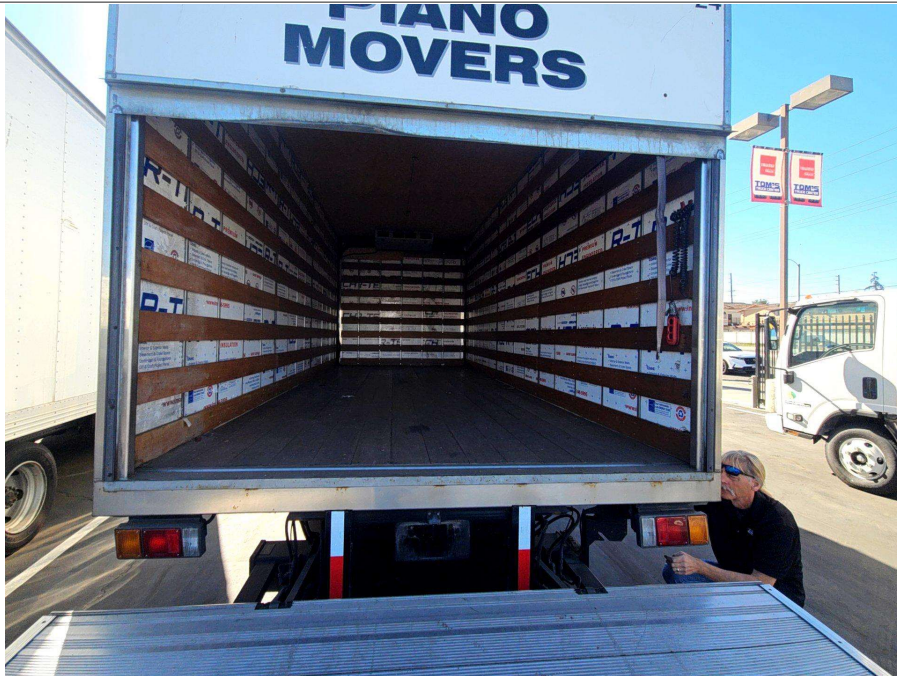
**Box Condition**

Rear Right Bumper	The bumper appears to be bent inward.
Sheetmetal Panels	The sheet metal panels on the unit are scratched.
