Inspection Detail

Client:		Isuzu Finance
	Inspected by:		Mark Hamilton
	Location of Inspection:		6225 State Rd., Philadelphia, PA 19135, USA
	Phone No / Email:		+1 610 220 0514 / fhalper@bentleytruckservices.com
	Date of Inspection:	Job#:	868dmgmjm
	Year:	Make:	ISUZU
	Model:	VIN:	54DK6S168JSG00601

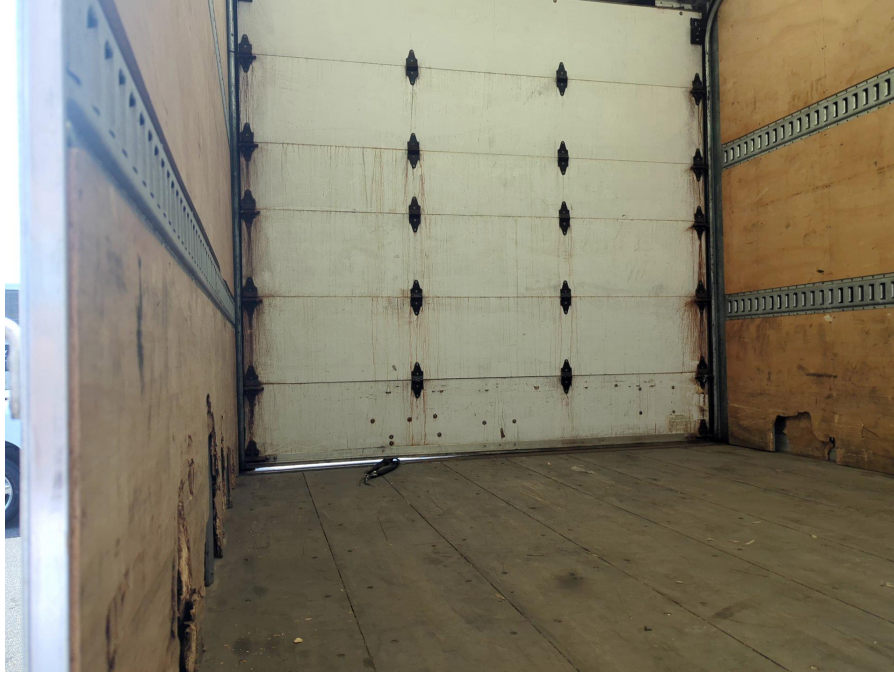
Box Condition

Wear and Tear Items	
Item Name	Item Comments
Dock Bumper	The rear right rubber dock bumper appears to be damaged.
Lift Gate Platform	There is a hole on the underside of the aluminum platform.
Right Steer Tire	The tire treads appear to be wearing along the inner edge.
Rear Differential	The front seal on the rear differential appears to be leaking or shows signs of a past leak.
Plywood	The plywood interior panels inside the box are damaged.
Engine Oil	The engine oil appears dark in color.
Warning	The check engine light was illuminated on the dash at the time of inspection.
Right Step	The right step for the door on the right side of the box is bent.
Sheetmetal Panel	The side sheetmetal panels are scratched.
