| Inspection Detail | | | |
| | <b>Date of Inspection:</b> | 5/12/2025 | <b>Job#:</b> 868dvrvg1 |
| | <b>Year:</b> | 2021 | <b>Make:</b> ISUZU |
| | <b>Model:</b> | NRR | <b>VIN:</b> JALE5W168M7300412 |

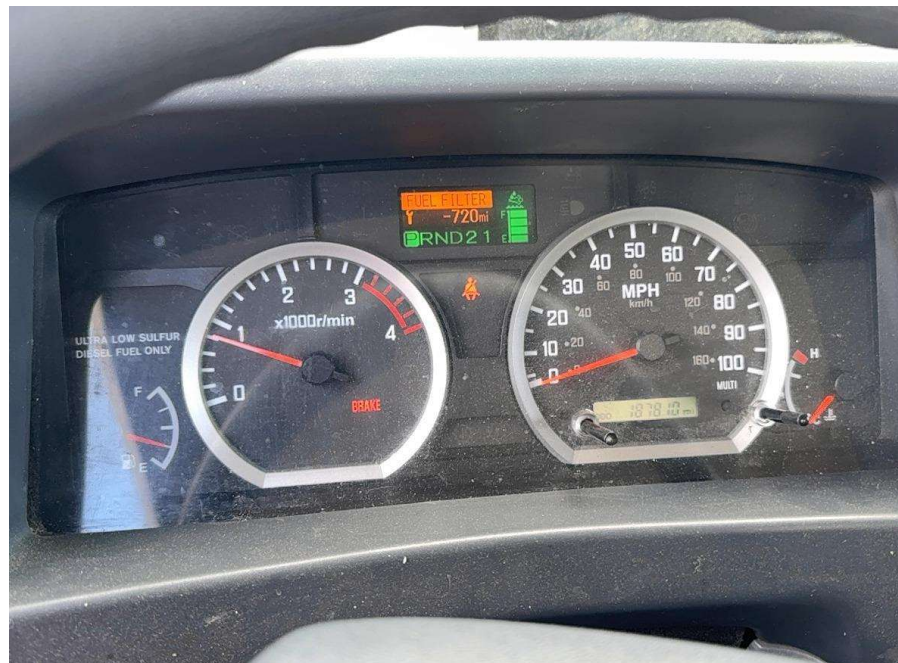
**EMS Warning Lights**

| <b>EMS Warning Lights:</b> | Yes | | | | |

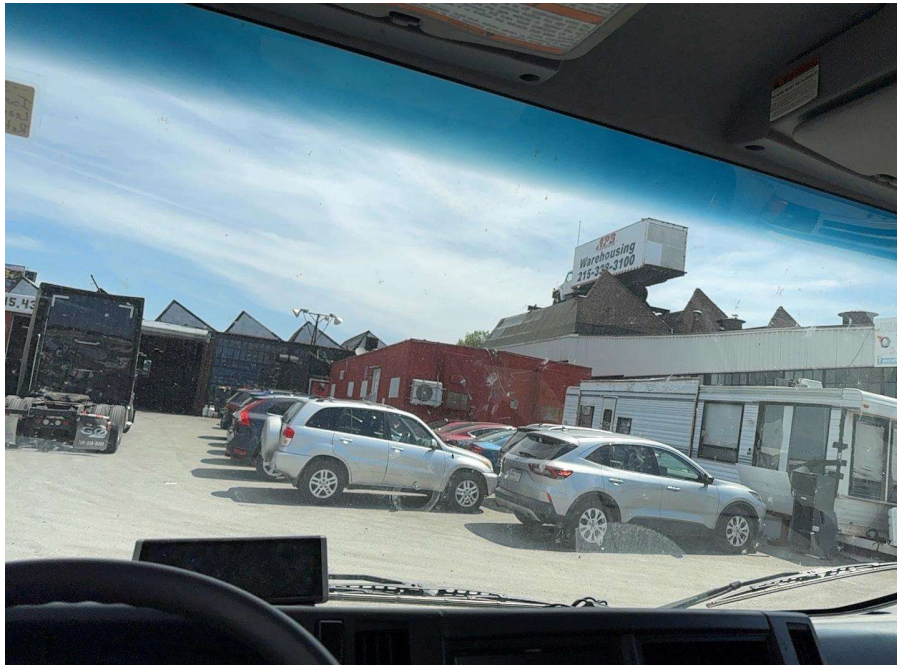
**Cab Interior**

| Wear and Tear Items | |
|---|---|
| Cleaning | Cab interior dirty and seats have spots on them. |

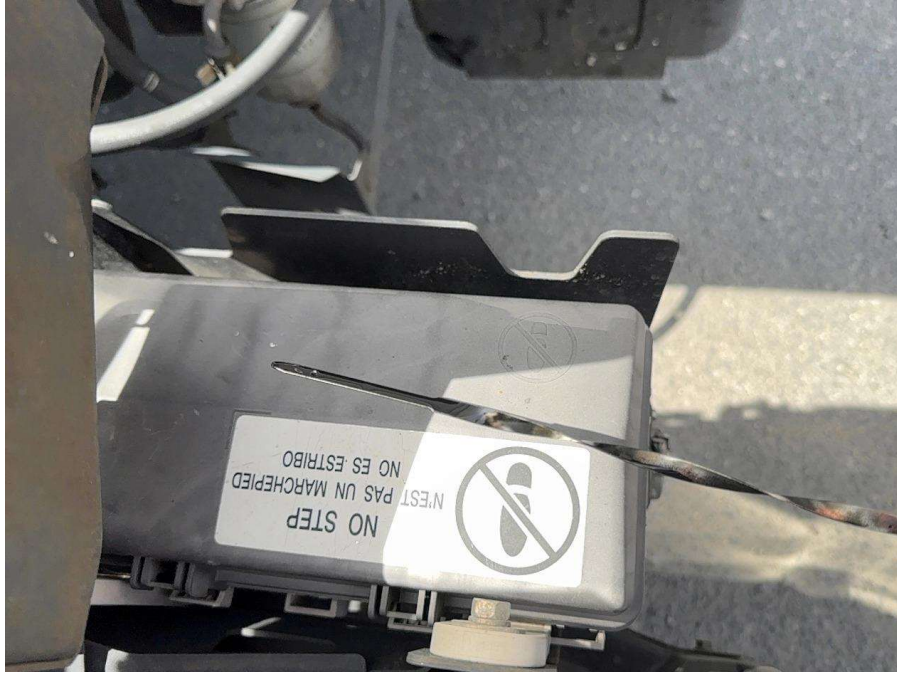
**Oil Dipstick**

| Wear and Tear Items | |
|---|---|
| Oil Change | The oil and oil filter need to be changed. |

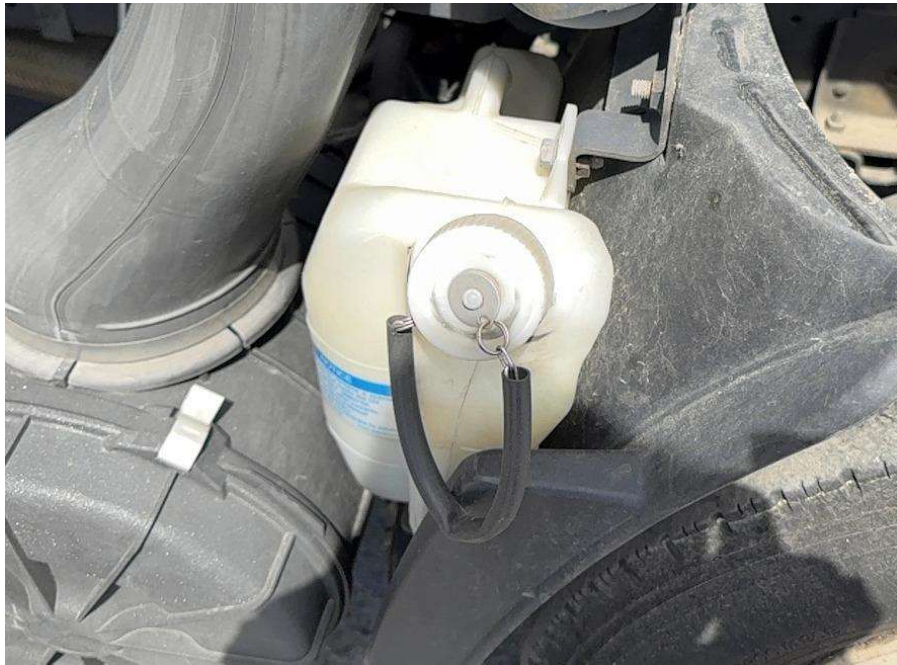
**Coolant Level**

| Wear and Tear Items | |
|---|---|
| Coolant Low | The coolant level is low. Refill and check for leaks. |

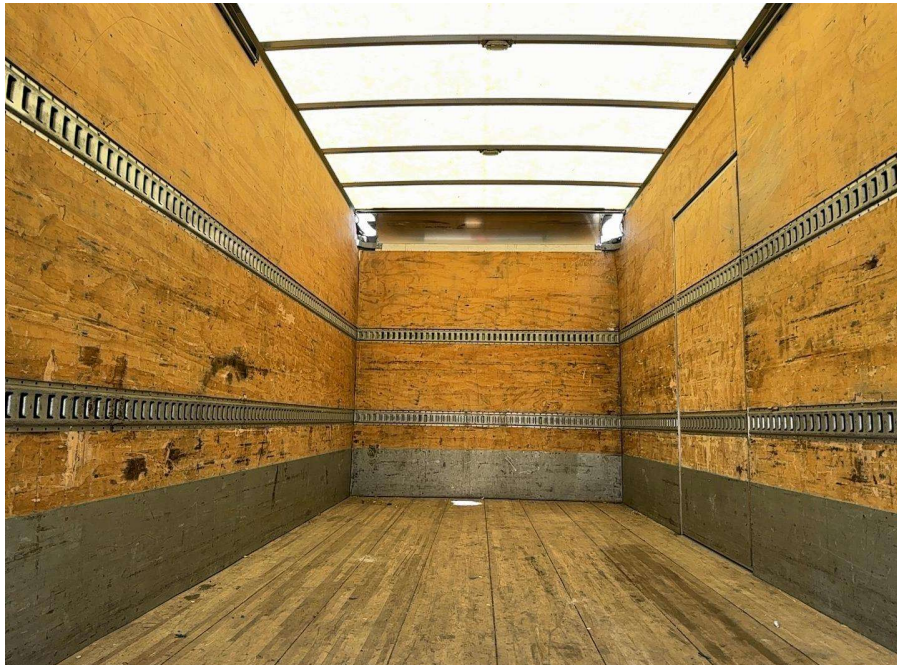
**Box Condition**

| Wear and Tear Items | |
|---|---|
| Paint | The paint is damaged in a few different areas and needs to be addressed. |
| Box Corner Caps | The box corner caps are busted and need to be replaced. |

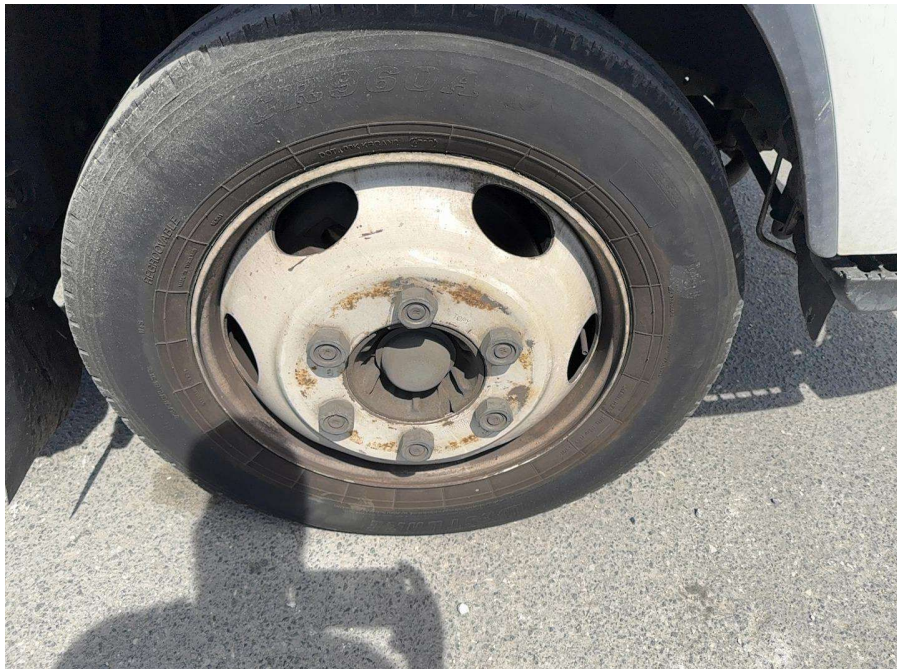
**First Right Steer Tire Condition**

The unit starts and operates. The unit is dirty. The right side steer tire is worn unevenly and has pits, indicating the unit might need an alignment. The fuel filter needs to be replaced. A full service is needed if the fuel filter is overdue. The lift gate needs maintenance or replacement. The paint on the box is in rough shape. The coolant appears to be low. The exhaust is rusted and the DPF heat shield is dented. The box has broken corner caps and is scratched and dirty above the cab and in the rear. The front tires are included in the damages due to poor alignment. They do not need to be replaced at this time, but if the truck receives an alignment, the tires will need to be replaced.

| Wear and Tear Items | |
|---|---|
| Front Steer Tires | The front tires have odd and uneven tread wear, indicating a bad alignment. |

| Wear and Tear Items | |
|---|---|
| Alignment | Tires wearing weird, alignment needed for safe driving |
