Inspection Detail

<b>Client:</b>	Isuzu Finance	
	<b>Inspected by:</b>		
	<b>Location of Inspection:</b>	2425 Broadway St NE, Minneapolis, MN 55413, USA	
	<b>Phone No / Email:</b>	+1 612 616 2017 / curran.maguire@transwest.com	
	<b>Date of Inspection:</b>	6/13/2025	<b>Job#:</b> 868e9u9rz
	<b>Year:</b>	2020	<b>Make:</b> ISUZU
	<b>Model:</b>	NPR-HD	<b>VIN:</b> 54DC4W1B8LS801655

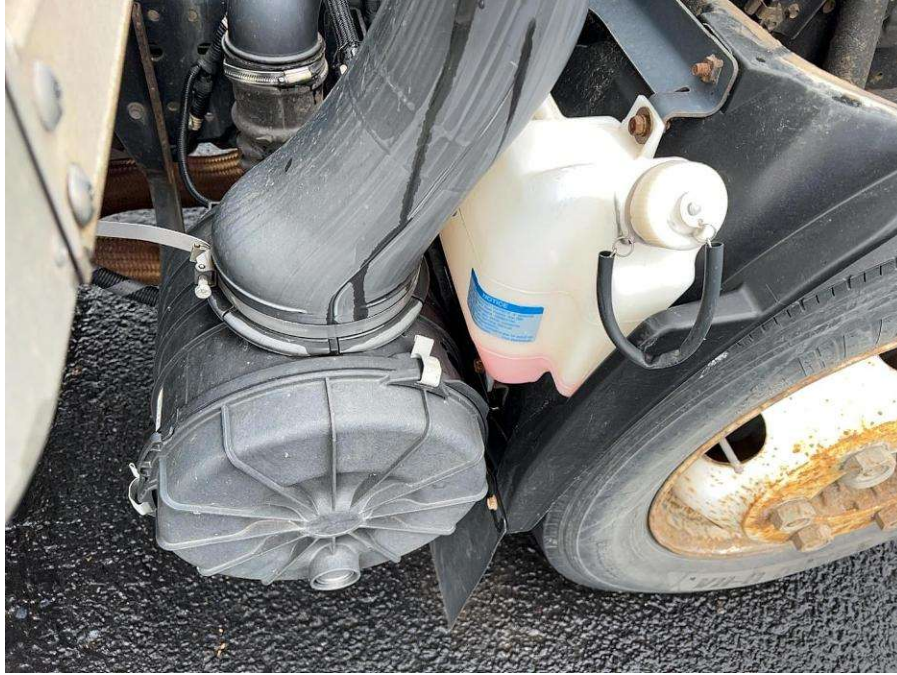
**Coolant Level**

<b>Engine Compartment:</b>	No Damages Observed	<b>Oil Dipstick:</b>	Good Level / Dark in Color	<b>Coolant Level:</b>	Low Level
<b>Engine Serial Plate:</b>	Obstructed

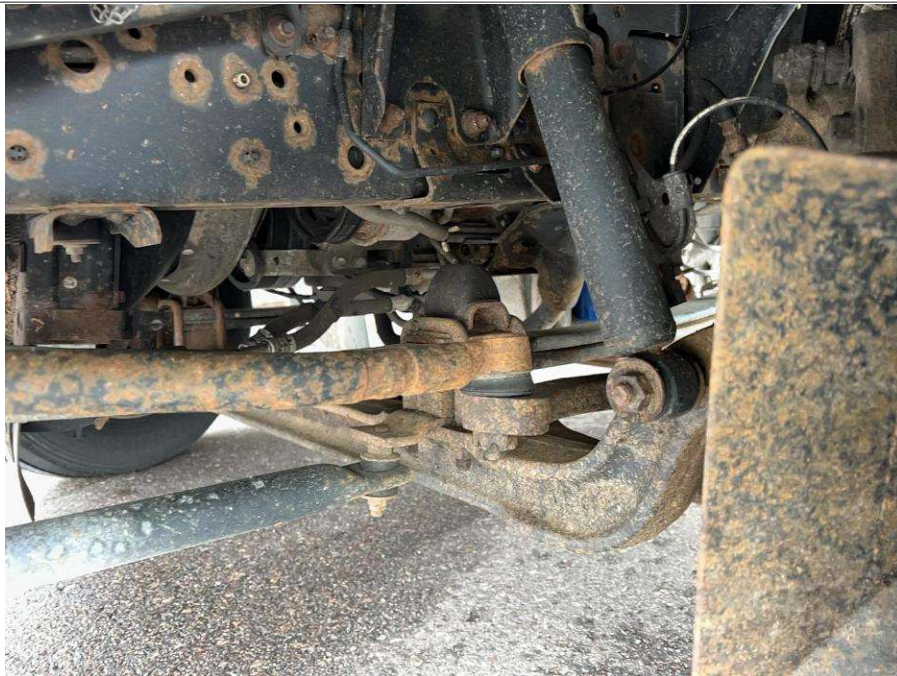
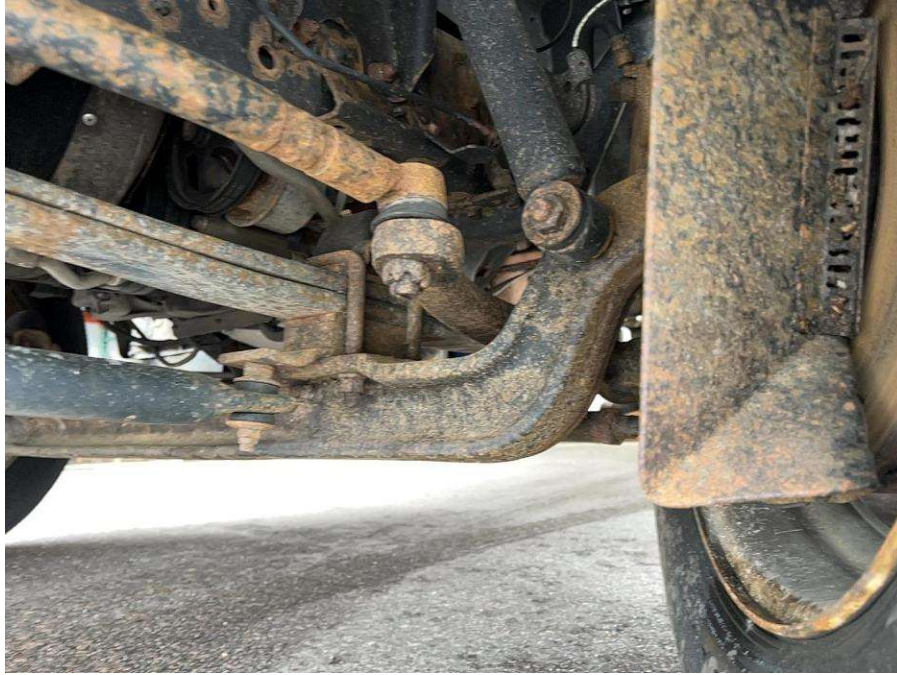
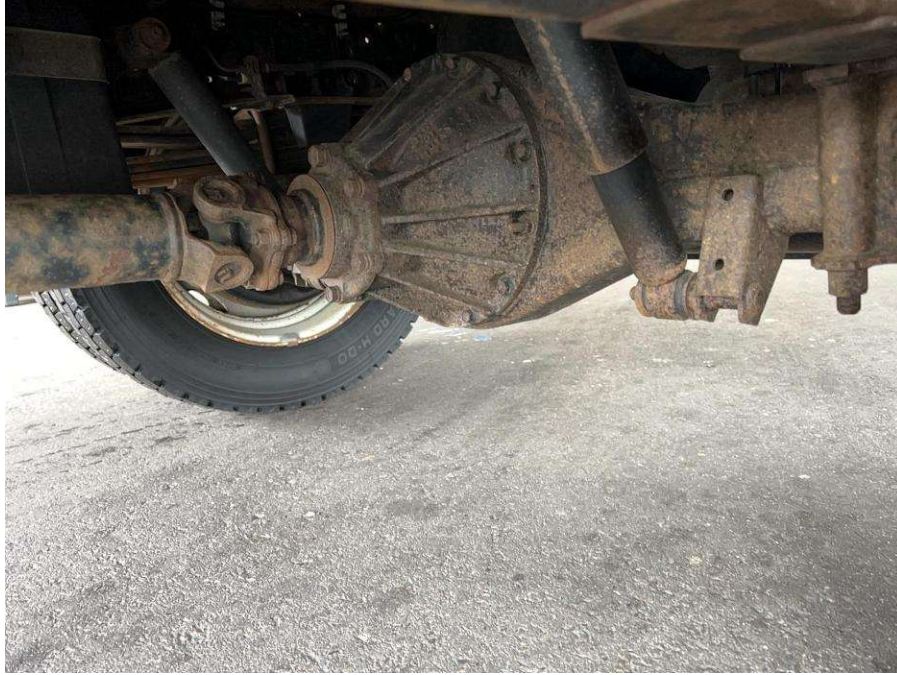
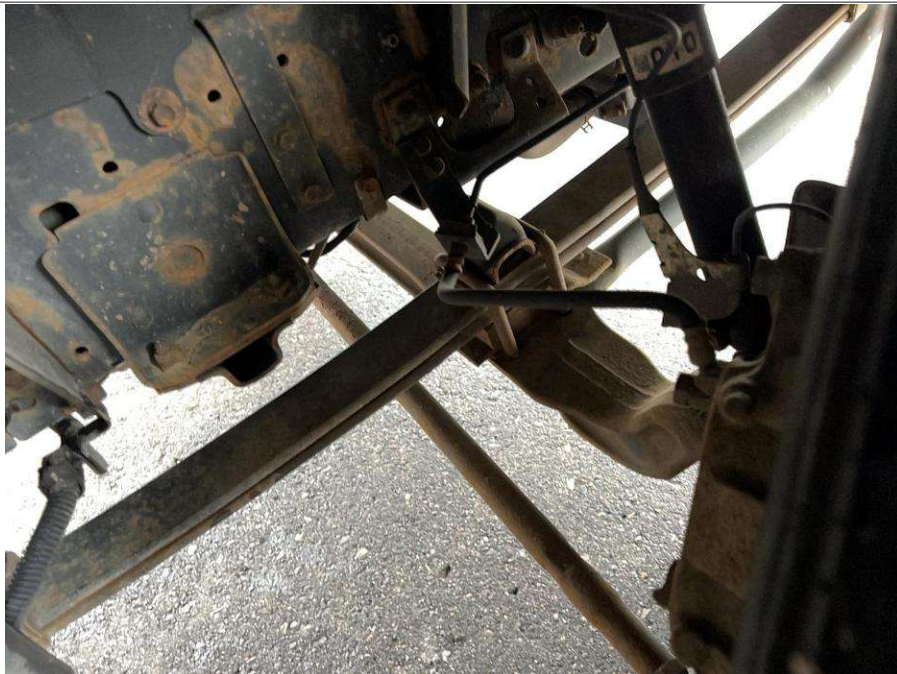
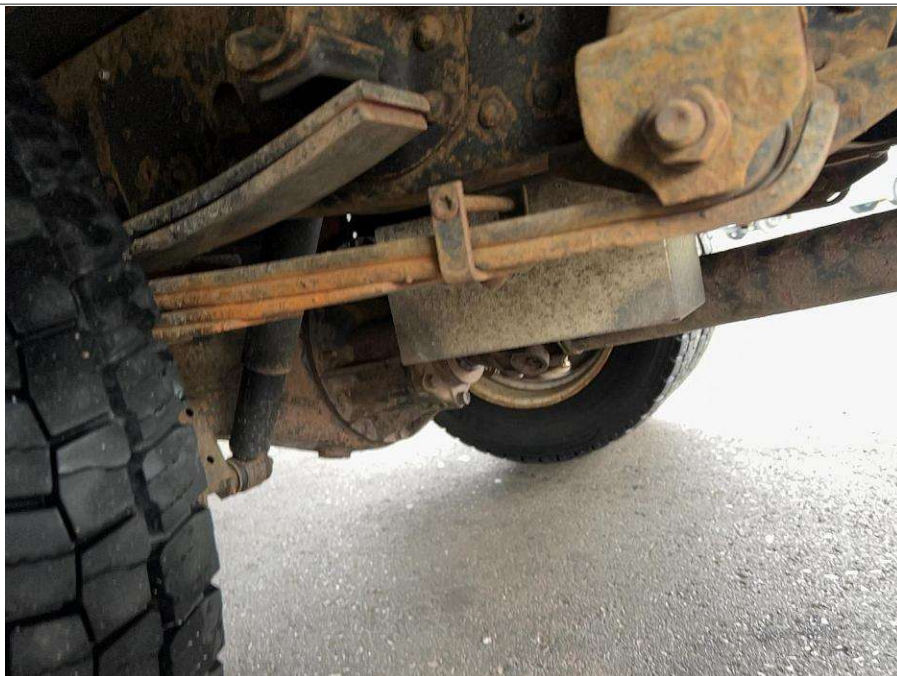
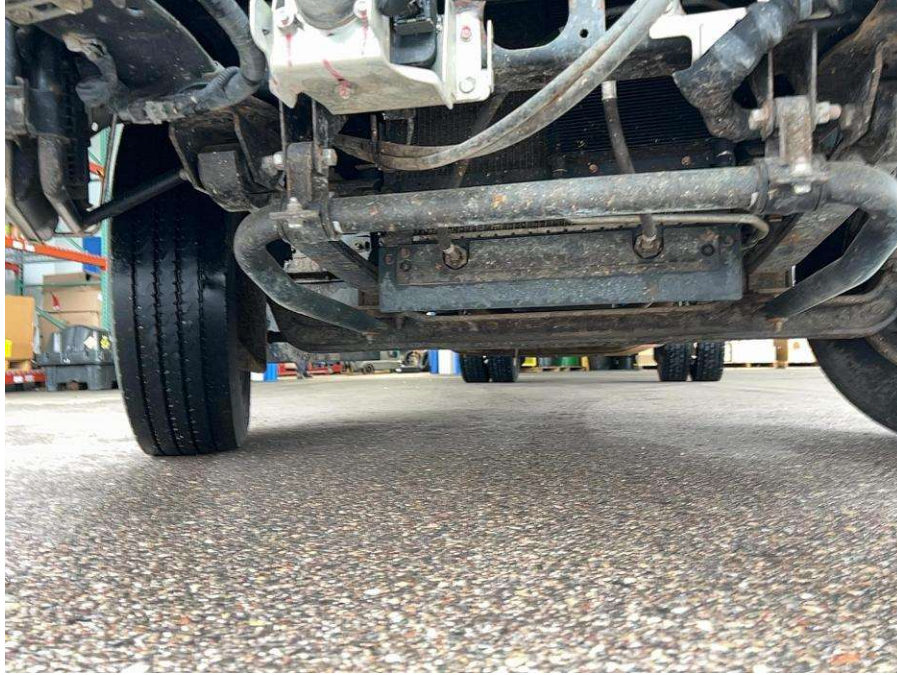
**Axles / Suspension**

Wear and Tear Items	
Item Name	Item Comments
Rust Damage	There is rust on the frame, rear Mansfield bar, and exhaust. The rust is slowly peeling the paint on the frame.
Front Ball Joints	The front steering ball joints are worn and can be replaced.
Oil Change	The oil is dark and should be replaced.
Coolant Low	The coolant level is low and needs to be refilled.
Drivers Side Steps	The driver's side plastic steps are broken and can be replaced.
Paint	The paint on the Mansfield bar and the frame has succumbed to rust, and the unit can be repainted.
Interior Dirty	The interior is dirty and has residue from a spilled drink that needs to be cleaned.
Turn Signals	The turn signals were not used in the operational video and may be inoperational.
