### Inspection Detail

<b>Client:</b>	Isuzu Finance		
<b>Inspected by:</b>	Jesse Herrera		
<b>Location of Inspection:</b>	8101 Daytona Road NW, Albuquerque, NM 87121, EUA		
<b>Phone No / Email:</b>	+1 505 839 5900 / esmith@brucknertruck.com		
<b>Date of Inspection:</b>	6/24/2025	<b>Job#:</b>	868d9by51
<b>Year:</b>	2022	<b>Make:</b>	Chevrolet
<b>Model:</b>	17CG33503	<b>VIN:</b>	1GB0GRF71N1271837

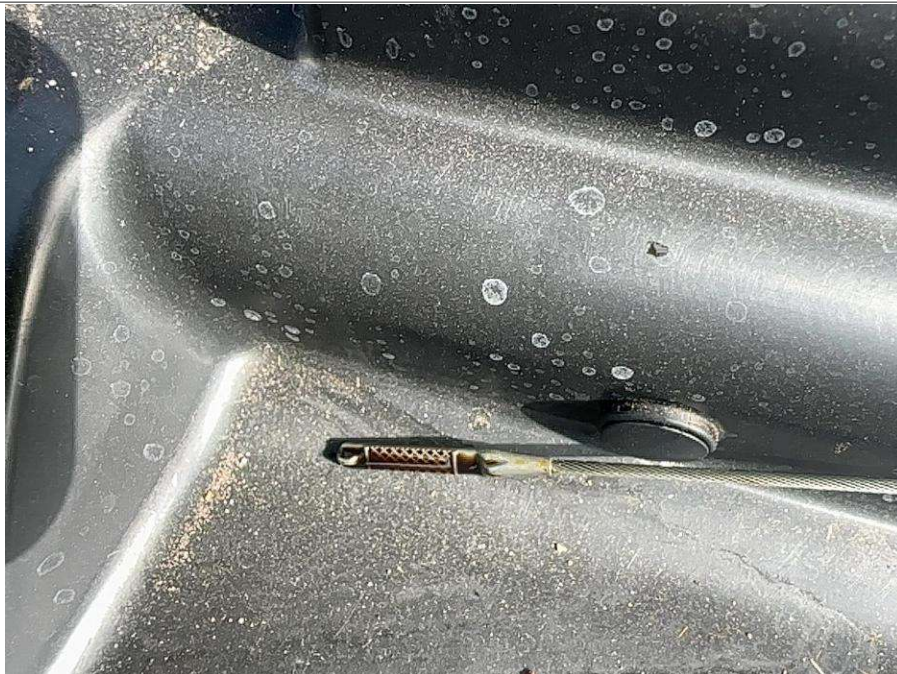
**Oil Dipstick**

<b>Engine Compartment:</b>	No Damages Observed	<b>Oil Dipstick:</b>	Good Level / Dark in Color	<b>Coolant Level:</b>	Good Level
<b>Engine Serial Plate:</b>	Obstructed

Wear and Tear Items	
Item Name	Item Comments
Box Interior	The box interior has shelves built from 2x4s and plywood. They need to be removed.
Dent In Bumper	There is a dent in the driver's side chrome bumper. Needs replacement.
Drivers Side Mirror	The driver's side mirror is broken and missing the glass. Needs replacement.
Inteiror Dirty	The interior is dirty and needs to be deep cleaned.
Steering Wheel	The steering wheel has small cuts and gouges in it.
Paint On Rear Step	The paint on the rear step on the units box, is worn and starting to rust.
Oil Is Dark	Unit may need an oil change.
