Inspection Detail

Client:	Isuzu Finance	
	Inspected by:		
	Location of Inspection:	2323 W Bell Rd, Phoenix, AZ 85023, USA	
	Phone No / Email:	+1 601 881 9525 / TFraser@vtag.com	
	Date of Inspection:	8/11/2025	Job#: 868f2491g
	Year:	2023	Make: Chevrolet
	Model:	Silverado HD	VIN / SN: 1GB3WRE70PF250355

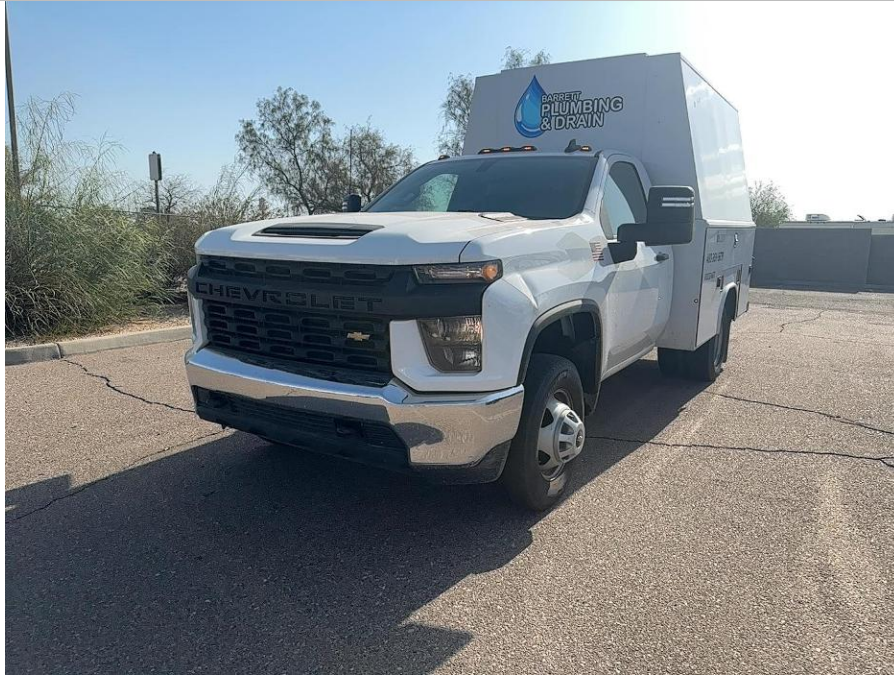
Wear and Tear Items	
Item Name	Item Comments
Front Bumper	The front bumper appears to be dented on the left side.
First Left Outside Drive Tire	The tire has a cut on the sidewall.
First Right Outside Drive Tire	The tire has a cut on the sidewall.
Hub Cap Cover	The hub cap cover on the front right is damaged.
Front Right Tire	The tire has a cut on the sidewall.
Inner Wheel Well Cover	The front left inner wheel well cover is missing.
Engine Valve Cover	The valve cover appears oily and may be leaking.
Box Interior	The sheet metal panels inside the box are scratched.
Headliner Stained	The headliner appears to be stained.
Seats Stained	The seat material is stained.
Warnings	The dash is displaying a warning for the air filter system and may need diagnostics.
Front Left Fender	The front left fender is dented.

Repair Items			
Item Name	Item Labor Cost	Item Part Cost	Total Cost
Warnings	\$300.00	\$500.00	800
First Left Outside Drive Tire	\$150.00	\$320.00	470
First Right Outside Drive Tire	\$150.00	\$320.00	470
Front Right Tire	\$150.00	\$320.00	470
Front Bumper	\$300.00	\$1,001.00	1301
Front Left Fender	\$300.00	\$650.00	950
