Inspection Detail

<b>Client:</b>		Isuzu Finance
	<b>Inspected by:</b>		
	<b>Location of Inspection:</b>		6225 State Rd., Philadelphia, PA 19135, USA
	<b>Phone No / Email:</b>		+1 267 255 0956 / jwallick@bentleytruckservices.com
	<b>Date of Inspection:</b>	<b>Job#:</b>	868f0c0y7
	<b>Year:</b>	<b>Make:</b>	Isuzu
	<b>Model:</b>	<b>VIN:</b>	54DK6S161LSG70007

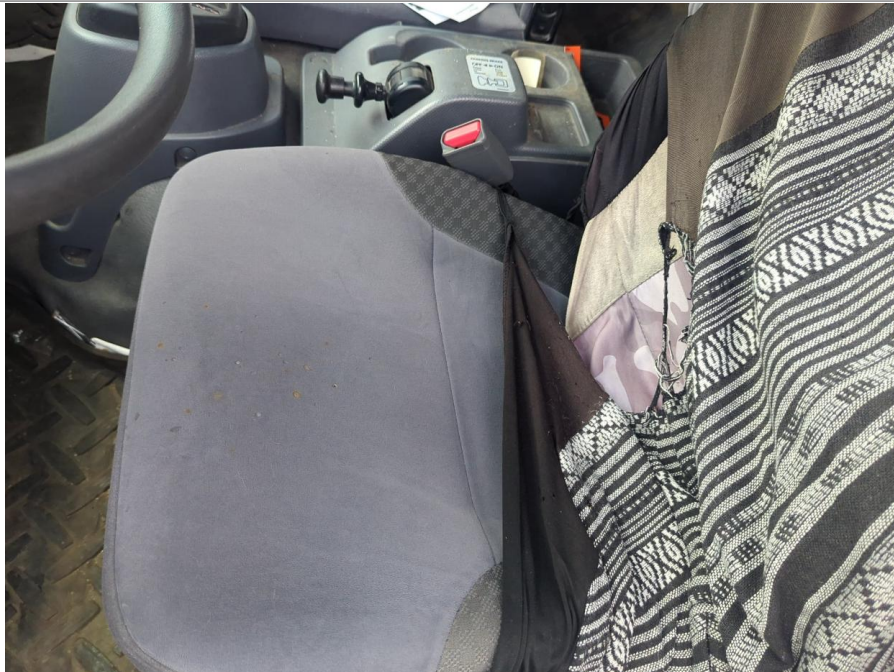
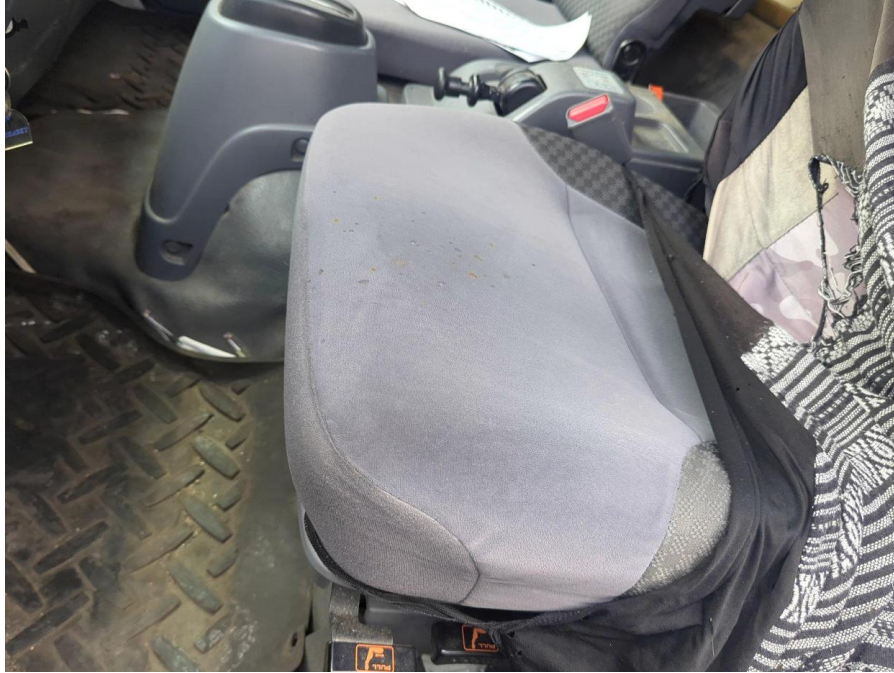
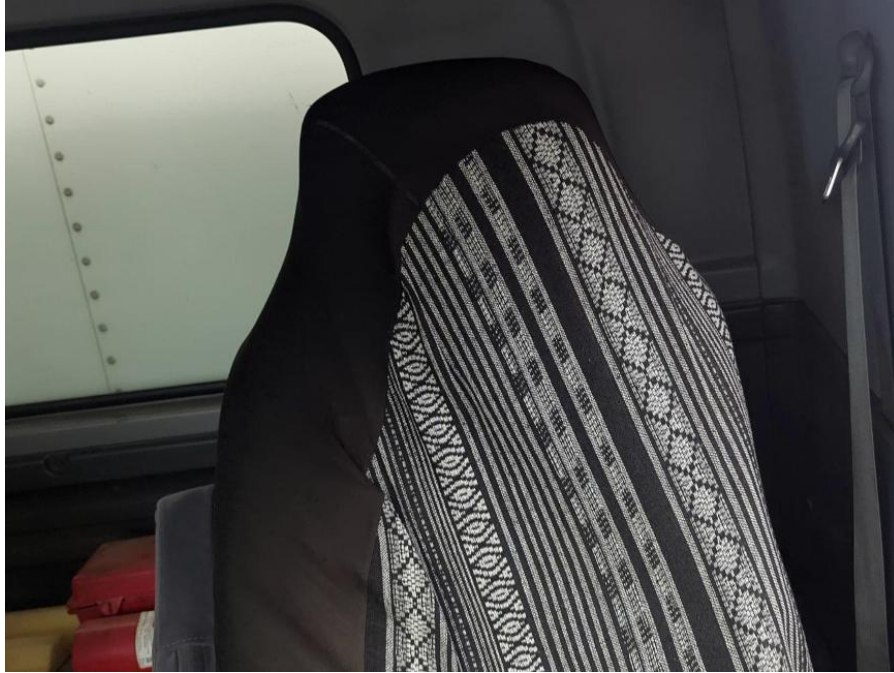
**Driver's Seat**

Right Steel Panel	The steel metal on the right side is rusted and damaged.
Driver's Seat	There are small holes in the seat cover.

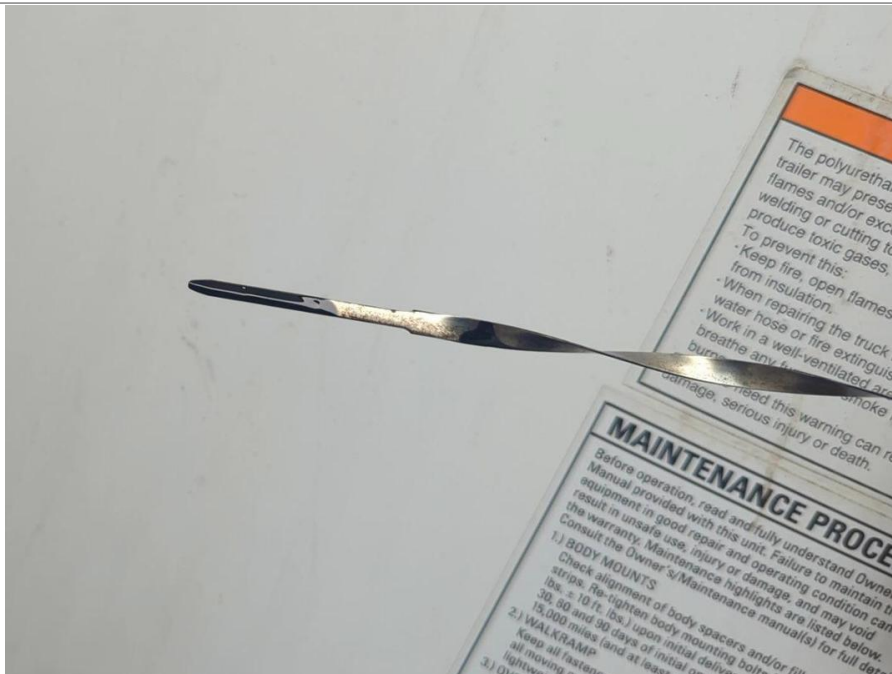
### Oil Dipstick

<b>Engine Compartment:</b>	No Damages Observed	<b>Oil Dipstick:</b>	Low Level / Dark in Color	<b>Coolant Level:</b>	Good Level
<b>Engine Serial Plate:</b>	Obstructed
