Inspection Detail

Client:	Isuzu Finance	
	Inspected by:		
	Location of Inspection:	2201 W Bell Rd, Phoenix, AZ 85023, USA	
	Phone No / Email:	+1 602 881 9525 / TFraser@vtag.com	
	Date of Inspection:	7/24/2025	Job#: 868ew81tz
	Year:	2019	Make: Mitsubishi FUSO
	Model:	FE160	VIN: 4UZBVG117KGKM6480

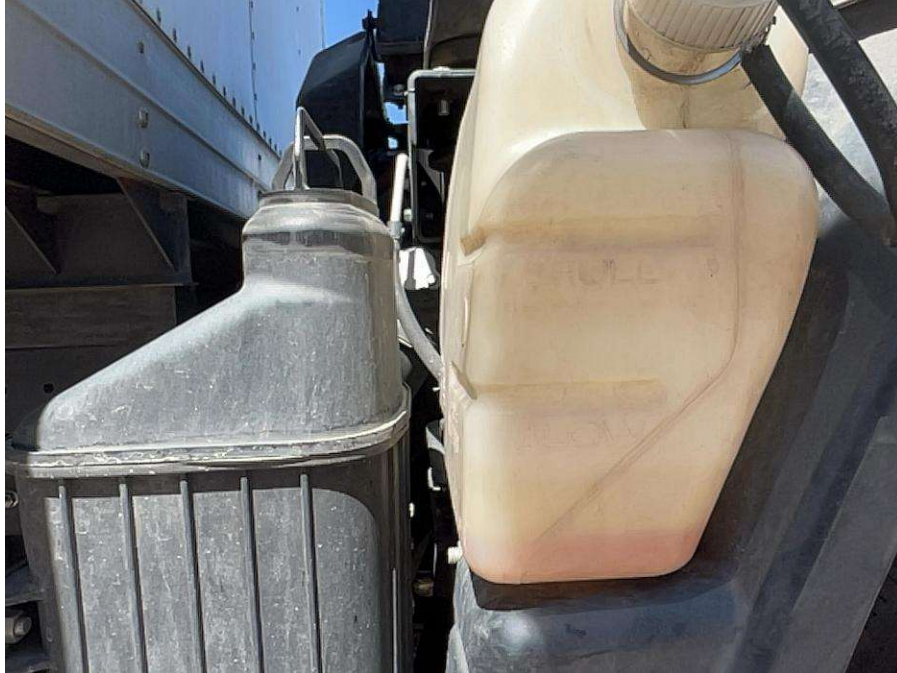
Coolant	The coolant level is low.

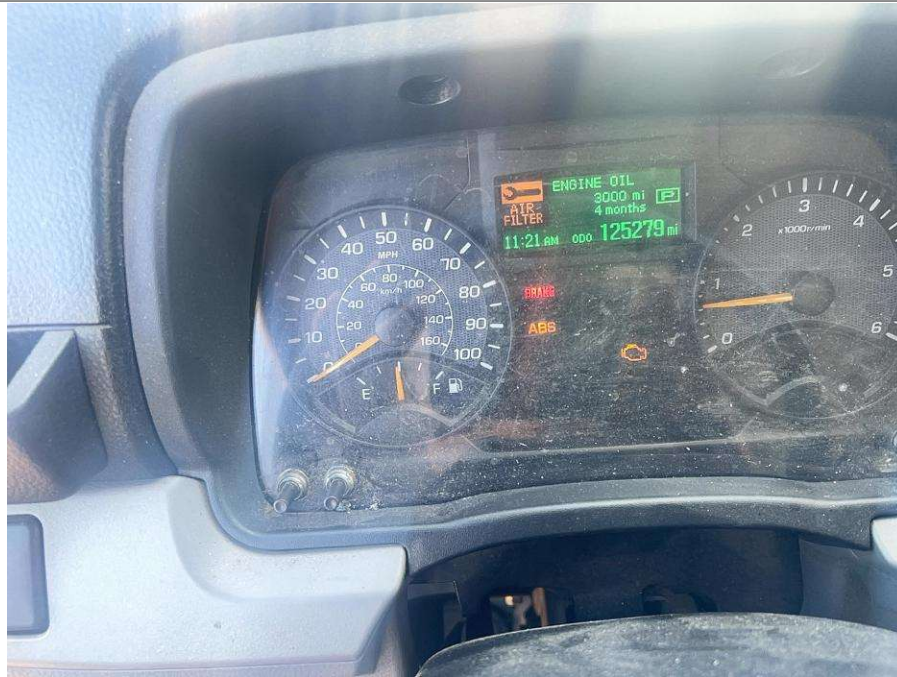
EMS Panel

GVWR:	15,995 lbs	Odometer:	125,279	Engine Hours:	See Notes
EMS Warning Lights:	Yes

Repair Items			
Item Name	Item Labor Cost	Item Part Cost	Total Cost
Box Side Panel	\$1,800.00	\$13,000.00	\$14,800.00
Dashboard	\$450.00	\$1,100.00	\$1,550.00
Warning Light	\$600.00	\$2,000.00	\$2,600.00
Rear Panel	\$600.00	\$2,500.00	\$3,100.00
Left Box Column Frame	\$900.00	\$1,500.00	\$2,400.00
Total Repairs:			\$24,450.00

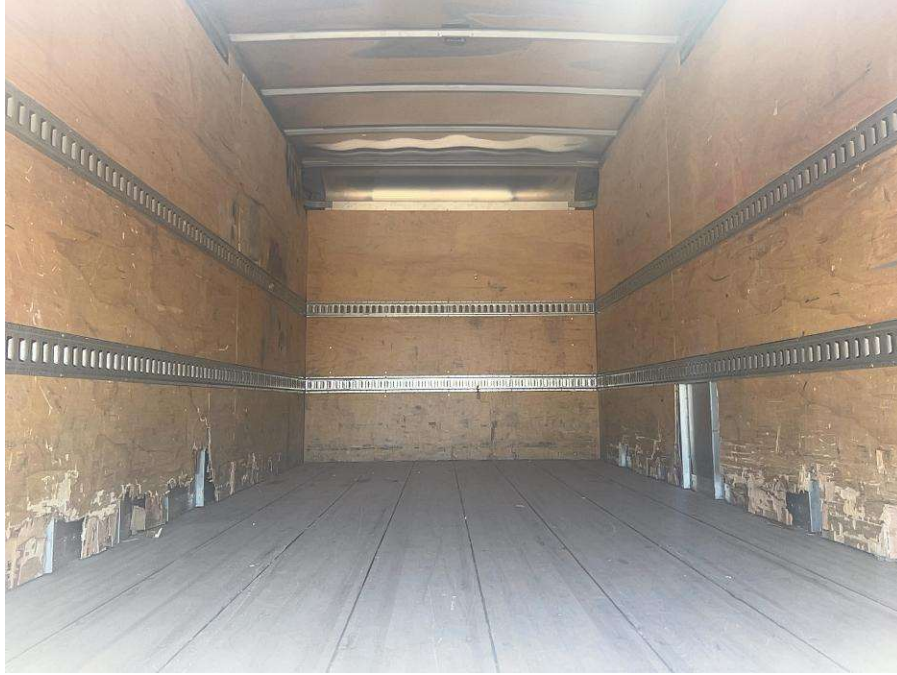
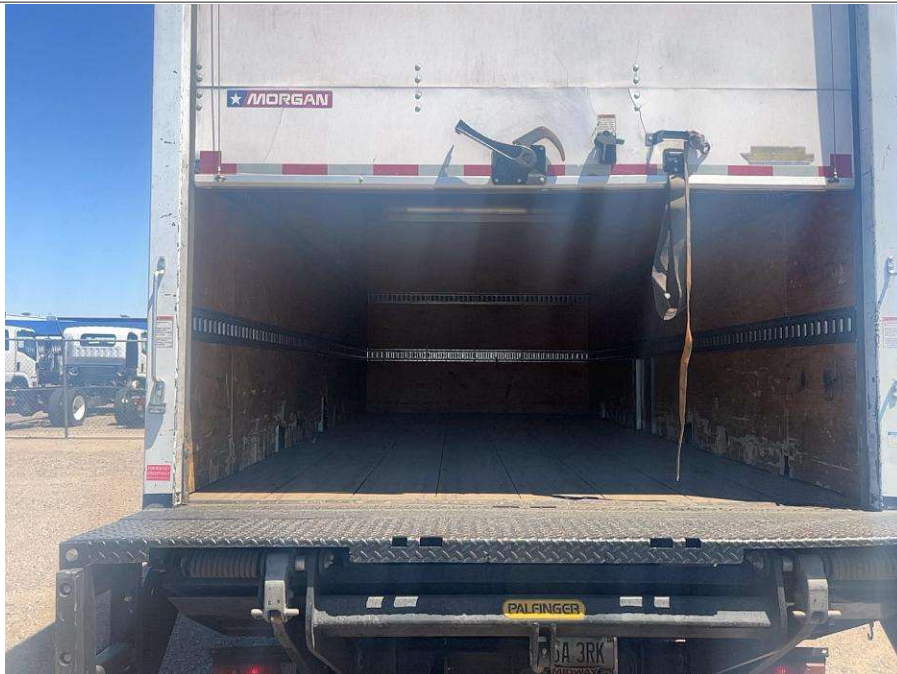
Box Condition

Wear and Tear Items	
Item Name	Item Comments
Left Box Column Frame	The front left box is bent on the lower corner.
Box Plywood	The sheet plywood is damaged on the box.
Transmission Cooler Radiator Line	The transmission line is bent and there is an oil mark on the radiator, possibly the beginning of a leak.
Absorber Shock	The front right shock is leaking.
Rear Panels	The rear panels are dented.
Driver's Door Panel	The door panel has small damages and wear.
Left Mirror	The left mirror is cracked
Warning Light	There are two lights on the panel: check engine and ABS. Needs to be repaired.
Dashboard	There are three balls marks on the panel.
Passenger's Seat	The seat is stained.
Headliner	The headliner has some stain marks.
12V Power Switch	The switch is loose.
Driver's Seat	The seat is stained.
Engine Oil	The engine oil level is low and dark in color.
Box Side Panel	The box side panels are dented on both sides.
