Inspection Detail			
<p>Click to watch the video</p>

Client:		Isuzu Finance
	Inspected by:		
	Location of Inspection:		2201 W Bell Rd, Phoenix, AZ 85023, USA
	Phone No / Email:		+1 602 881 9525 / tfraser@vtaig.com
	Date of Inspection:	Job#:	9/2/2025 868fcqemn
	Year:	Make:	2021 Isuzu
	Model:	VIN:	NQR JALE5J16XM7901159

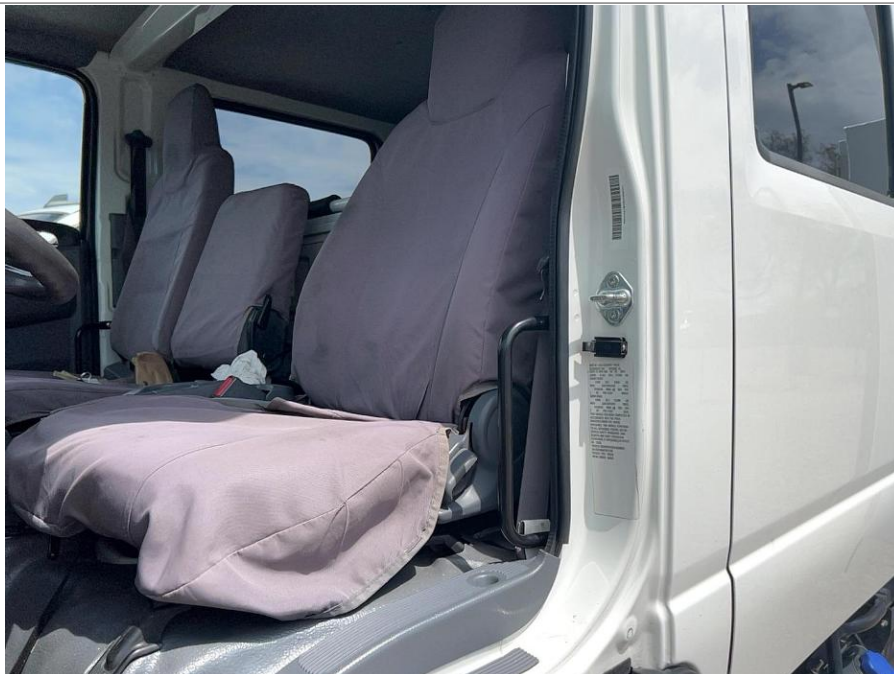
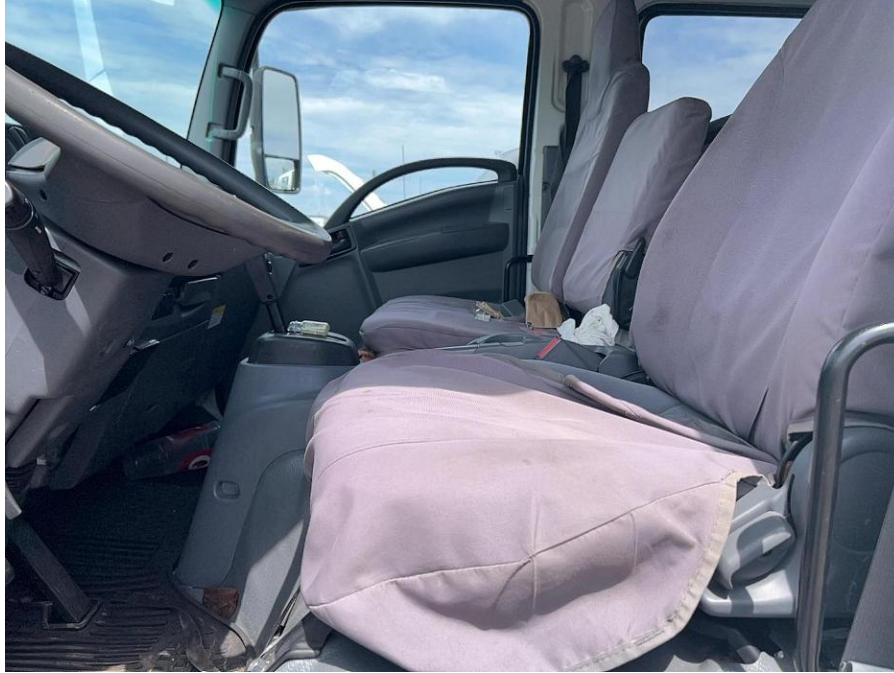
**Driver's Seat**

Passenger's Seat Cover	The seat cover is stained and faded.
Driver's Seat Cover	The seat cover is stained and faded.
Box Side Panel	There are small dents on both side panels.
Floor Mat	The floor mat is torn.

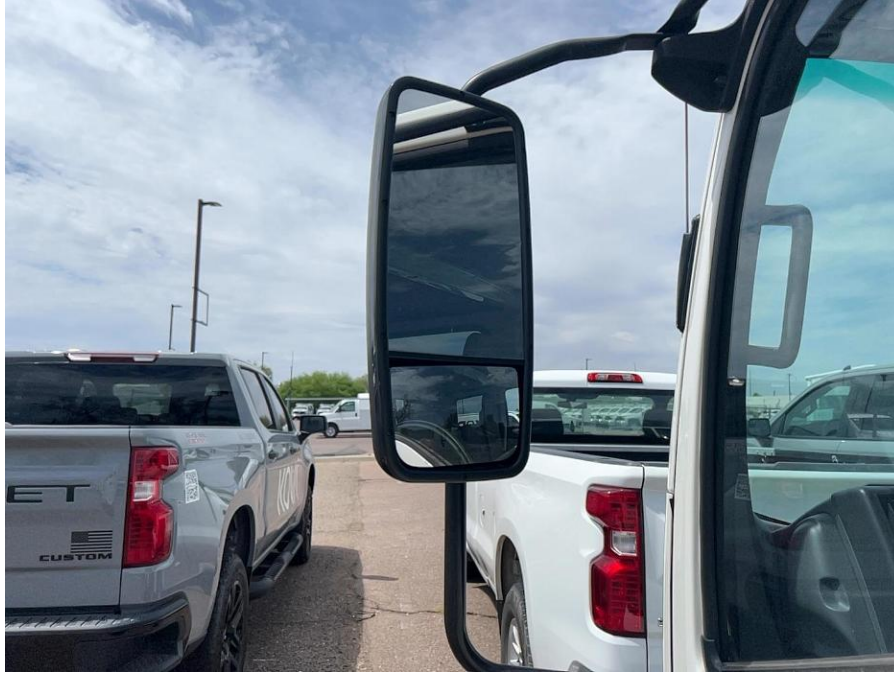
Mirrors

Wear and Tear Items	
Item Name	Item Comments
First Left Inner Tire	The tire is worn and regroovable.
First Left Outer Tire	The tire is bald and regroovable.
First Left Steer Tire	The tire is regroovable and nearly bald.
First Right Inner Tire	The tire is regroovable.
First Right Outer Tire	The tire is regroovable.
First Right Steer Tire	The tire is worn on the right side, which may indicate an alignment issue.
Box Storage Door Seal	The door seal is damaged and loose.
Box Storage Condition	The interior of the box has a bent shelf, and the paint is damaged.
Rear Mud Flap	The rear left mud flap is damaged.
Skirt Flap	The skirt flap below the radiator is damaged.
Coolant	The coolant reservoir is empty and needs to be topped up.
Hood	The front hood frame has small dents.
Driver's Door Seal	The door seal is loose.
Mirror Trim	The mirror trim cover is damaged.
Back Seat Cover	The seat cover is stained and faded.
