Inspection Detail

Client:	Isuzu Finance		
Inspected by:			
Location of Inspection:	2201 W Bell Rd, Phoenix, AZ 85023, USA		
Phone No / Email:	+1 602 881 9525 / tfraser@vtaig.com		
Date of Inspection:	9/2/2025	Job#:	868fcp6h2
Year:	2015	Make:	Isuzu
Model:	NQR/NRR	VIN:	JALE5W168F7301238

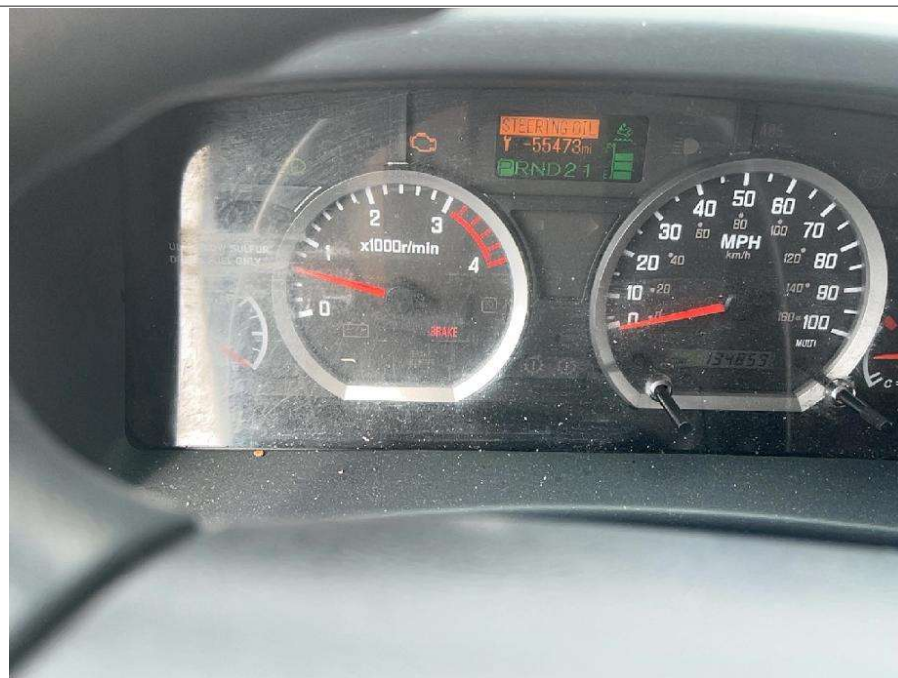
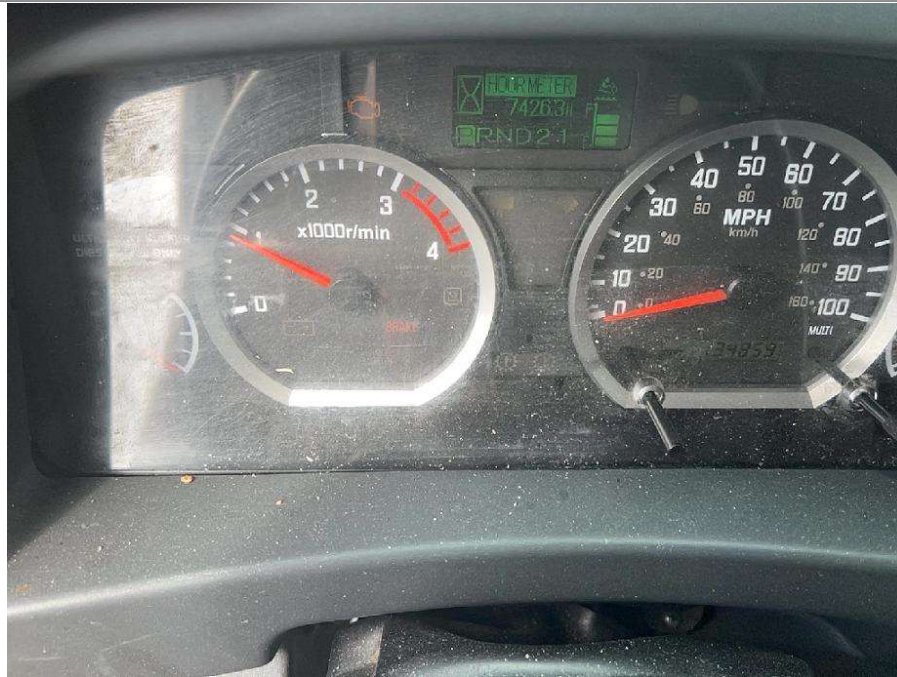
EMS Panel

Floor Mat	The floor mat is torn.
Warning Lights	The engine check light is on and needs to be diagnosed.
Box Side Panels	The side panels on both sides are dented.

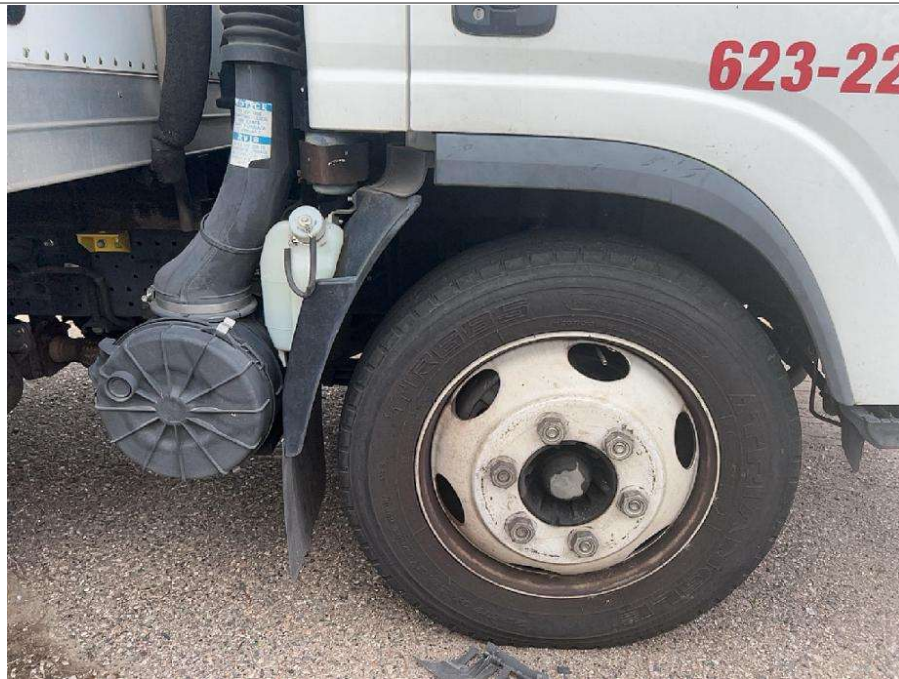
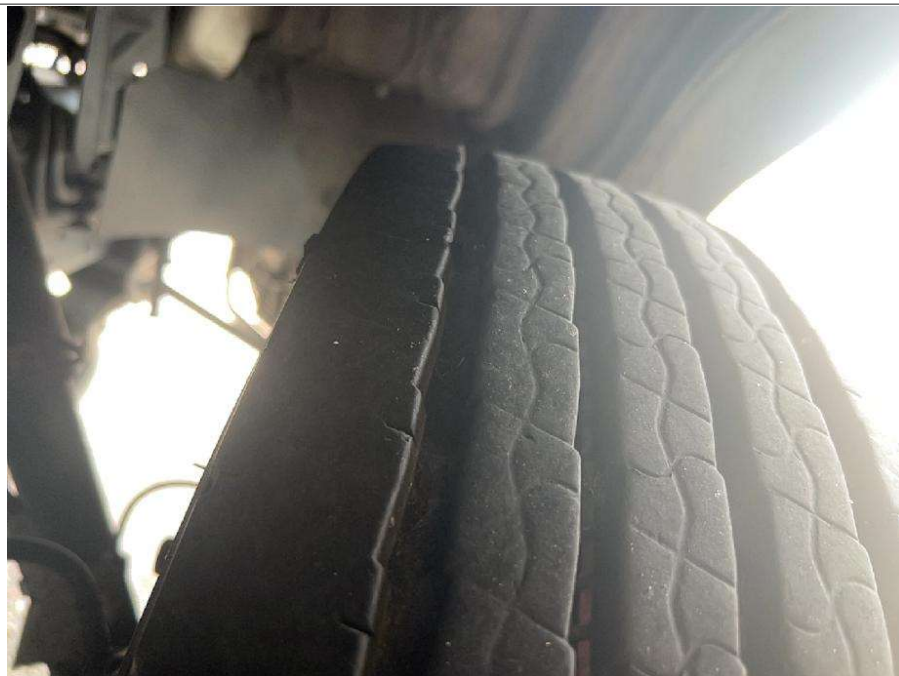
First Right Steer Tire Condition

Wear and Tear Items	
Item Name	Item Comments
Right Steer Tire	The tire has small gouges and is worn.
Box Metal Panel	The metal panel is dented.
First Right Outer Tire	The tire is regroovable and worn.
First Right Inner Tire	The tire is bald and regroovable.
First Left Inner Tire	The tire is regroovable and worn.
First Left Outer Tire	The tire is regroovable and worn.
Left Steer Tire	The tire is regroovable.
Toolbox	The toolbox is held in place with a zip tie. The toolbox latches are damaged and broken.
Coolant	The coolant reservoir is empty and needs to be topped up.
Driver Door Panel	The driver's door panel is scratched.
Cab Interior	There are some items in the cab interior.
Dash Cover	The fuse cover on the dash is missing.
Driver's Seat	The seat cover is stained, has small holes, and is fraying.
Steering Column Cover	The cover is misaligned, possibly due to damaged latches.
Windshield	The windshield is cracked.
