Inspection Detail

Client: Isuzu Finance		
Inspected by:	Rayfield (Ray) Wyatt II		
Location of Inspection:	6225 State Rd., Philadelphia, PA 19135, USA		
Phone No / Email:	+1 267 255 0956 / jwallick@bentleytruckservices.com		
Date of Inspection:	5/12/2025	Job#:	868dvrvgl
Year:	2021	Make:	ISUZU
Model:	NRR	VIN:	JALE5W168M7300412

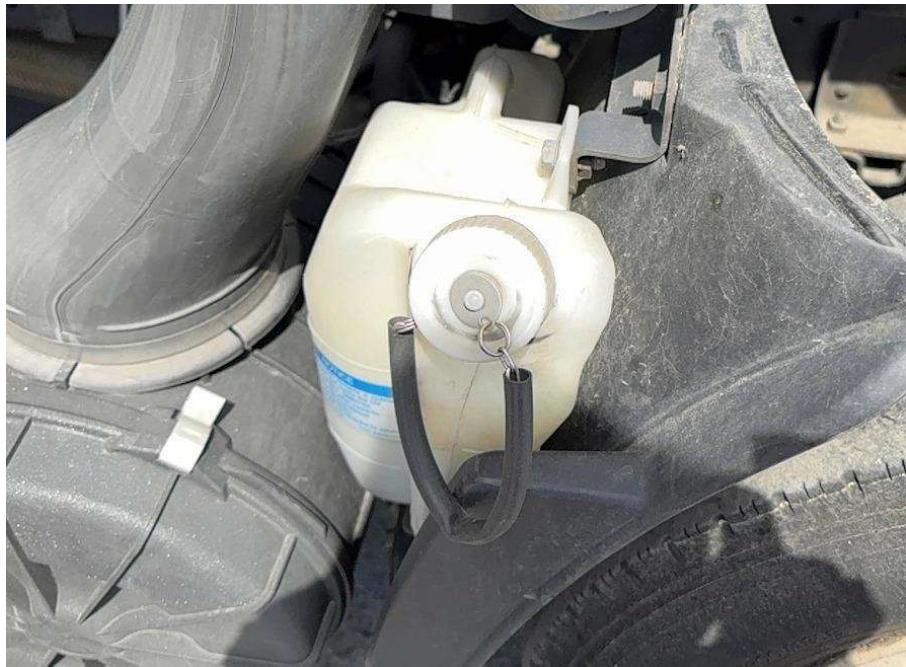
Coolant Level

Engine Compartment:	No Damages Observed	Oil Dipstick:	See Notes	Coolant Level:	Low Level
Engine Serial Plate:	Obstructed

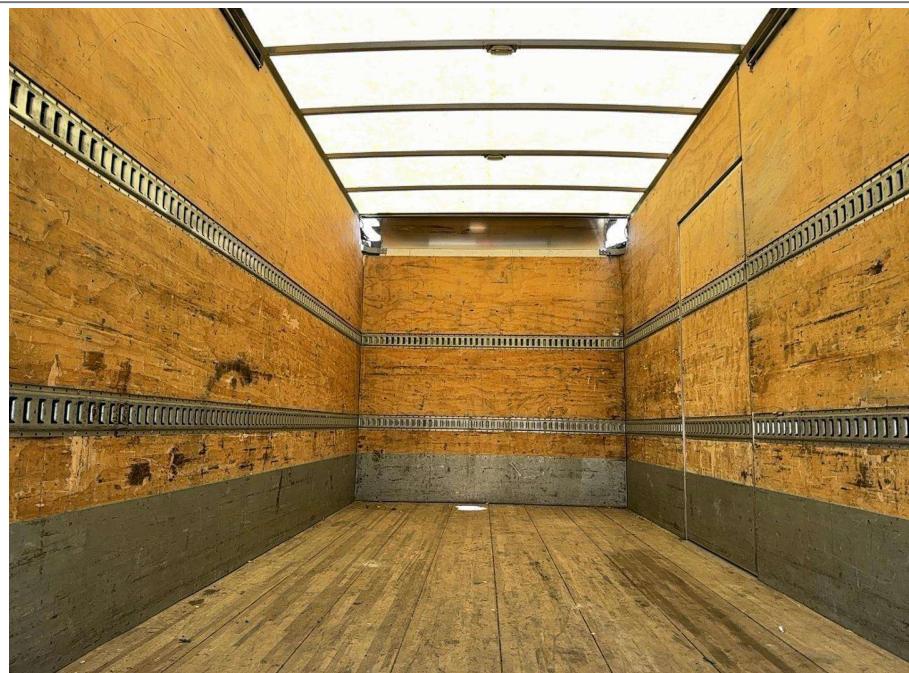
**Box Condition**

The unit starts and operates. The unit is dirty. The right side steer tire is worn unevenly and has pits, indicating the unit might need an alignment. The fuel filter needs to be replaced. A full service is needed if the fuel filter is overdue. The lift gate needs maintenance or replacement. The paint on the box is in rough shape. The coolant appears to be low. The exhaust is rusted and the DPF heat shield is dented. The box has broken corner caps and is scratched and dirty above the cab and in the rear. The front tires are included in the damages due to poor alignment. They do not need to be replaced at this time, but if the truck receives an alignment, the tires will need to be replaced.
