## Isuzu Vehicle HEALTH REPORT

Beginning Report Date: Vehicle Production Date  
 Ending Report Date: 2020-02-19 13:53:02  
 VIN: JALC4W165F7K00362  
 Current Mileage: 177824 Miles  
 Rear Body Type: Dry Box w/Liftgate  
 Freight Type: Delivery  
 Customer Name: Rush Truck Center  
 Customer Email:  
 Customer Address: usa  
 usa

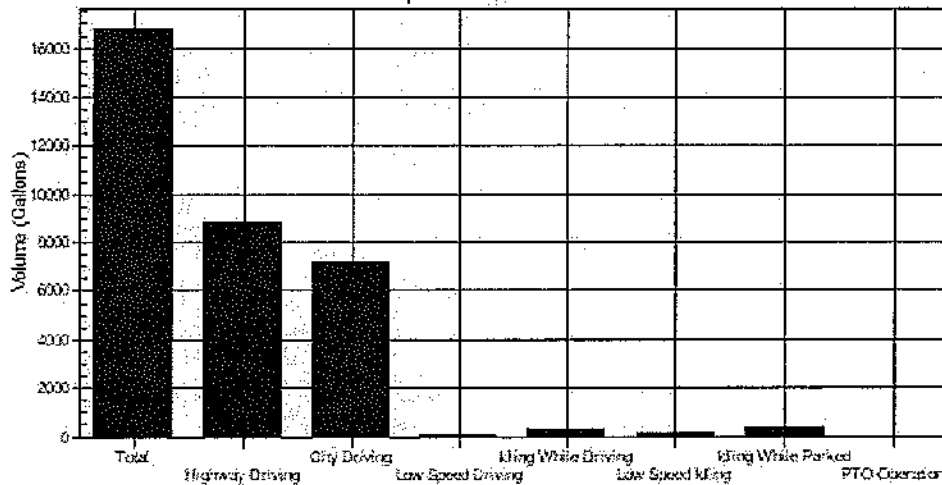
### Fuel Consumption (Gallons)

Total: 16,814.11  
Highway Driving: 8,837.38  
City Driving: 7,154.9  
Low Speed Driving: 26.57  
Idling While Driving: 313.55  
Low Speed Idling: 86.02  
Idling While Parked: 395.69  
PTO Operation: 0
