Job #: 58893 /

VIN: JALE5W162J7304435

DIESEL 2018 ISUZU NRR / LA124936

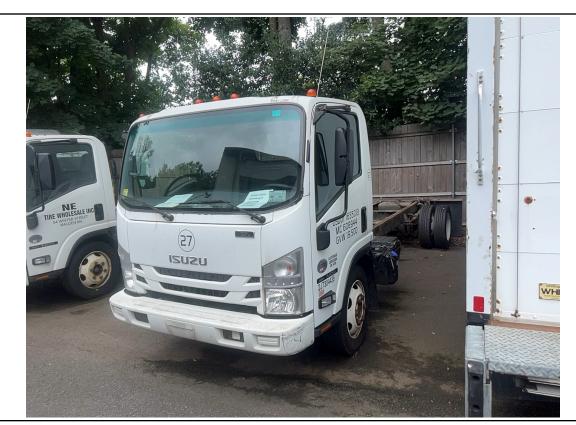
Front Left / 08-17-2023

Visible Damages	
Front Bumper	The bumper is damaged on the left side.
Frame Rails	The frame rails are rusty.
Rear Left Tires	Both tires' shoulders seem to be worn.
Rear Right Inner Drive Tire	The inside tire's shoulder seems worn.
Valve Cover	The engine valve cover is leaking.
Cooler Tube	The charge air cooler tube is rusty.
Coolant	The coolant is low in the reservoir.
Engine Oil	The engine oil is dark in color.
Mirror	The step mirror is missing from the right door.
Keys	The keys are missing for the unit.

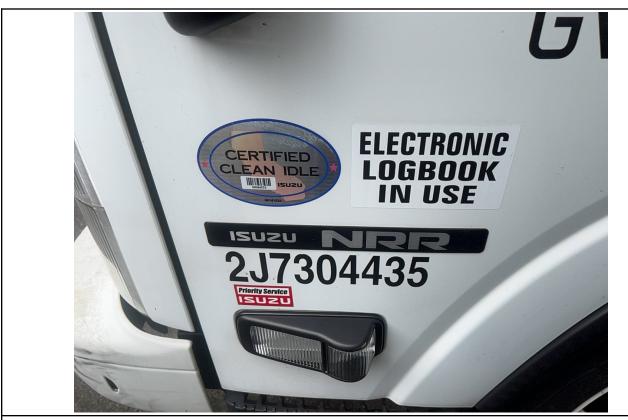
Chassis Number: 2J7304435 / 08-17-2023

The key was missing, therefore several items could not be captured. As the VIN sticker/tag could not be located, the Chassis Number found printed onto the unit's exterior was added to the document.

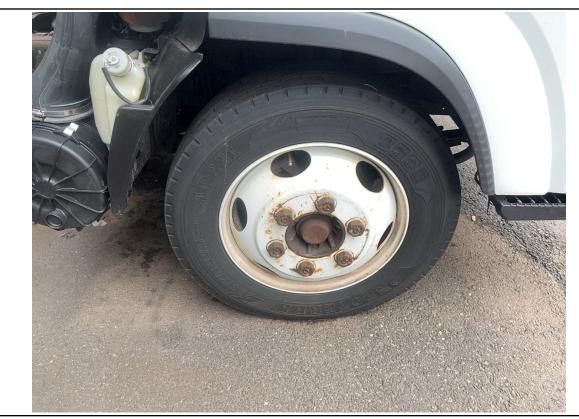
Right Steer Tire Condition / 08-17-2023

Right Steer Tire Condition	No Damages Observed
Right Steer Tire Brand	Neoterra
Right Steer Tire Size	225/70R19.5
Rear Right Outer Drive Tire Condition	No Damages Observed
Rear Right Outer Drive Tire Brand	Continental
Rear Right Outer Drive Tire Size	225/70R19.5
Rear Right Inner Drive Tire Condition	See Notes
Axle Information	See Notes
Transmission Information	See Notes
Engine Information	5.2L Isuzu In-Line I1B - 4HK1TC
Chassis Number	2J7304435 (See Notes)

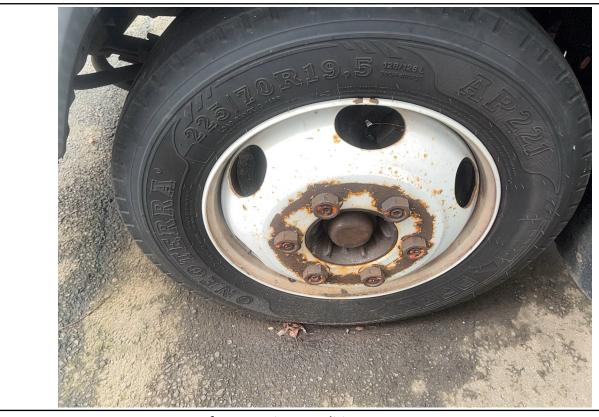
Left Steer Tire Condition / 08-17-2023

Specifications	
Year	2018
Make	Isuzu
Model	NRR
Date of Inspection	08/17/2023
Location of Inspection	1463 US Hwy 22, Mountainside, NJ, 07092
VIN	JALE5W162J7304435 (See Notes)
GVWR	19,500 lbs
Odometer	See Notes
Engine Hours	See Notes
EMS Warning Lights	See Notes
Cab Interior	See Notes
Driver's Seat	See Notes
Passenger's Seat	See Notes
Transmission Type	See Notes
Pedals	See Notes
Floorboard	See Notes
Radio	See Notes
A/C	See Notes
Switches and Controls	See Notes
Power Mirrors	See Notes
Heated Mirrors	See Notes
Steering Wheel	See Notes
Mirrors	See Notes
Steps	See Notes
Handrails	See Notes
Exhaust Pipe	Single / No Damages Observed
Engine Compartment	See Notes
Oil Dipstick	Good Level / Dark Color
Coolant Level	Low Level
Suspension	Leaf Spring / No Damages Observed
Axles	No Damages Observed
Front Lights	No Damages Observed
Rear Lights	No Damages Observed
Left Steer Tire Condition	No Damages Observed
Left Steer Tire Brand	Neoterra
Left Steer Tire Size	225/70R19.5
