Aspen Field Services

Job #: 60621 /

VIN: JALE5W160L7300466

18' MORGAN DRY VAN BODY WITH MAXON TE-25 LIFTGATE, DIESEL 2020 ISUZU NRR / LA130010

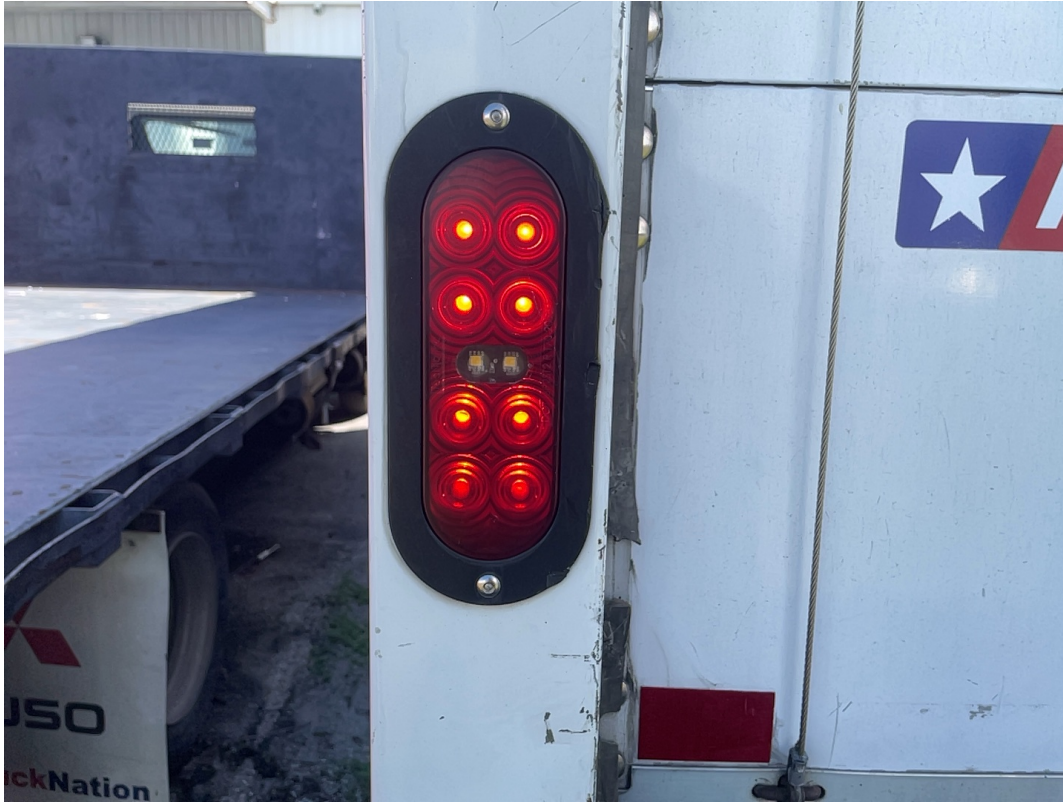
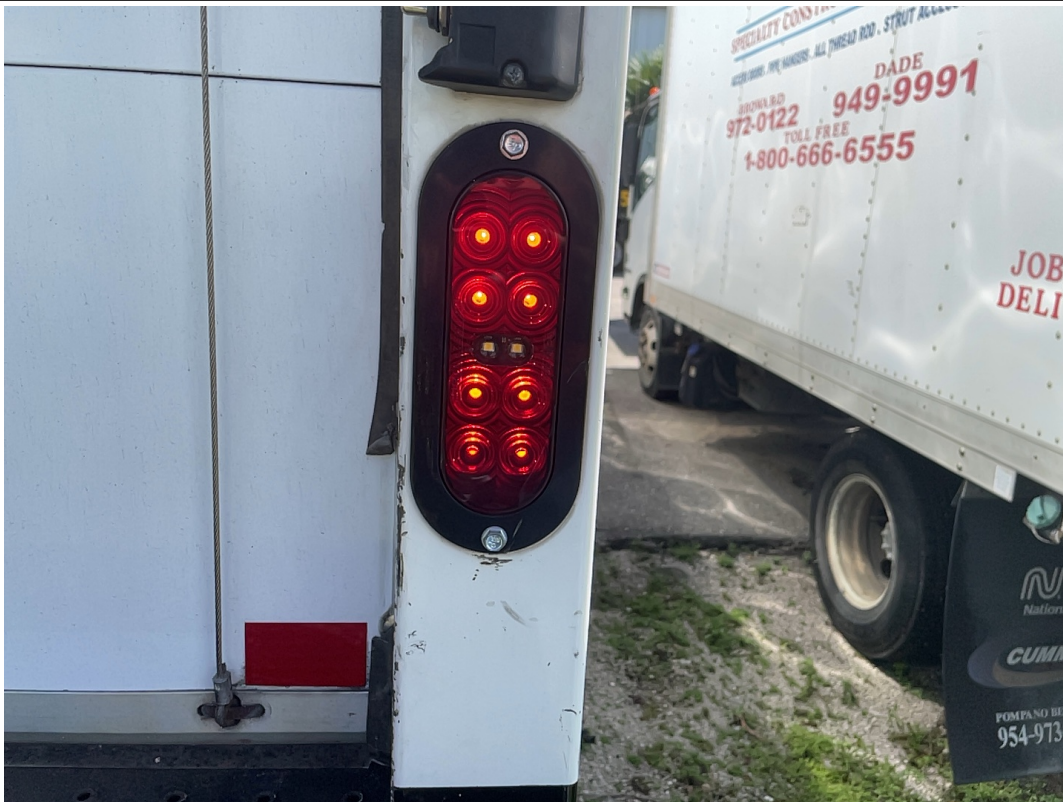
Rear Lights / 09-21-2023

Taillight	The left taillight grommet is damaged.
Engine Oil	The oil is dark in color and high on the dipstick.
Rear Right Inner Drive Tire	The tire tread appears to be worn out.
Rear Left Outer Drive Tire	The tire tread appears to be worn out.
Right Steer Tire	The tread is uneven.
Left Steer Tire	The tread is uneven.
Fuel Tank	The side of the tank is dented.
