## DIESEL 2019 - ISUZU FTR, CAB AND CHASSIS / LA127625

Job #: 58895 /

VIN: 54DK6S164KSG00273

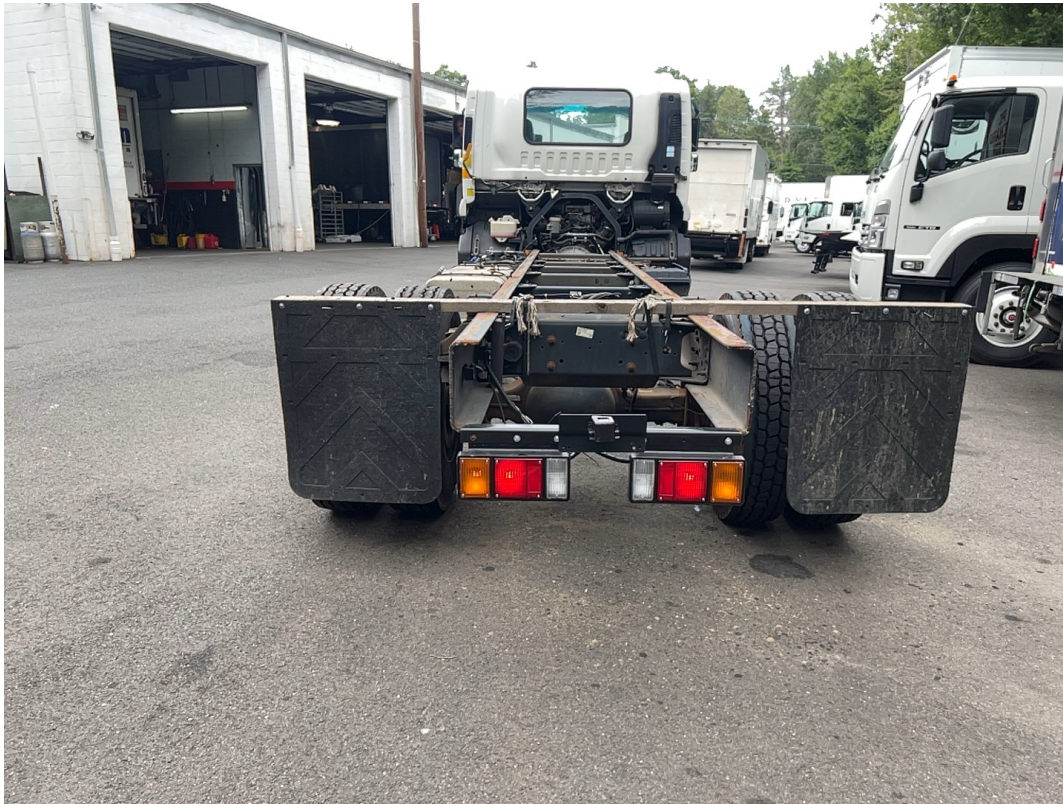
Rear Lights / 08-17-2023

The unit has temporary mud flaps installed on it and aftermarket rear light bracket have been installed on the rear.
