20' TRANSIT BODY WITH RAMP, DIESEL 2019 ISUZU NRR / LA128159

Specifications	
Year	2019
Make	Isuzu
Model	NRR
Date of Inspection	08/15/2023
Location of Inspection	109 Lindberg Avenue, Methuen, MA, 01844
VIN	JALE5W165K7303765
GVWR	19,500 lbs
Odometer	133,791
Engine Hours	5,884
EMS Warning Lights	Active Warnings
Cab Interior	See Notes
Driver's Seat	See Notes
Passenger's Seat	See Notes
Transmission Type	Automatic
Pedals	No Damages Observed
Floorboard	No Damages Observed
Radio	Yes
A/C	Yes
Switches and Controls	No Damages Observed
Power Mirrors	No
Heated Mirrors	Yes
Steering Wheel	No Damages Observed
Mirrors	No Damages Observed
Steps	No Damages Observed
Handrails	See Notes
Exhaust Pipe	Single - No Damages Observed
Engine Compartment	No Damages Observed
Oil Dipstick	Good Level / Dark Color
Coolant Level	Low Level
Suspension	Leaf Spring - See Notes
Axles	No Damages Observed
Front Lights	No Damages Observed
Rear Lights	No Damages Observed
Left Steer Tire Condition	No Damages Observed
Left Steer Tire Brand	Roadmaster

Job #: 58878 /

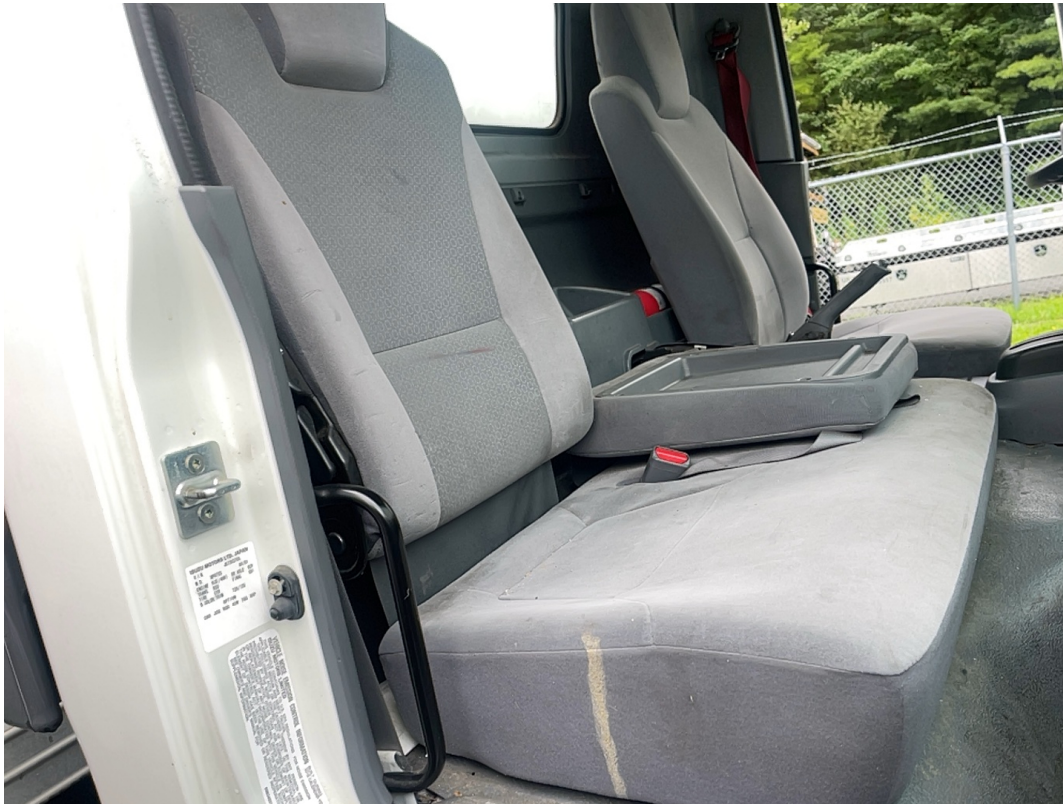
Passenger's Seat / 08-15-2023

Wiper Blade	The front left wiper blade is torn.
Grab Iron	The rear grab irons are bent.
EMS Warning Lights	The "check engine" is lit on the EMS screen.
Seats Stained	The seats' cushions are stained.
Driver's Seat	The seat has small holes in the bottom cushion.
Cab Interior	The cab interior is dirty and there are stains on the rubber material under the seats.
Floor Mat	The rubber floor mat is torn.
Front Bumper	The front left bumper is damaged.
Coolant	The coolant is low in the reservoir.
Engine Oil	The engine oil is dark in color.
Frame Rails	The frame rails are rusty.
Air Cooler Tube	The charge air cooler tube is rusty in the engine compartment.
Right Outer Drive Tire	The tire has cuts in the sidewall.
Leaf Springs	The rear left leaf springs are not pilled straight.
Hangers	The leaf spring hangers are rusty.
Rubber Bumpers	The rear rubber bumpers are missing.
Reflective Tape	The reflective tape on the rear of the unit is missing and scratched off.

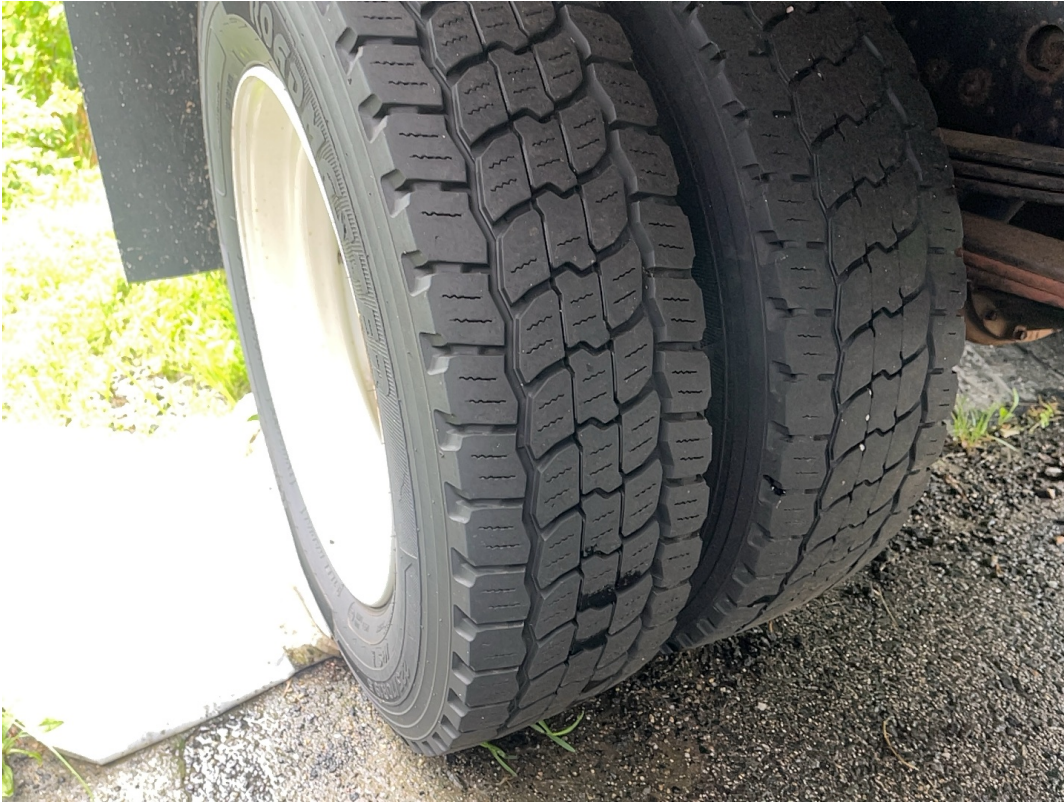
Rear Right Outer Drive Tire Condition / 08-15-2023

Right Steer Tire Size	225/70R19.5
Right Outer Drive Tire Condition	See Notes
Right Outer Drive Tire Brand	Roadmaster
Right Outer Drive Tire Size	225/70R19.5
Right Inner Drive Tire Condition	No Damages Observed
Axle Information	GAWR F: 7,275 lbs / R: 13,660 lbs
Transmission Information	Could Not Be Located
Engine Information	5.2L Isuzu In-Line I1B - 4HK1TC
