Aspen Field Services

Job #: 58880 /

VIN: 54DB4W1B2LS802618

14' MORGAN DRY VAN BODY, GAS 2020 - ISUZU NPR / LA133371

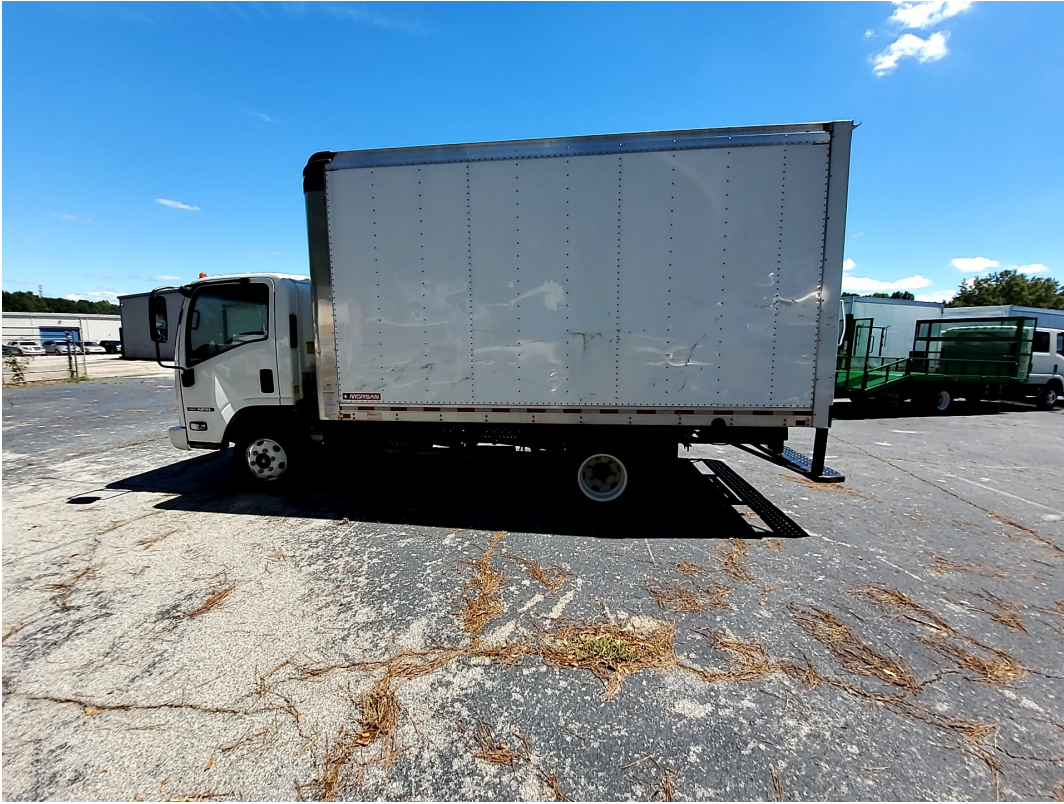
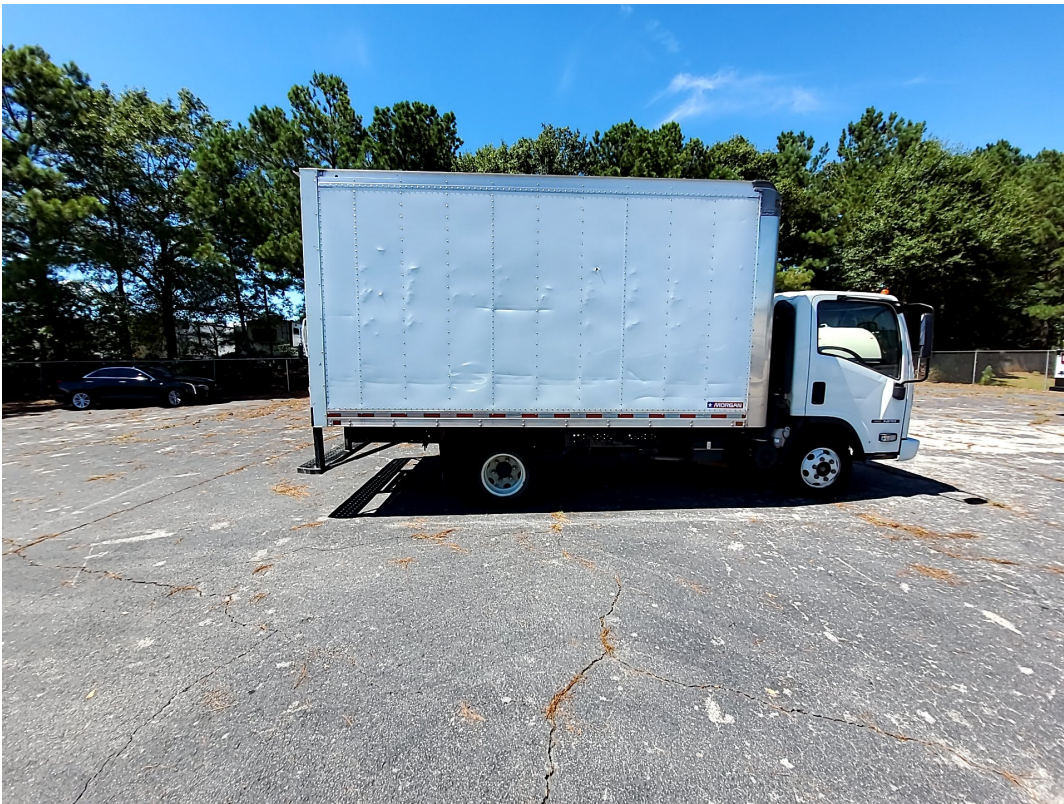
Visible Damages	
Sheet Metal Panels	The panels on the side of the box are dented.
Active Warnings	The check-engine warning is active on the EMS screen.
Driver's Seat	The bottom seat cushion has stains and the backrest has a small hole.
Passenger's Seat	The bottom seat cushion has stains and the backrest has a small hole.
Cover	The screw access cover is missing from the driver door.
Grab Iron	The rear right grab iron on the box is bent.
Right Steer Tire	The tire is low on air pressure and the outside shoulder is cupping.
Mud Flap	The front left mud flap is missing.
Shocks	The rear shocks are leaking.
Coolers	The coolers seem to be dirty.
Left Mirror	The mirror housing seems to be broken on the side.
Glove Box	The glove box is not staying closed.
