Isuzu Finance
of America, Inc.

TRUCK INSPECTION SHEET

Dealership:	Hayes Truck Group
City / State:	Houston Texas
Lease #:	LA 126993
Vin #:	JALC4W161K7008463

Year:	2019
Make / Model:	Isuzu NPR

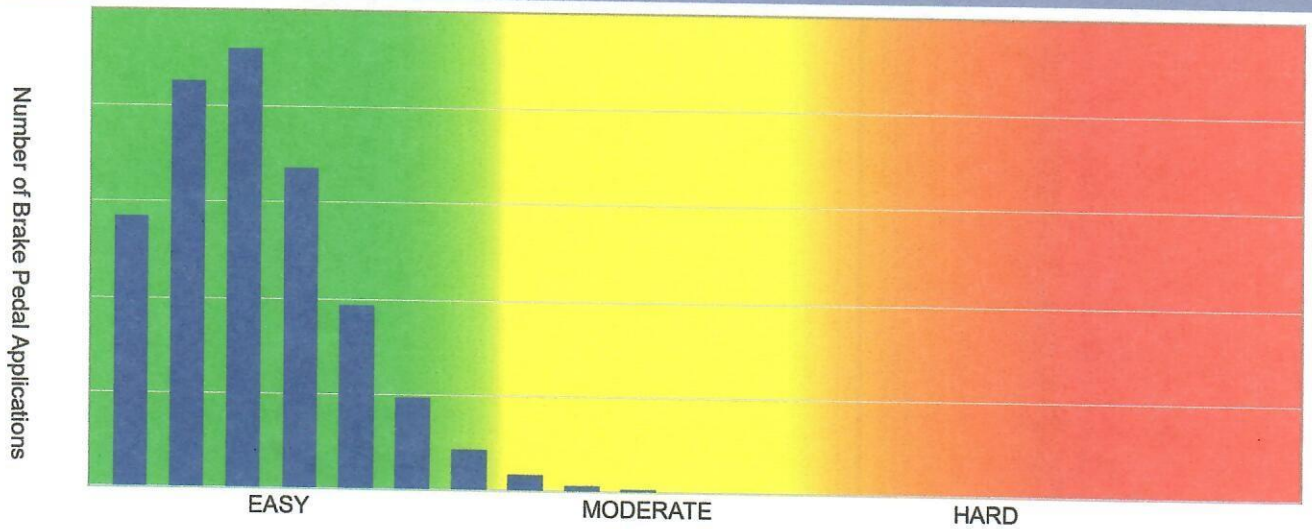
Deceleration Frequency By Operation Type

Your exhaust brake could be used to greater efficiency. Refer to your owners' manual on how to properly use the exhaust brake to reduce regular brake wear.
