Aspen Field Services

Job #: 59575 /

VIN: JALC4W162J7009166

SUPREME 16' DRY VAN BODY, DIESEL 2018 - ISUZU NPR-HD / LA122588 DARREN ANDERSON INVESTMENTS CORP

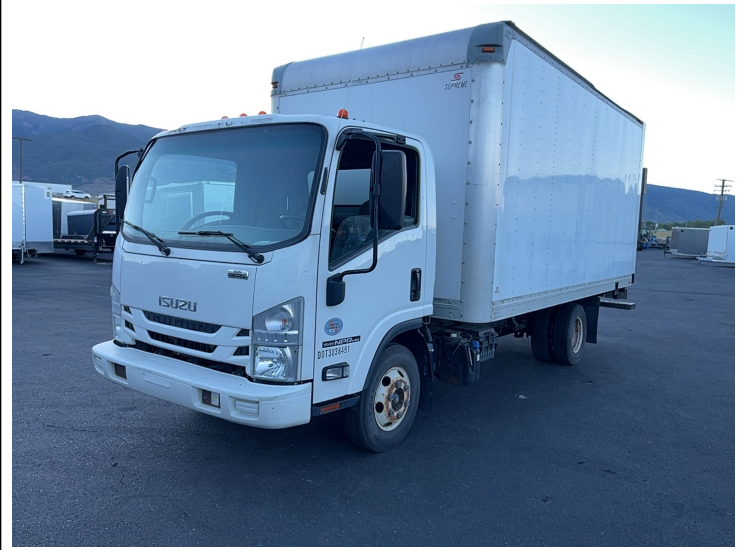
Equipment Photo

Some of the engine information was obtained via a VIN-Decoding software. The engine oil is dry, indicating an empty reservoir or a very low engine oil level.
