Aspen Field Services

Job #: 60605 /

20' DRY VAN BODY, DIESEL 2019 - ISUZU NPR-XD - LA130074 / LA130074

| Specifications | |
|---|--|
| Date of Inspection | 09/21/2023 |

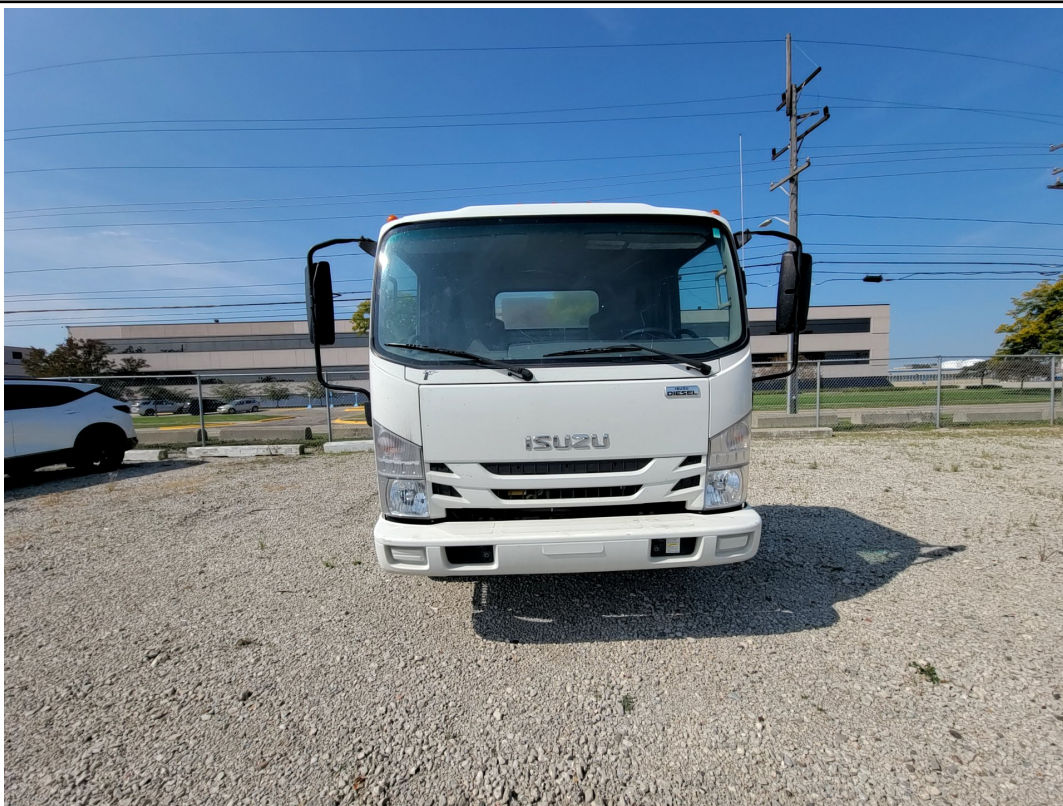
Front / 09-21-2023

| Visible Damages | |
|---|--|
| Windshield | The glass is cracked. |

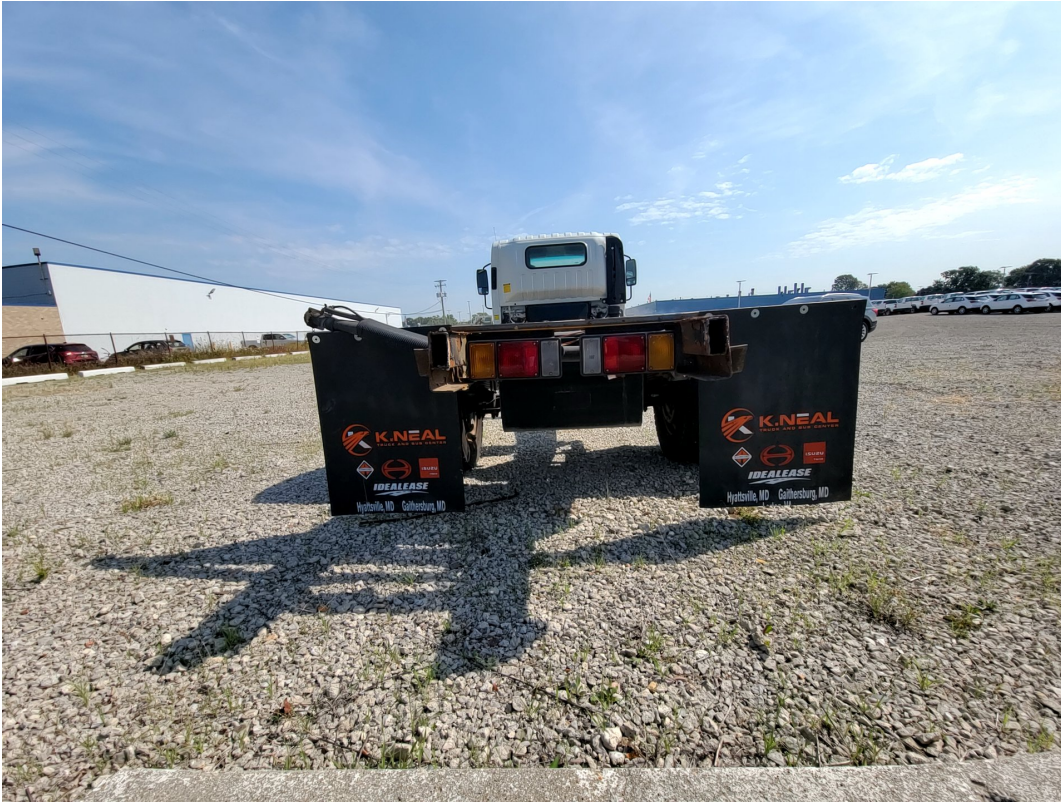
Rear / 09-21-2023

Part of the engine information was acquired from <https://driving-tests.org/vin-decoder/>. The rear of the frame rails has been cut to remove the box off the frame.

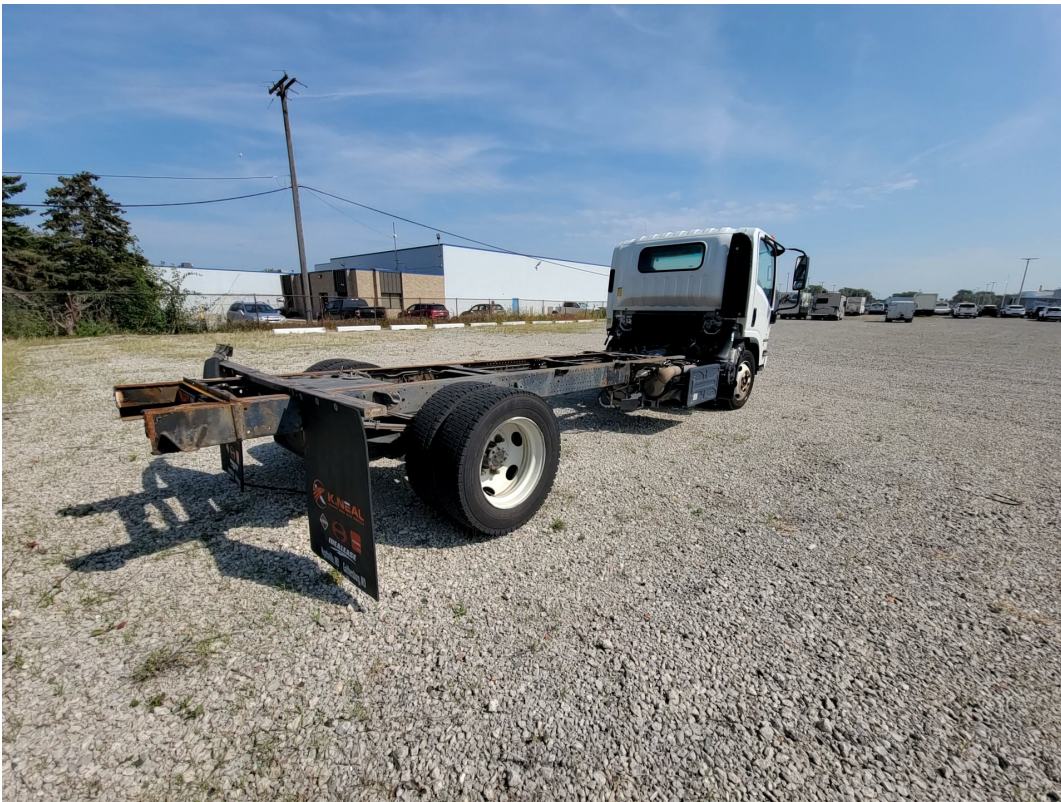
Rear Right / 09-21-2023

| Visible Damages | |
|---|--|
| Signal Light Lens | The rear right signal light lens is cracked. |

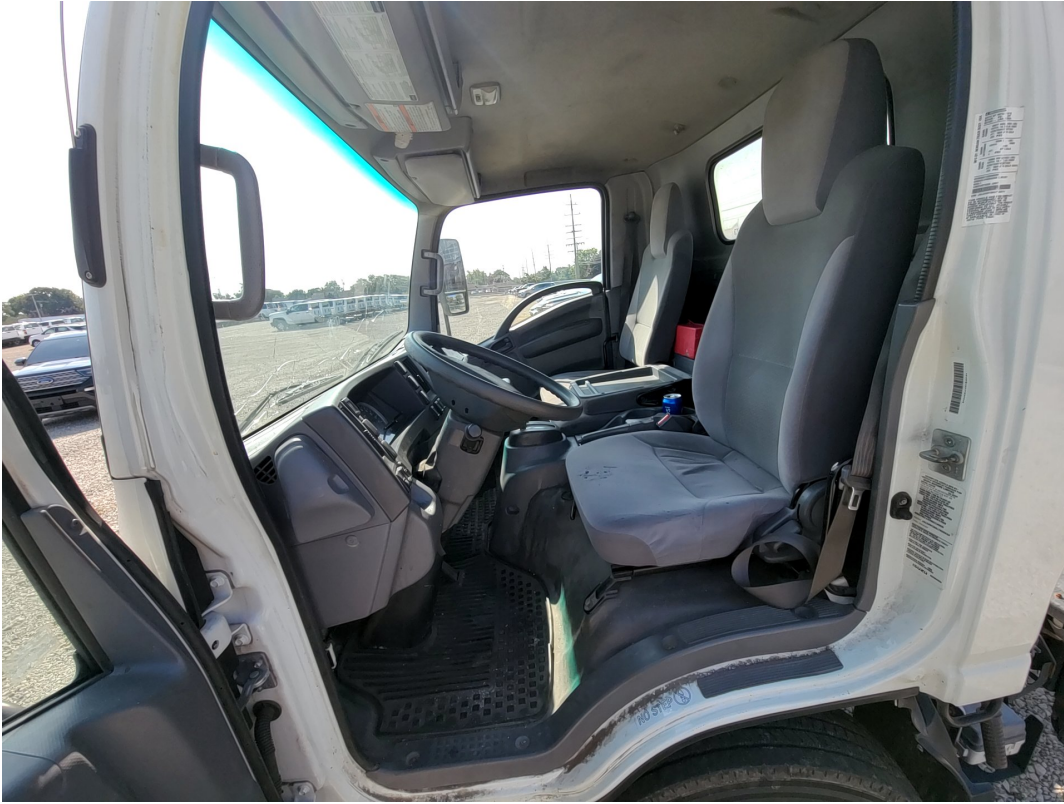
Cab Interior / 09-21-2023

| Visible Damages | |
|---|--|
| Steering Oil Service | The dash is showing that the steering oil service is past due. |

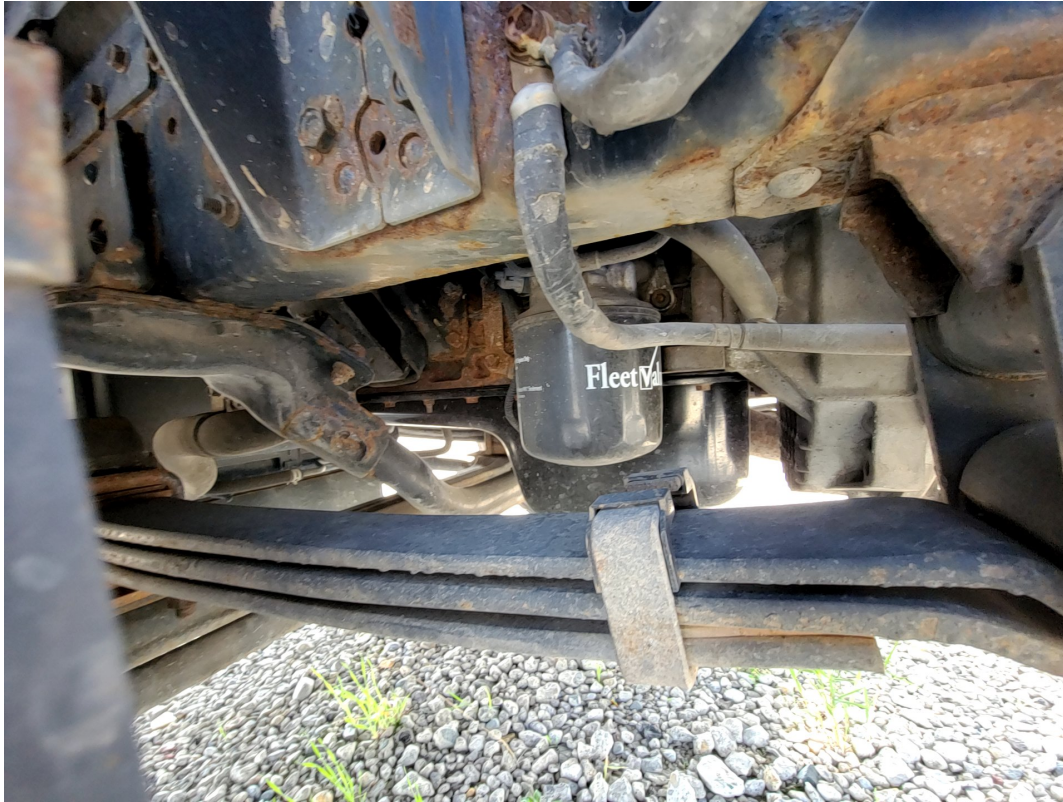
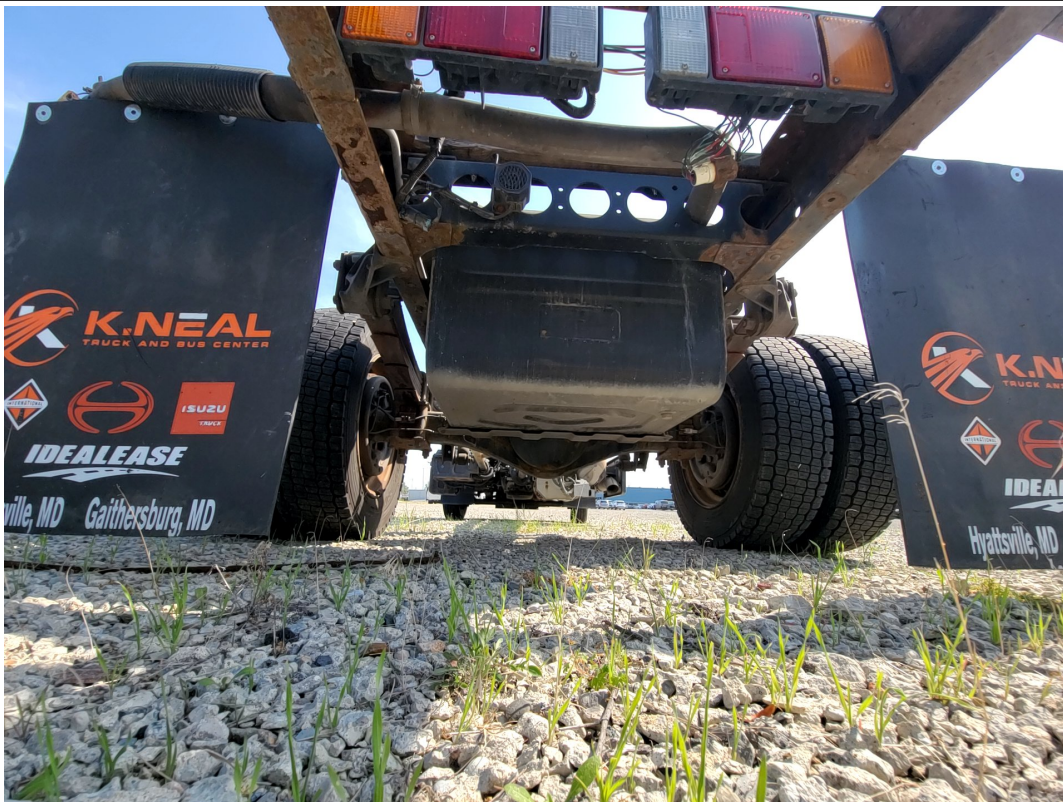
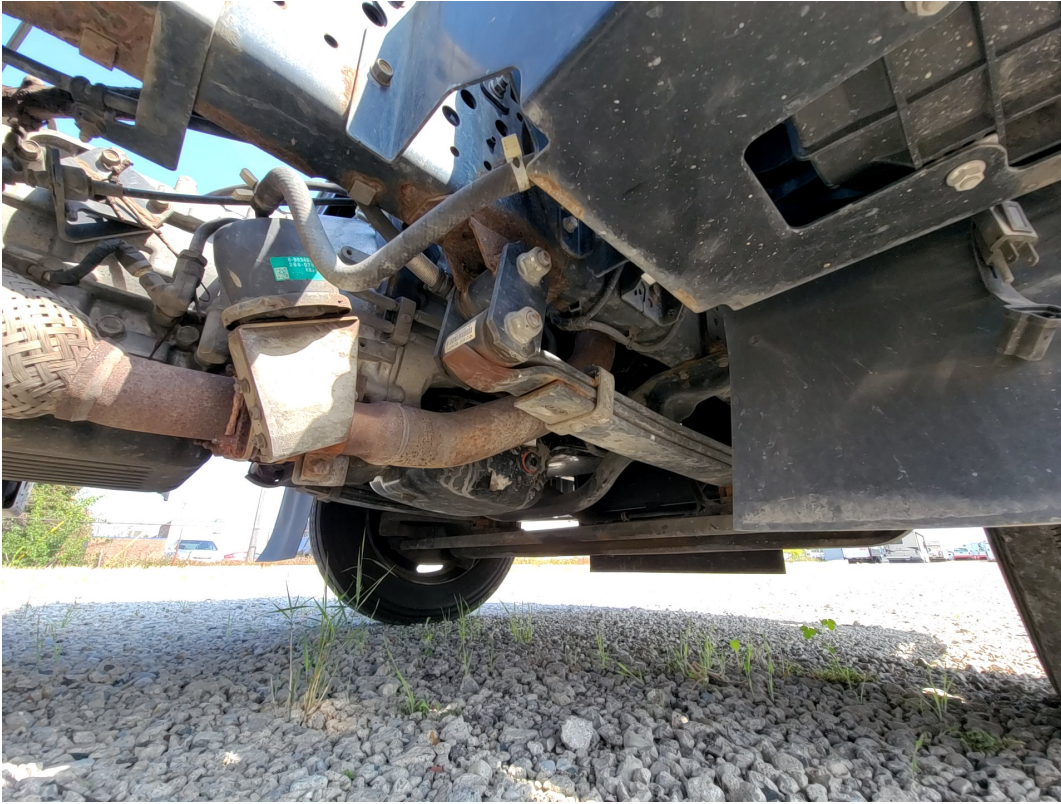
| Visible Damages | |
|---|--|
| Frame Rails Rusty | The frame rails are rusty. |
