DIESEL 2020 - ISUZU FTR CHASSIS - LA130109 / LA130109

Specifications

Job #: 59616 /

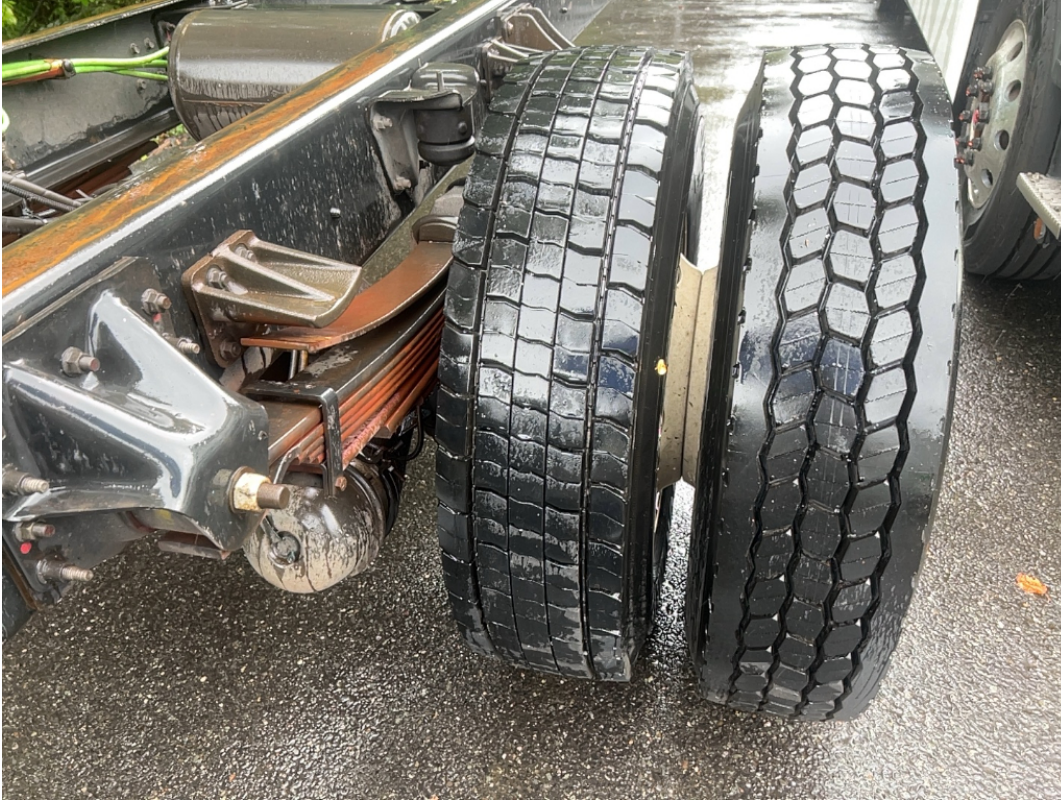
Rear Left Outer Drive Tire Condition / 09-18-2023

Left Steer Tire Brand	Gripower
Left Steer Tire Size	11R22.5
Rear Left Outer Drive Tire Condition	No Damages Observed
Rear Left Outer Drive Tire Brand	Tourador
Rear Left Outer Drive Tire Size	11R22.5
Rear Left Inner Drive Tire Condition	No Damages Observed
