Aspen Field Services

Job #: 60453 /

16' MORGAN DRY VAN BODY, DIESEL 2020 - ISUZU NPR-HD / LA130166

Specifications

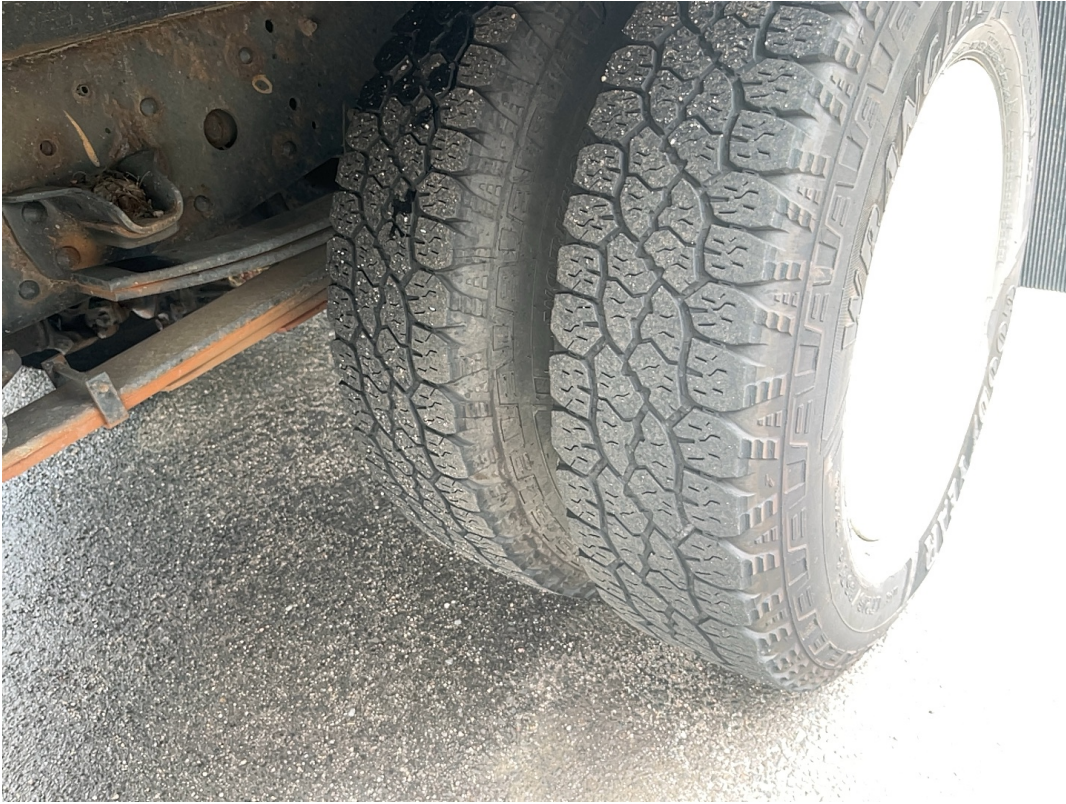
Left Inner Drive Tire Condition / Suspension / 09-19-2023

Left Steer Tire Size	LT215/85R16
Left Outer Drive Tire Condition	No Damages Observed
Left Outer Drive Tire Brand	Goodyear
Left Outer Drive Tire Size	LT215/85R16
Left Inner Drive Tire Condition	No Damages Observed
Right Steer Tire Condition	No Damages Observed

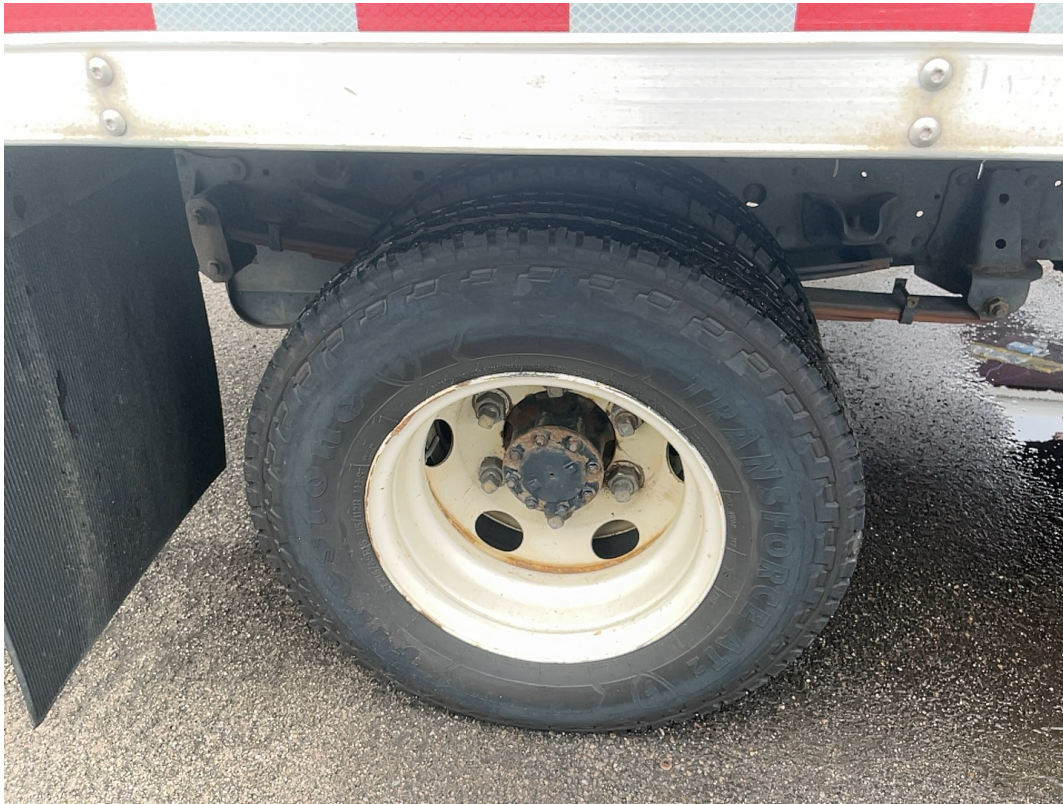
Right Outer Drive Tire Condition / Suspension / 09-19-2023

Right Steer Tire Brand	Firestone
Right Steer Tire Size	LT215/85R16
Right Outer Drive Tire Condition	No Damages Observed
Right Outer Drive Tire Brand	Firestone
Right Outer Drive Tire Size	LT215/85R16
Right Inner Drive Tire Condition	No Damages Observed
Axle information	Front: 5,360 lbs / Rear: 9,880 lbs
Transmission Information	Could Not Be Located
Engine Information	Isuzu 5.2L In-Line 4HK1-TC / 210 HP
