# 16' VAN BODY, GAS 2020 ISUZU NPR-HD (LA137591) / LA137591

## Aspen Field Services

Job #: 59439 /

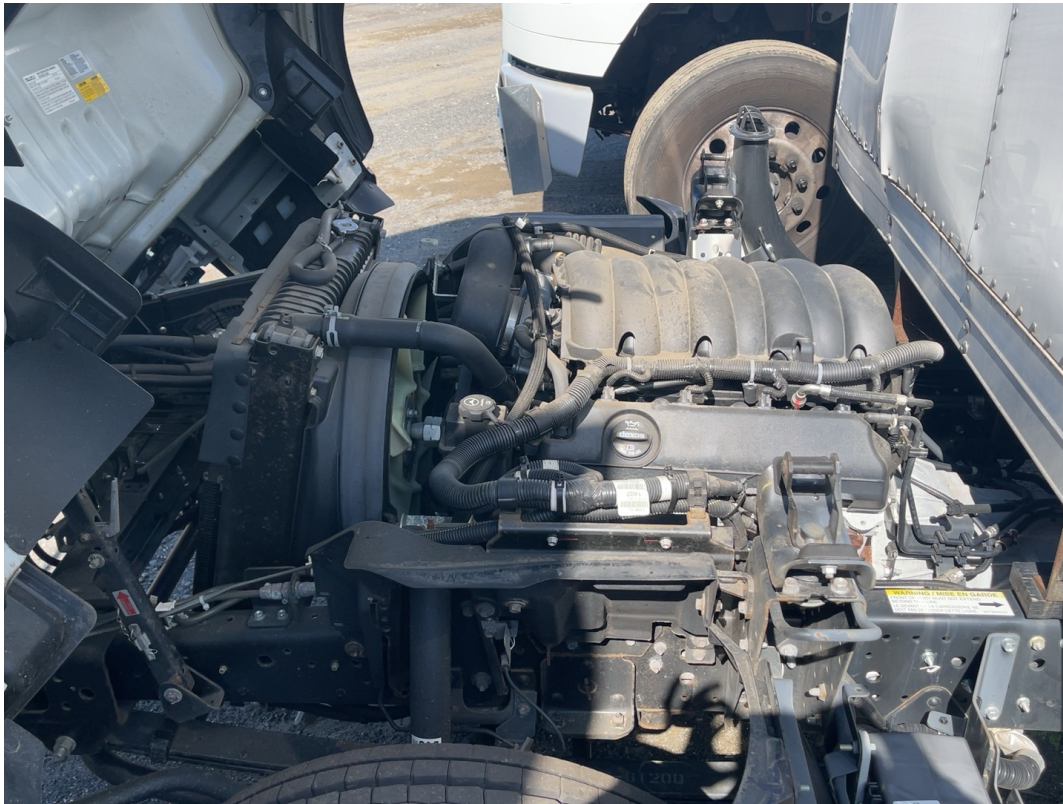
Engine Compartment / 08-30-2023

The unit was left with a missing catalytic converter and a rag in place of a coolant cap. Therefore, the truck was not started during the time of the inspection, in order to avoid further damage to the engine. The Engine Information was obtained from a VIN-Decoding software.

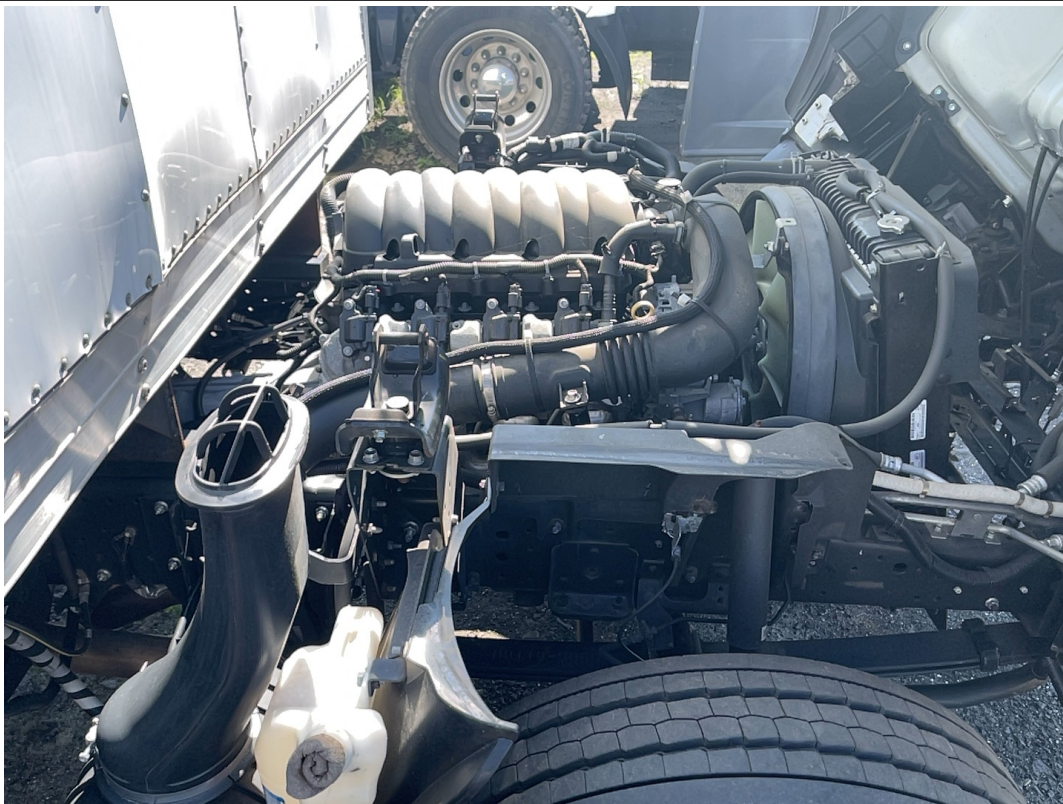
Engine Compartment / 08-30-2023

Catalytic Converters	Both of the catalytic converters are missing.
Mirror	The right mirror is cracked.
Plywood	The plywood panels in the box are damaged on the bottom.
Sheet Metal Panels	A couple of the metal panels on the front of the box are bent behind the cab.
Coolant Cap	The cap is missing.
Coolant	The coolant is low in the reservoir.
Engine Oil	The oil level on the dipstick is low.
Rear Right Platform	The aluminum strip is bent under the rear platform.
