Inspection Detail

Client:	Isuzu Finance	
	Inspected by:	Victor Carreras	
	Location of Inspection:	64 Union St, Brooklyn, NY 11231, USA	
	Phone No / Email:	+1 201 954 4480 / dgenes@mileautogroup.com	
	Date of Inspection:	2/14/2025	Job#: 868ceqbt
	Year:	2019	Make: Isuzu
	Model:	NPR/NPR-HD	VIN: 54DC4W1B7KS811995

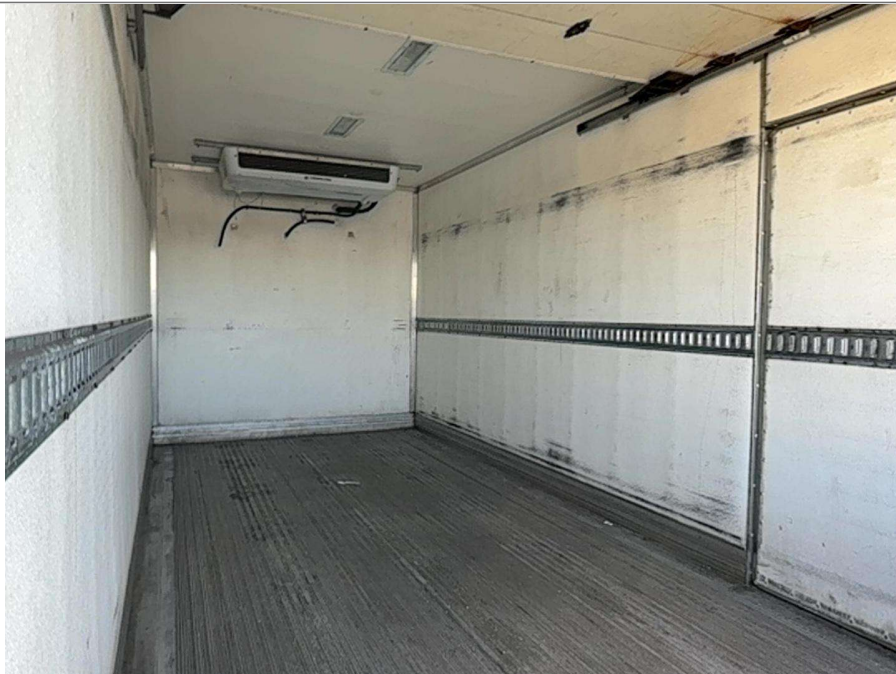
**Box Interior / Box Condition**

Wear and Tear Items	
Item Name	Item Comments
Decal Peeling	The decal is peeling on the front top of the box.
Corner Cover	The bottom edge of the right corner cover has a dent.
Sheetmetal Panels	The sheet metal panels on the box are spray-painted and damaged.
First Right Inner Drive Tire	The tire appears flat and coming off the wheel, and the tread shows wear on the outside shoulder.
Shocks	The front and rear shocks appear oily and leaking.
First Left Steer Tire	The steer tire is worn out on the inner shoulder.
Engine Oil	The engine oil appears to be above the full mark on the dipstick.
Left Door	The left door appears to be dented on the front corner.
Taillights	The left taillight is missing, and the housing is rusty.
Front Bumper	The bumper appears to have scratches on the front left side.
Driver's Seat Material	The material on the seat appears to be stained.
Climate Control Module	The selector knob on the module is missing, and the tip inside where the knob attaches appears to have been broken off.

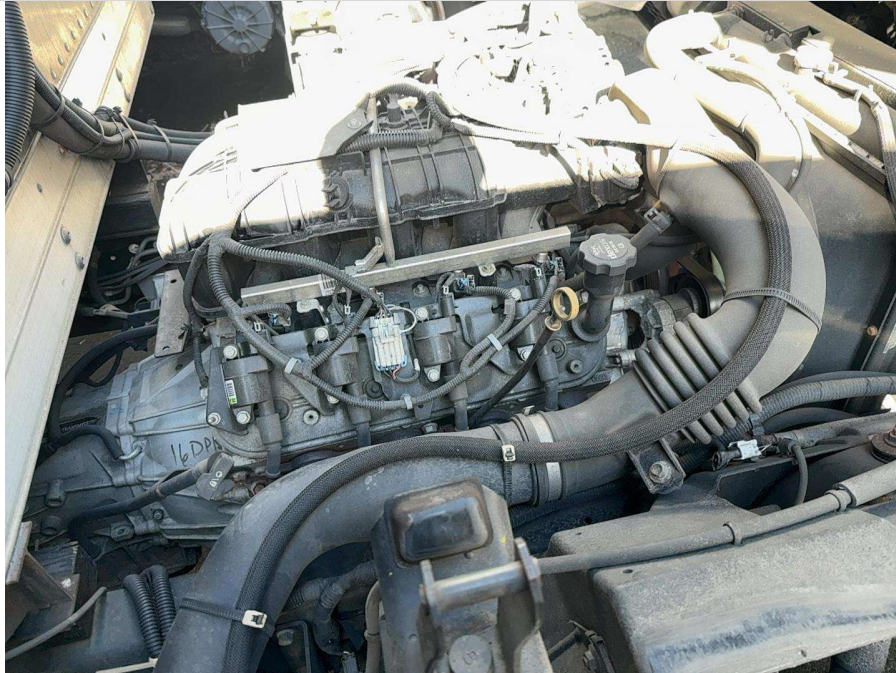
**Engine Compartment**

Engine Compartment:	No Damages Observed	Oil Dipstick:	High Level / Good Color	Coolant Level:	Good Level
----------------------------	---------------------	----------------------	-------------------------	-----------------------	------------
