Inspection Detail

Client:		Isuzu Finance
	Inspected by:		Mearl Martin
	Location of Inspection:		909 N Grand Ave, Santa Ana, CA 92701, USA
	Phone No / Email:		+1 800 638 1015 / dvillafana@ttruck.com
	Date of Inspection:	Job#:	868c528fj
	Year:	Make:	Isuzu
	Model:	VIN:	JALE5W166L7302240

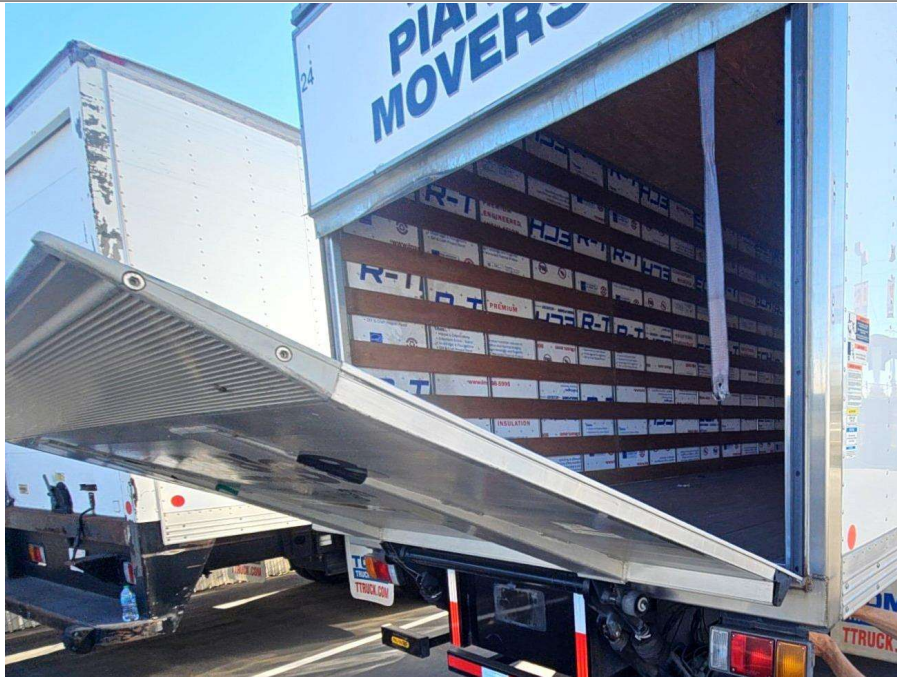
Unit Condition

Rear Right Bumper	The bumper appears to be bent inward.
Sheetmetal Panels	The sheet metal panels on the unit are scratched.

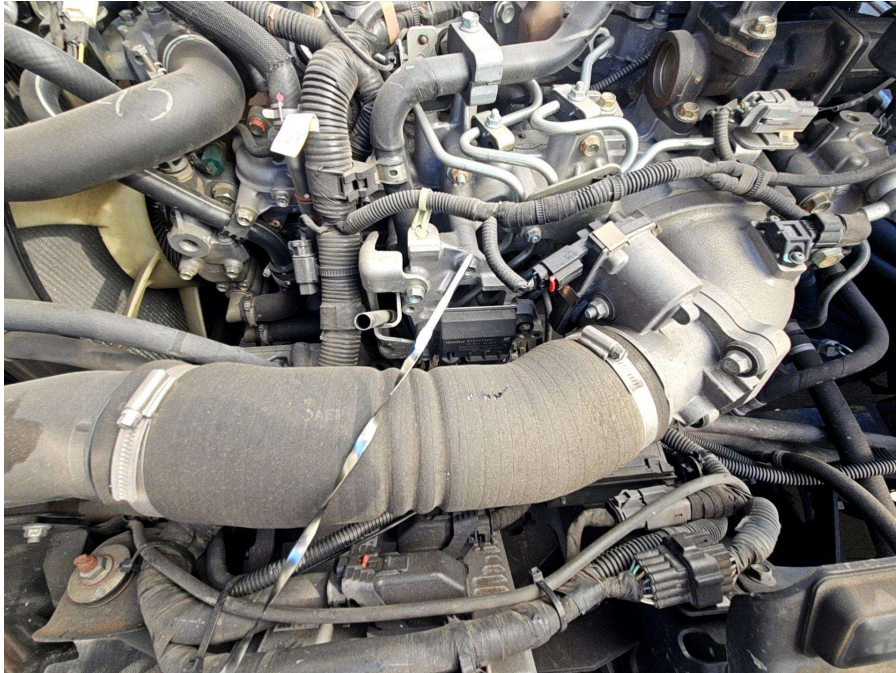
**Oil Dipstick**

Engine Compartment:	No Damages Observed	Oil Dipstick:	Good Level / Dark in Color	Coolant Level:	Good Level
----------------------------	---------------------	----------------------	----------------------------	-----------------------	------------

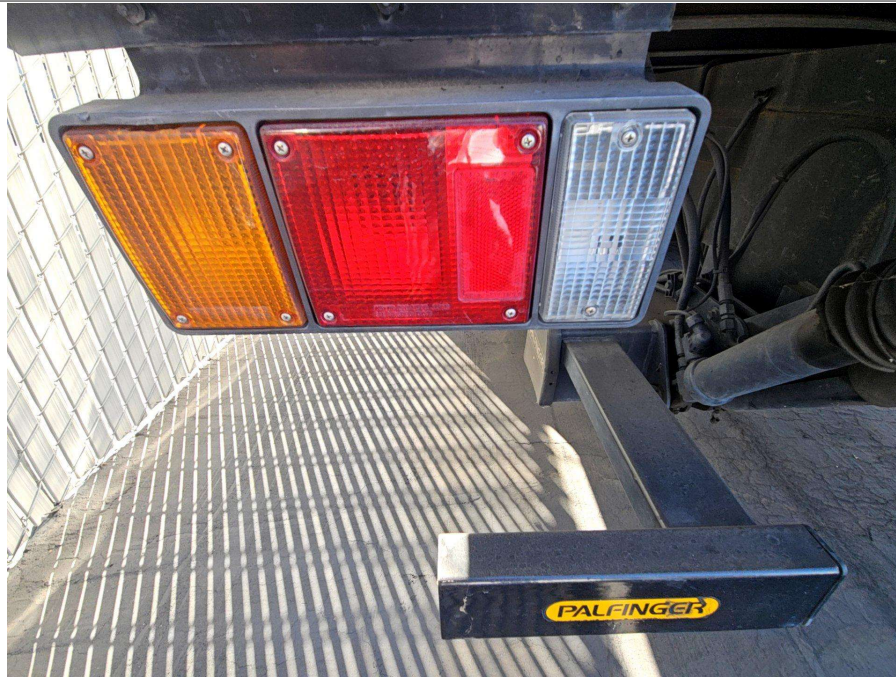
Rear Lights

Wear and Tear Items	
Item Name	Item Comments
Taillight	The left taillight appears to be slightly bent downward.
Grab Handle	The grab handle is missing from the rear right door frame of the box.
Rubber Boots	The rubber boot protectors on the rear lift cylinders are torn.
Lift Platform Cylinder	The left cylinder for the lift platform appears to be leaking.
Mud Flap	The front left mud flap appears to be broken off at the bottom.
Front Shocks	The front shocks are leaking and appear to be oily.
First Right Inner Drive Tire	The drive tire treads are worn down
First Left Outer Drive Tire	The drive tire treads appear worn down.
Engine Oil	The engine oil is dark in color.
Backup Alarm	The backup alarm is not operational.
Floor Mat	The floor mat shows wear on both the driver's and passenger's sides.
Warnings	The unit has warning lights on the dash at the time of inspection.
Top Lip	The top lip on the right side of the box is dented.
