Inspection Detail

Client:		Isuzu Finance
	Inspected by:		Mark Hamilton
	Location of Inspection:		6225 State Rd., Philadelphia, PA 19135, USA
	Phone No / Email:		+1 610 220 0514 / fhalper@bentleytruckservices.com
	Date of Inspection:	Job#:	868dmgmjm
	Year:	Make:	ISUZU
	Model:	VIN:	54DK6S168JSG00601

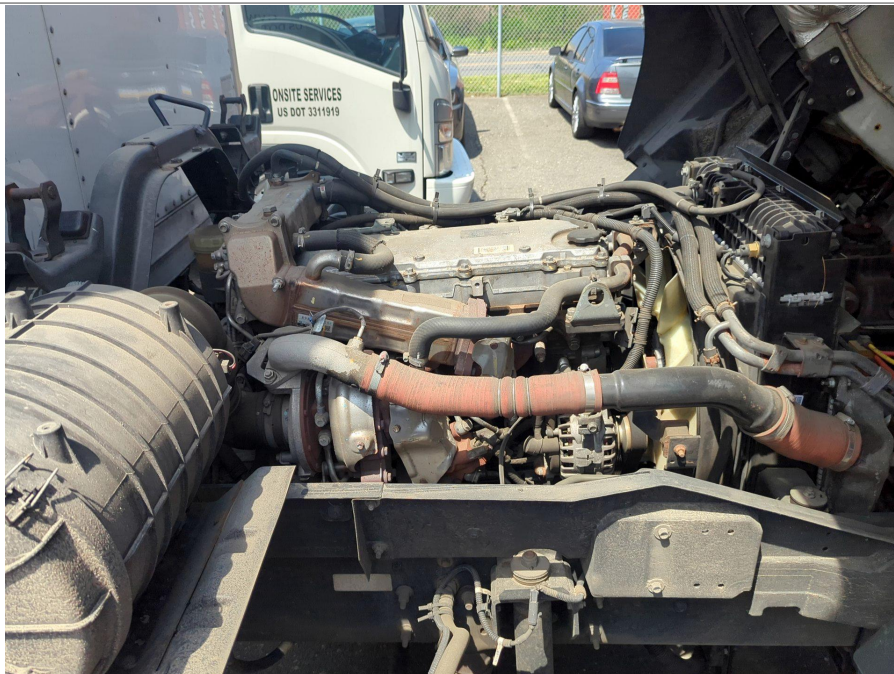
**Engine Compartment**

Engine Compartment:	No Damages Observed	Oil Dipstick:	Good Level / Dark in Color	Coolant Level:	Good Level
Engine Serial Plate:	Obstructed

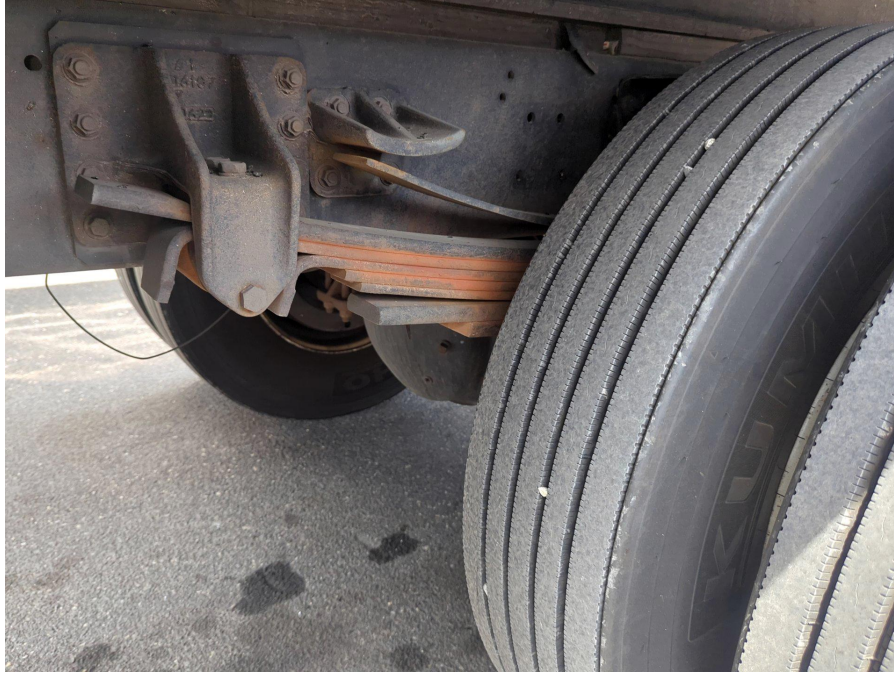
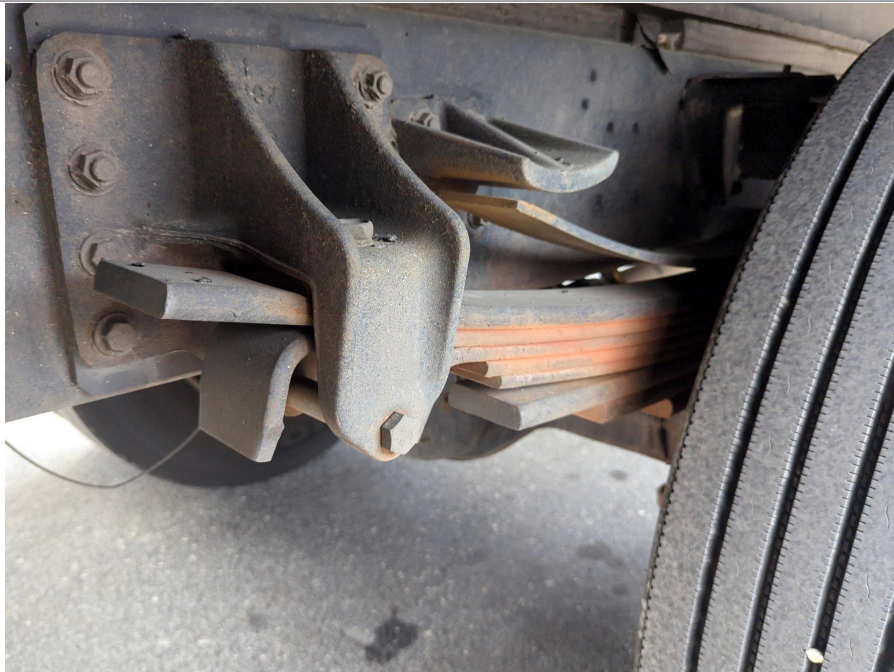
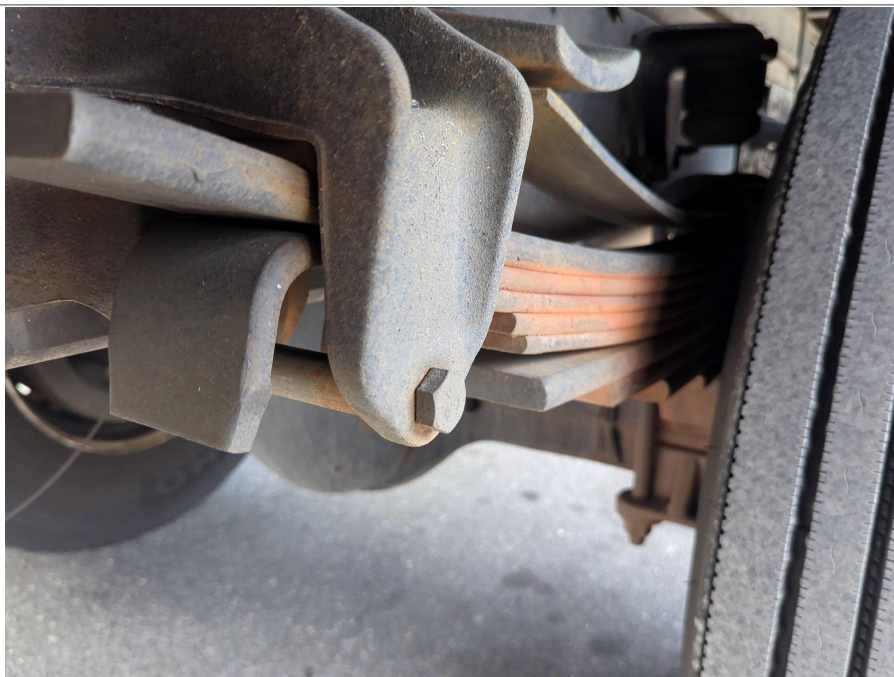
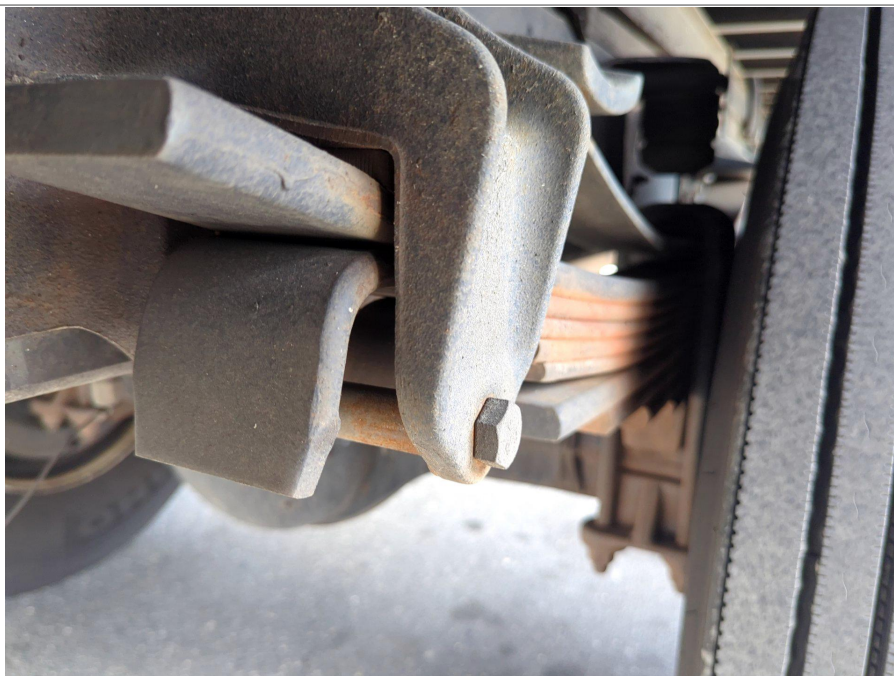
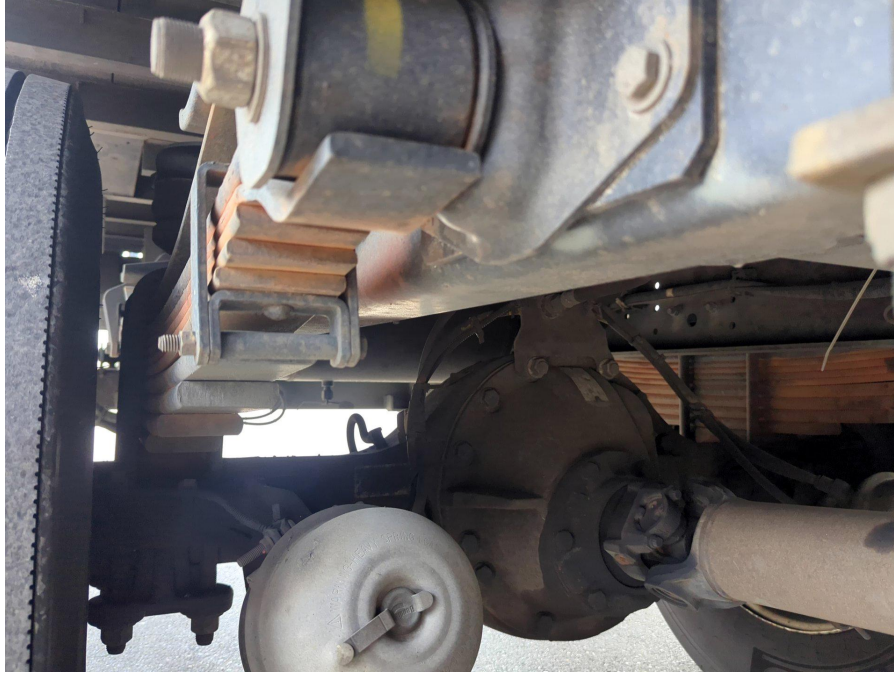
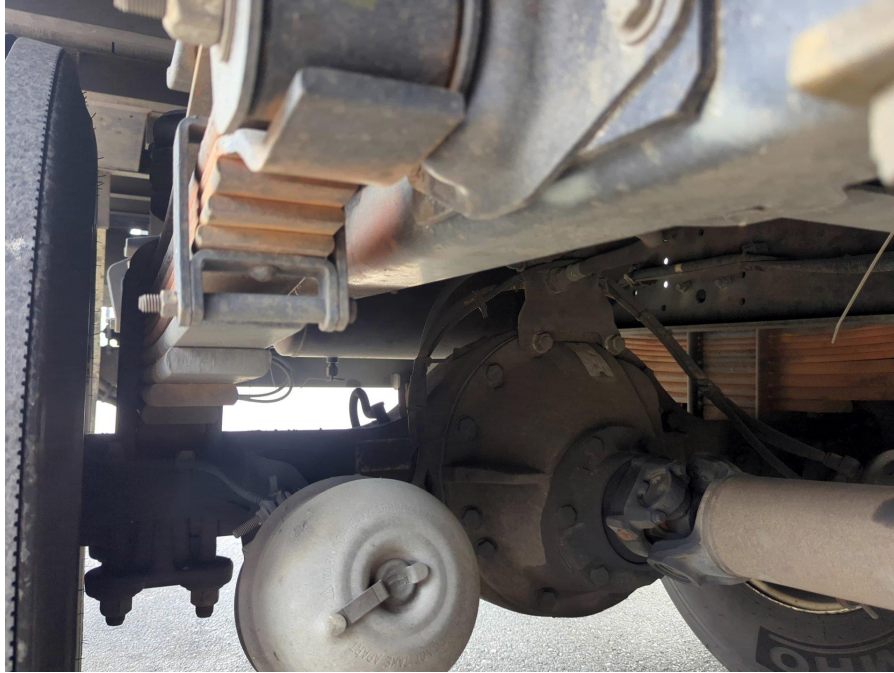
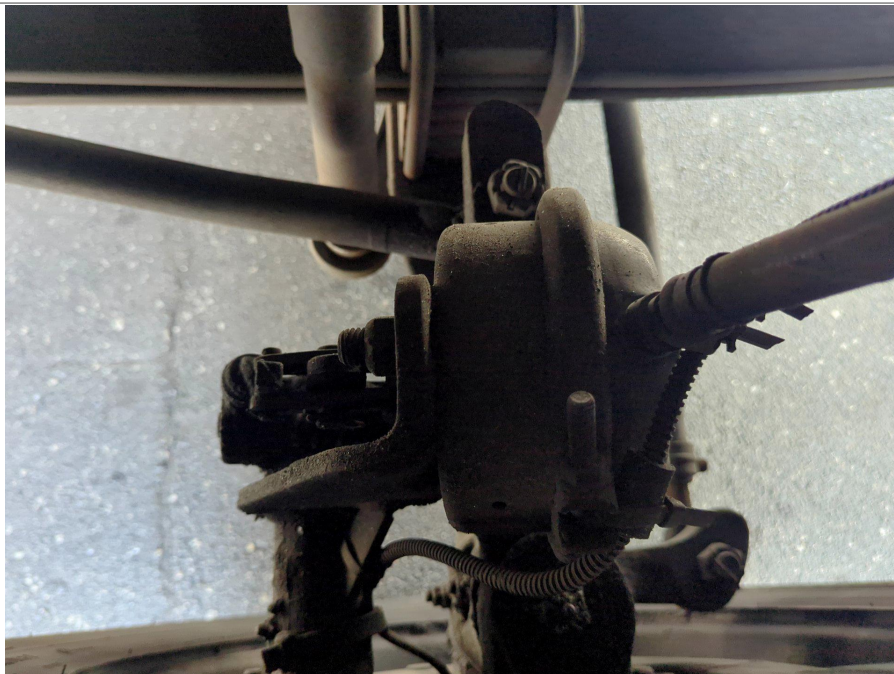
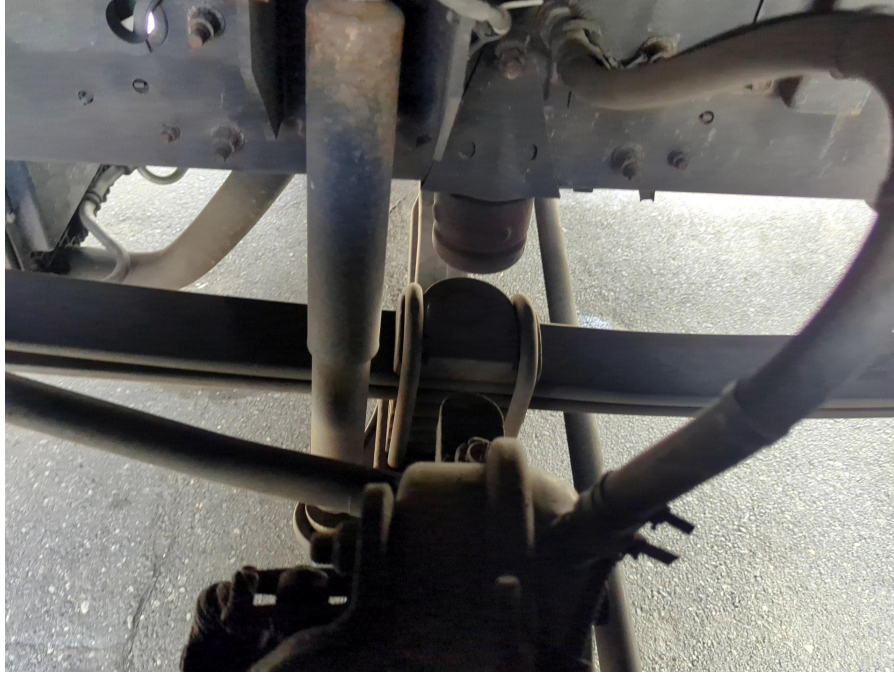
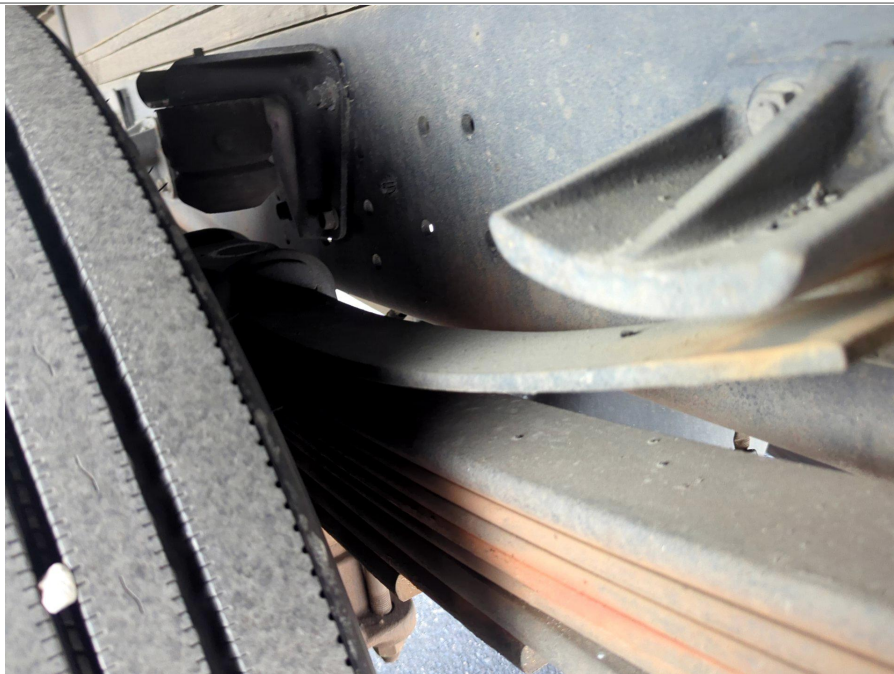
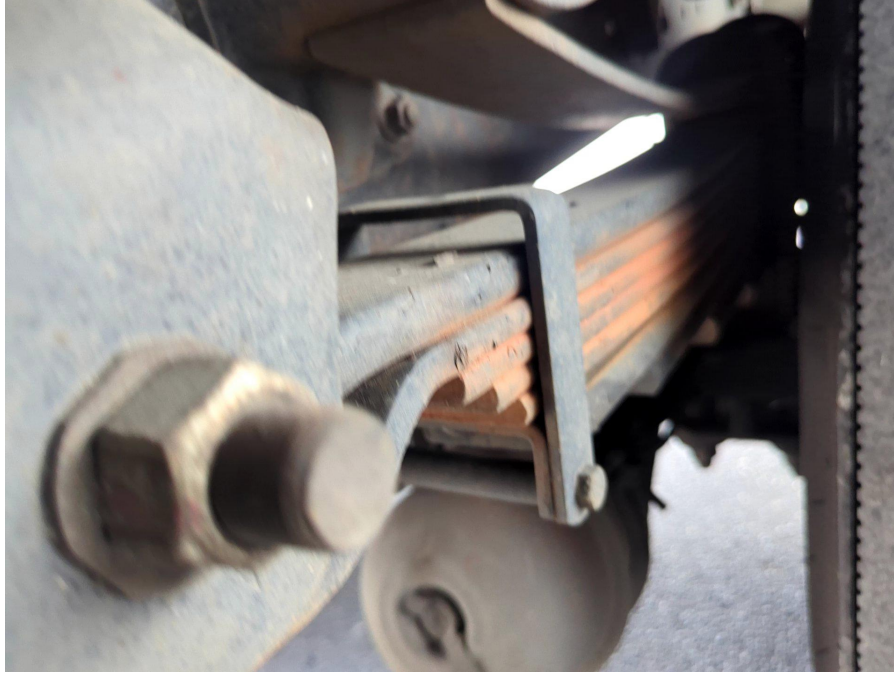
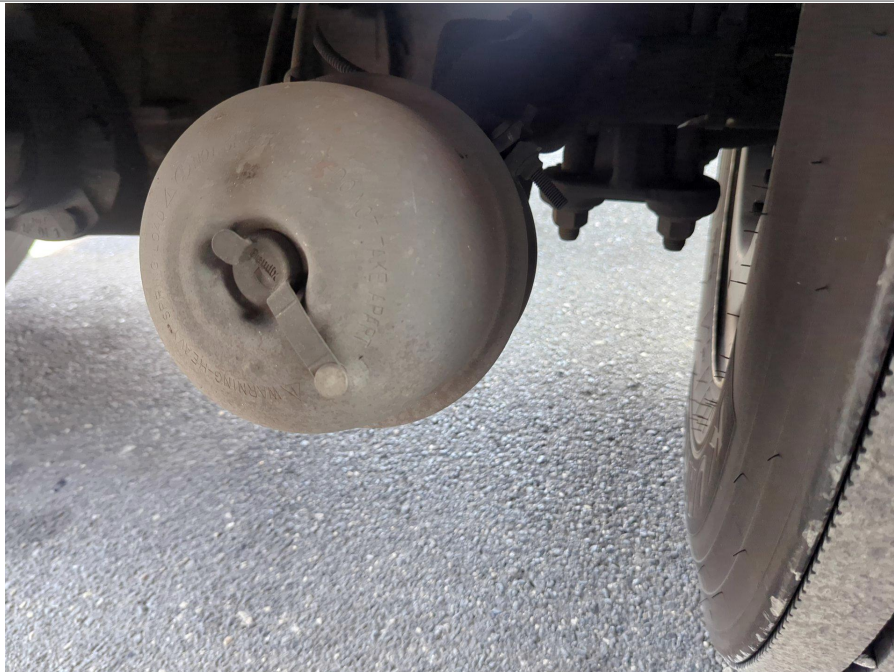
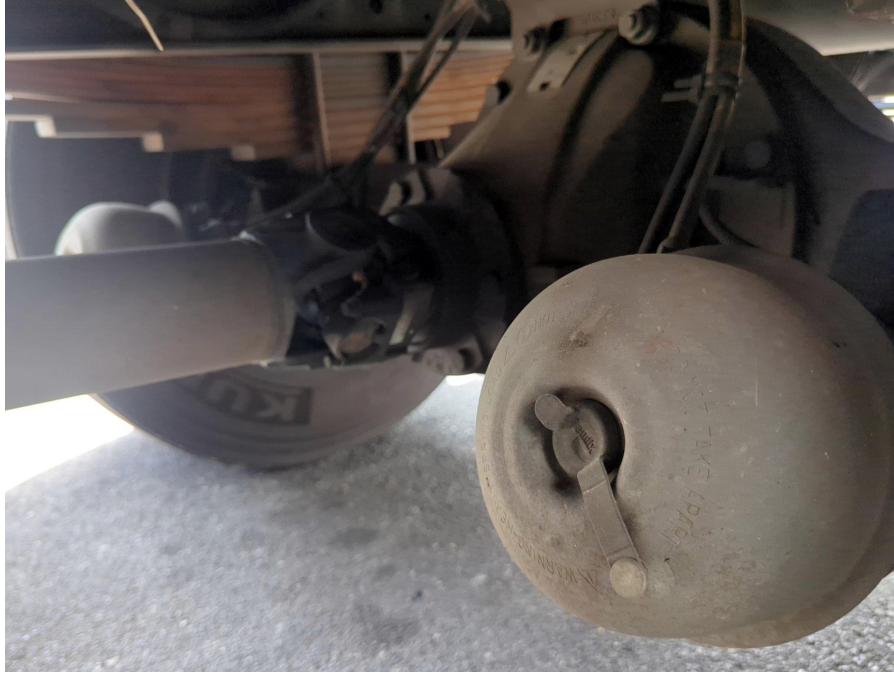
Axles / Suspension

Mirrors:	No Damages Observed	Steps:	See Notes	Handrails:	No Damages Observed
Exhaust System:	No Damages Observed	Front Lights:	No Damages Observed	Rear Lights:	No Damages Observed
Suspension:	No Damages Observed	Axles:	See Notes

Wear and Tear Items	
Item Name	Item Comments
Dock Bumper	The rear right rubber dock bumper appears to be damaged.
Lift Gate Platform	There is a hole on the underside of the aluminum platform.
Right Steer Tire	The tire treads appear to be wearing along the inner edge.
Rear Differential	The front seal on the rear differential appears to be leaking or shows signs of a past leak.
Plywood	The plywood interior panels inside the box are damaged.
Engine Oil	The engine oil appears dark in color.
Warning	The check engine light was illuminated on the dash at the time of inspection.
Right Step	The right step for the door on the right side of the box is bent.
Sheetmetal Panel	The side sheetmetal panels are scratched.

Repair Items			
Item Name	Item Labor Cost	Item Part Cost	Total Cost
Lift Gate Platform	\$300.00	\$1,500.00	\$1,800.00
Right Steer Tire	\$150.00	\$580.00	\$730.00
Rear Differential	\$450.00	\$300.00	\$750.00
Plywood	\$450.00	\$800.00	\$1,250.00
Warning	\$600.00	\$1,200.00	\$1,800.00
Sheetmetal Panel	\$1,200.00	\$2,500.00	\$3,700.00
Total Repairs:			\$10,030.00
