| Inspection Detail | | | |
| | <b>Date of Inspection:</b> | 5/12/2025 | <b>Job#:</b> 868dvrvg1 |
| | <b>Year:</b> | 2021 | <b>Make:</b> ISUZU |
| | <b>Model:</b> | NRR | <b>VIN:</b> JALE5W168M7300412 |

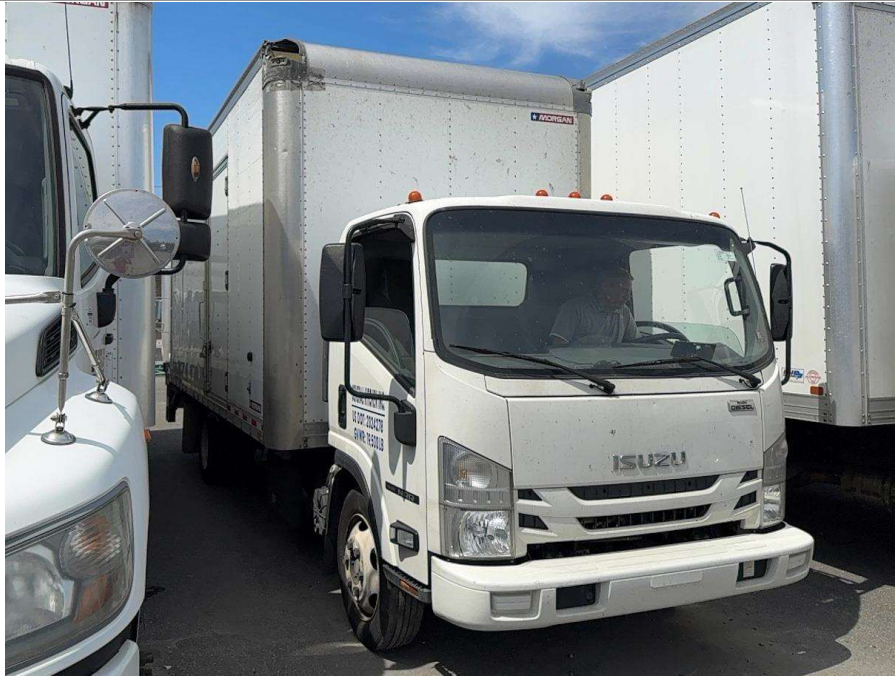
**Front Left**

| Wear and Tear Items | |
|---|---|
| Paint | The paint is damaged in a few different areas and needs to be addressed. |

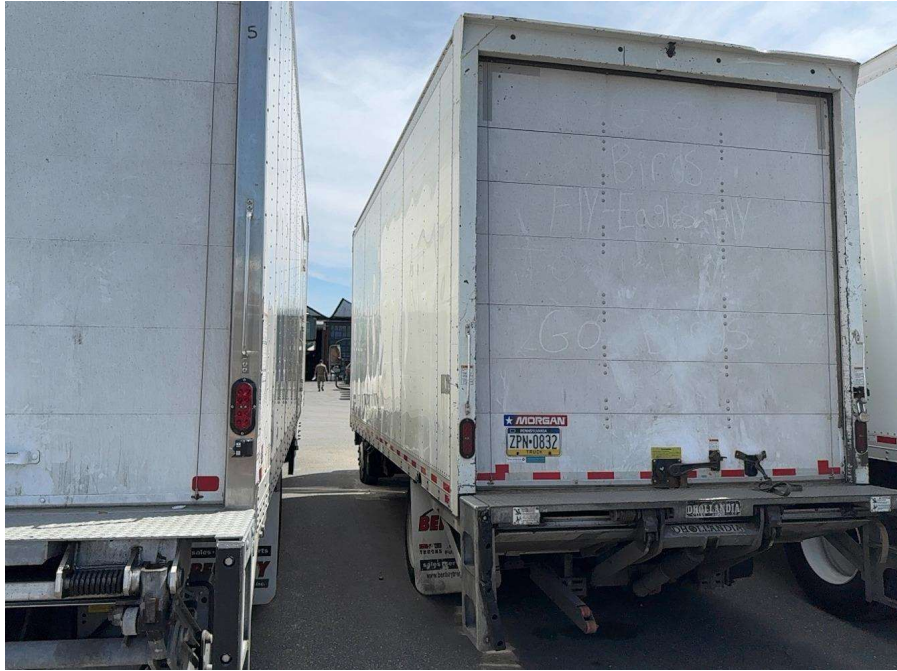
**Rear Left**

| Wear and Tear Items | |
|---|---|
| Box Corner Caps | The box corner caps are busted and need to be replaced. |

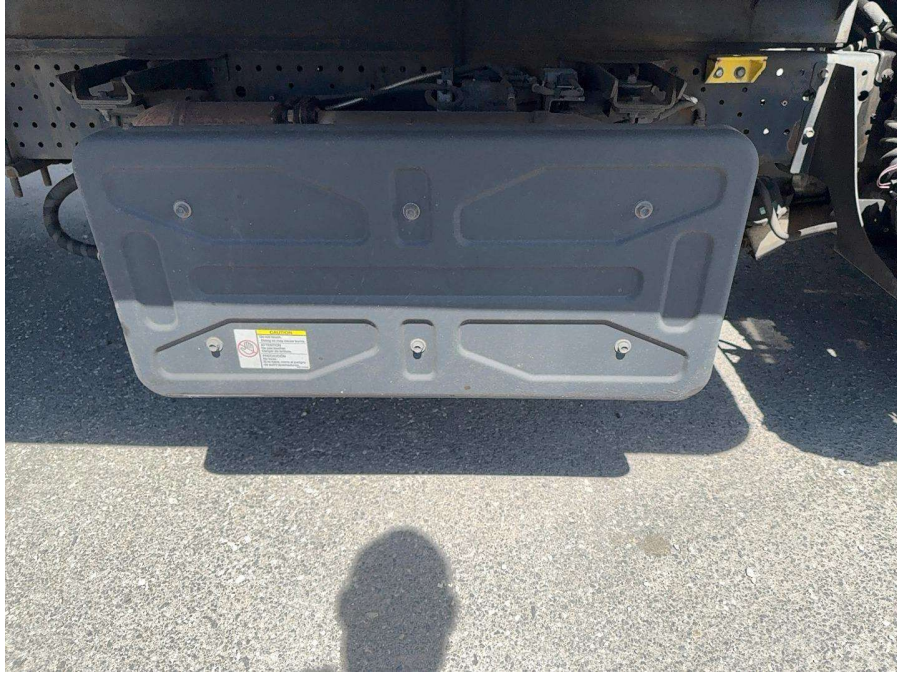
**Exhaust System**

| <b>Exhaust System:</b> | See Notes | <b>Front Lights:</b> | No Damages Observed | <b>Rear Lights:</b> | No Damages Observed |

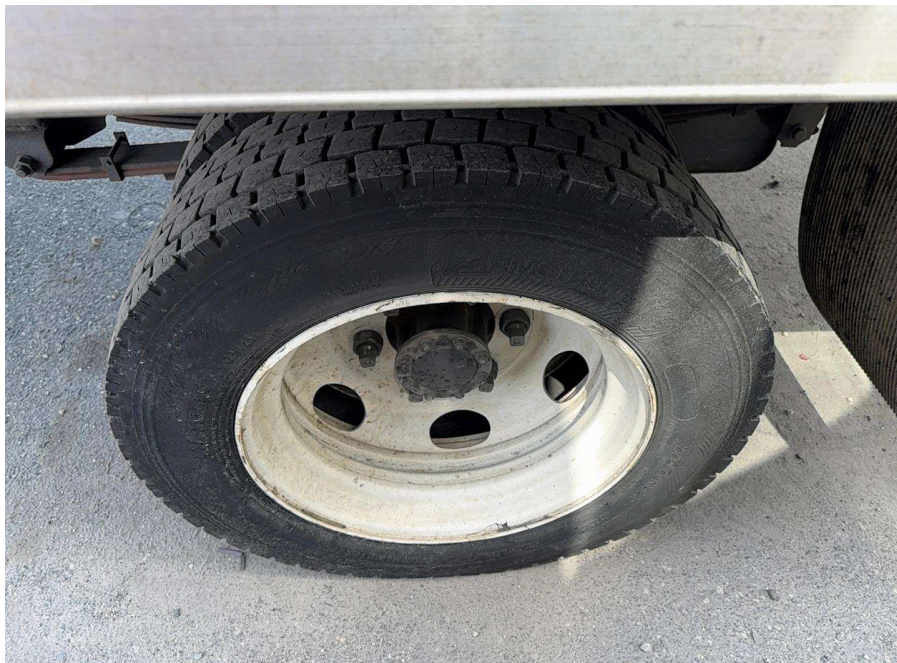
**First Left Outer Drive Tire Condition**

| Tires Details | | | | | |
|---|---|---|---|---|---|
| <b>First Left Outer Drive Tire Condition:</b> | No Damages Observed | <b>First Left Outer Drive Tire Brand:</b> | Armstrong | <b>First Left Outer Drive Tire Size:</b> | 225/70R 19.5 |

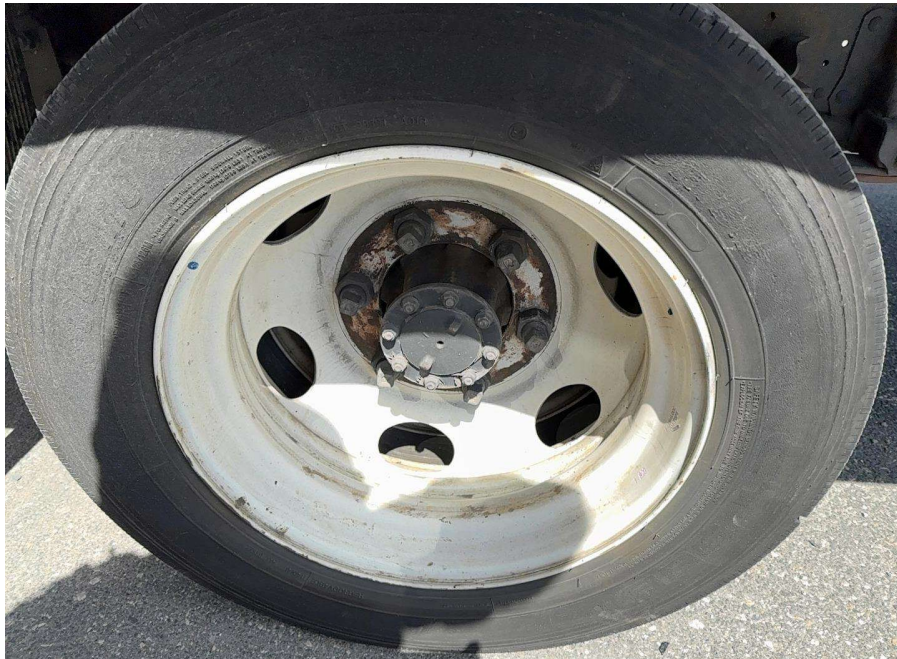
**First Right Outer Drive Tire Condition**

| Tires Details | | | | | |
|---|---|---|---|---|---|
| <b>First Right Outer Drive Tire Condition:</b> | No Damages Observed | <b>First Right Outer Drive Tire Brand:</b> | Cosmo | <b>First Right Outer Drive Tire Size:</b> | 225/70R 19.5 |
