Inspection Detail

<b>Client:</b>	Isuzu Finance	
	<b>Inspected by:</b>		
	<b>Location of Inspection:</b>	2425 Broadway St NE, Minneapolis, MN 55413, USA	
	<b>Phone No / Email:</b>	+1 612 616 2017 / curran.maguire@transwest.com	
	<b>Date of Inspection:</b>	6/13/2025	<b>Job#:</b> 868e9u9rz
	<b>Year:</b>	2020	<b>Make:</b> ISUZU
	<b>Model:</b>	NPR-HD	<b>VIN:</b> 54DC4W1B8LS801655

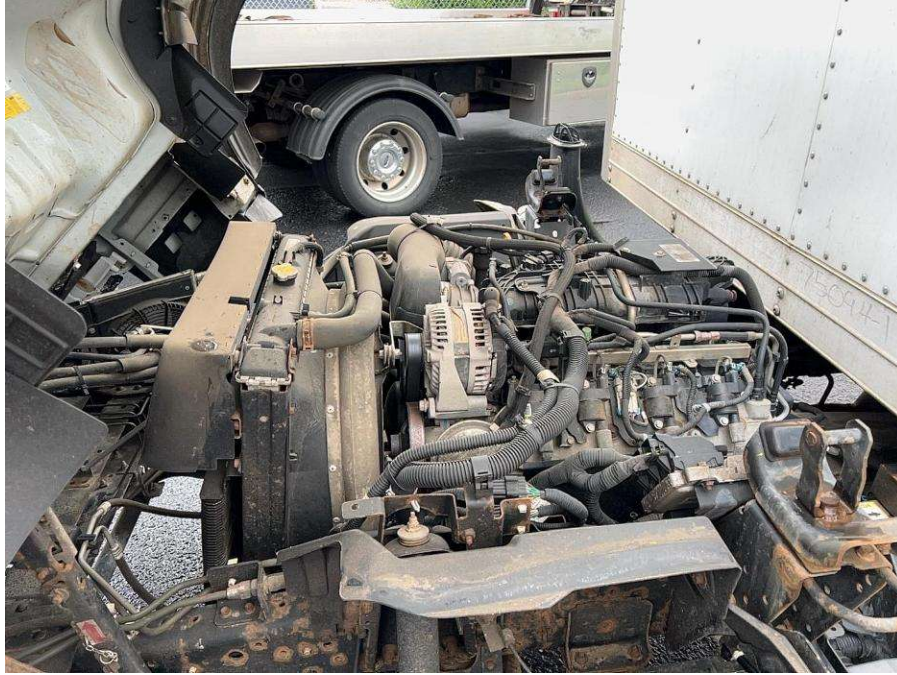
**Engine Compartment**

<b>Engine Compartment:</b>	No Damages Observed	<b>Oil Dipstick:</b>	Good Level / Dark in Color	<b>Coolant Level:</b>	Low Level
<b>Engine Serial Plate:</b>	Obstructed
