### Inspection Detail

<b>Client:</b>	Isuzu Finance		
<b>Inspected by:</b>	Jesse Herrera		
<b>Location of Inspection:</b>	8101 Daytona Road NW, Albuquerque, NM 87121, EUA		
<b>Phone No / Email:</b>	+1 505 839 5900 / esmith@brucknertruck.com		
<b>Date of Inspection:</b>	6/24/2025	<b>Job#:</b>	868d9by51
<b>Year:</b>	2022	<b>Make:</b>	Chevrolet
<b>Model:</b>	17CG33503	<b>VIN:</b>	1GB0GRF71N1271837

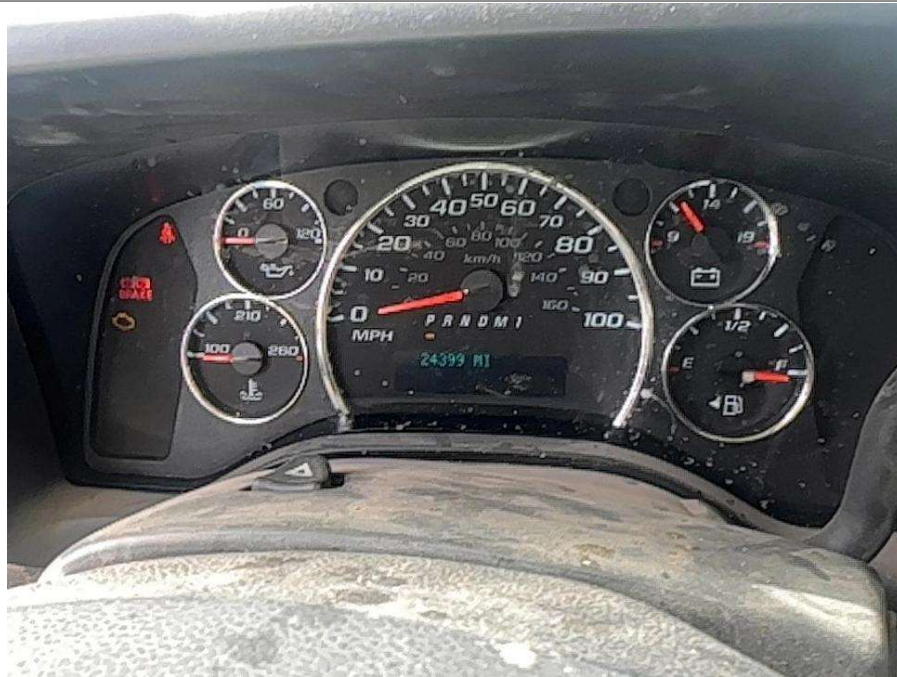
**EMS Panel**

<b>GVWR:</b>	9,900 lbs	<b>Odometer:</b>	24,399	<b>Engine Hours:</b>	N/A
<b>EMS Warning Lights:</b>	No

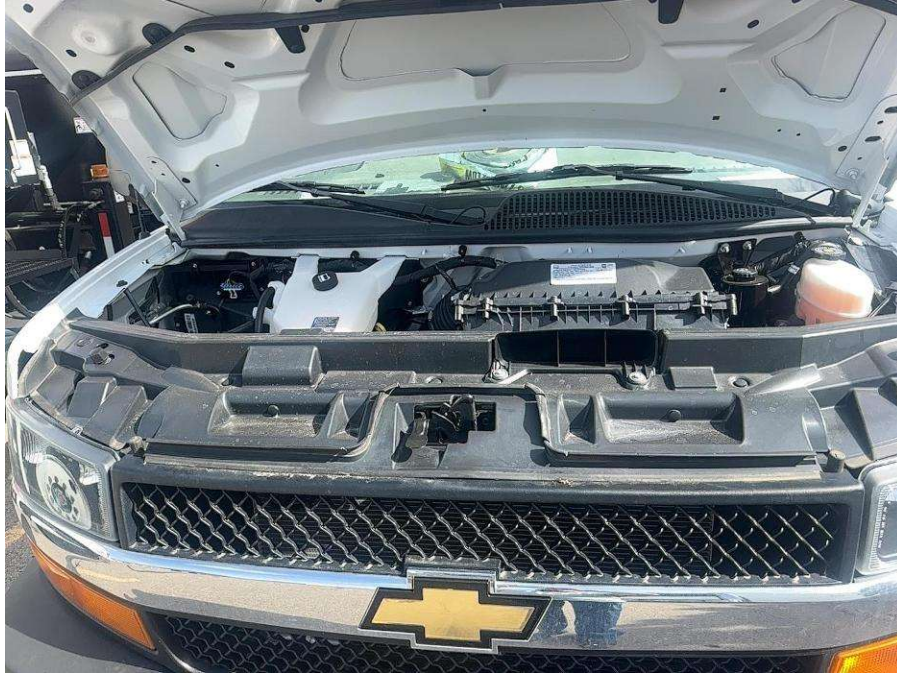
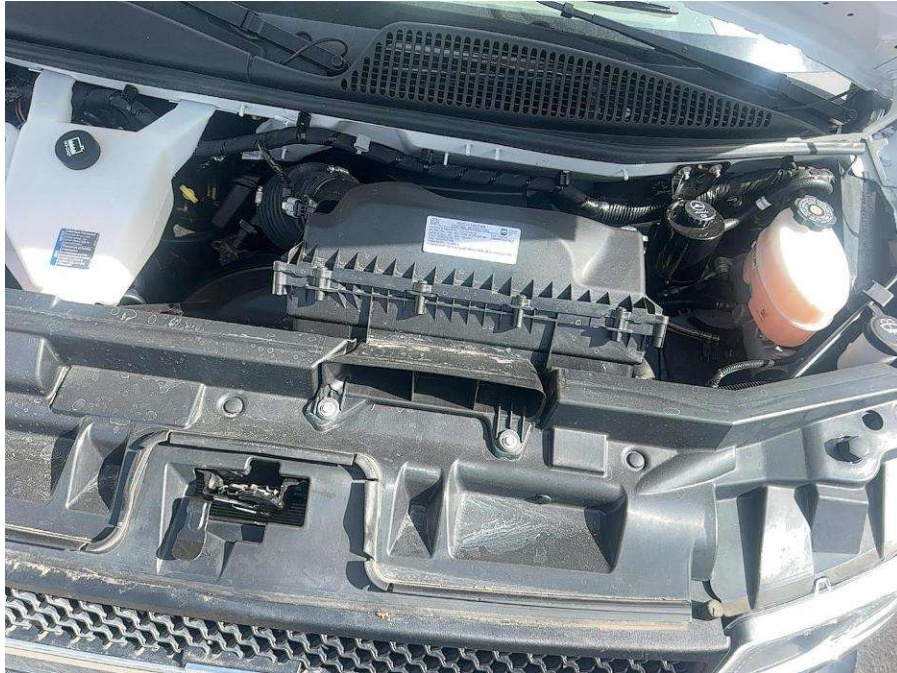
**Engine Compartment**

<b>Engine Compartment:</b>	No Damages Observed	<b>Oil Dipstick:</b>	Good Level / Dark in Color	<b>Coolant Level:</b>	Good Level
<b>Engine Serial Plate:</b>	Obstructed

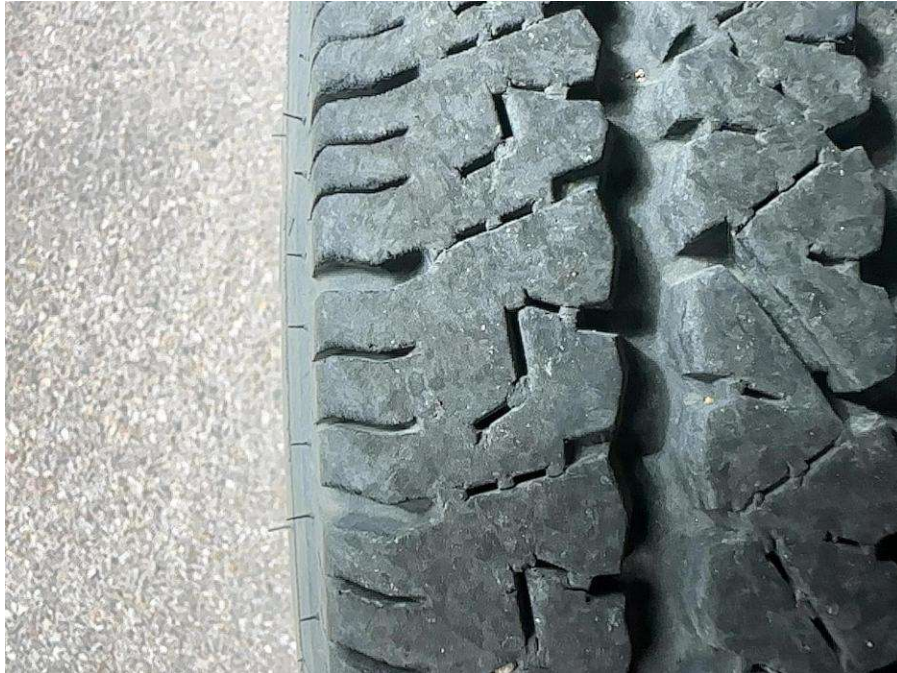
**First Left Steer Tire Condition**

Tires Details					
<b>First Left Steer Tire Condition:</b>	No Damages Observed	<b>First Left Steer Tire Brand:</b>	Bridgestone	<b>First Left Steer Tire Size:</b>	LT245/75R16
<b>First Right Steer Tire Condition:</b>	No Damages Observed	<b>First Right Steer Tire Brand:</b>	Bridgestone	<b>First Right Steer Tire Size:</b>	LT245/75R16
<b>First Left Outer Drive Tire Condition:</b>	No Damages Observed	<b>First Left Outer Drive Tire Brand:</b>	Bridgestone	<b>First Left Outer Drive Tire Size:</b>	LT245/75R16
<b>First Right Outer Drive Tire Condition:</b>	No Damages Observed	<b>First Right Outer Drive Tire Brand:</b>	Bridgestone	<b>First Right Outer Drive Tire Size:</b>	LT245/75R16

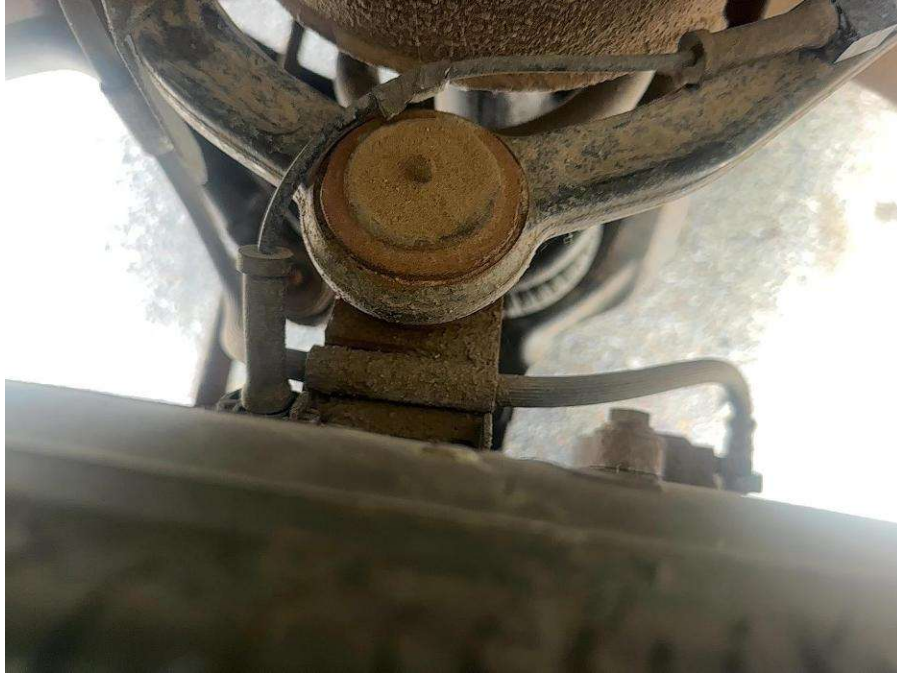
**Axles / Suspension**

<b>Mirrors:</b>	See Notes	<b>Steps:</b>	See Notes	<b>Handrails:</b>	No Damages Observed
<b>Exhaust System:</b>	No Damages Observed	<b>Front Lights:</b>	No Damages Observed	<b>Rear Lights:</b>	No Damages Observed
<b>Suspension:</b>	No Damages Observed	<b>Axles:</b>	No Damages Observed
