Inspection Detail

<b>Client:</b>		Isuzu Finance
	<b>Inspected by:</b>		
	<b>Location of Inspection:</b>		6225 State Rd., Philadelphia, PA 19135, USA
	<b>Phone No / Email:</b>		+1 267 255 0956 / jwallick@bentleytruckservices.com
	<b>Date of Inspection:</b>	<b>Job#:</b>	868f0c0y7
	<b>Year:</b>	<b>Make:</b>	Isuzu
	<b>Model:</b>	<b>VIN:</b>	54DK6S161LSG70007

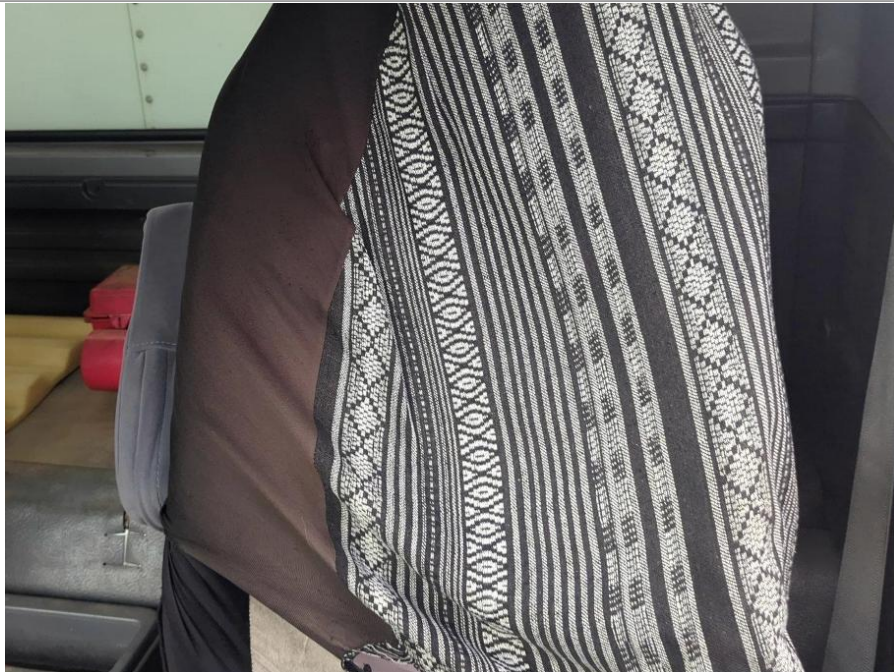
**Driver's Seat**

Right Steel Panel	The steel metal on the right side is rusted and damaged.
Driver's Seat	There are small holes in the seat cover.
