Inspection Detail

Client:	Isuzu Finance	
	Inspected by:		
	Location of Inspection:	2201 W Bell Rd, Phoenix, AZ 85023, USA	
	Phone No / Email:	+1 602 881 9525 / TFraser@vtag.com	
	Date of Inspection:	7/24/2025	Job#: 868ew81tz
	Year:	2019	Make: Mitsubishi FUSO
	Model:	FE160	VIN: 4UZBVG117KGKM6480

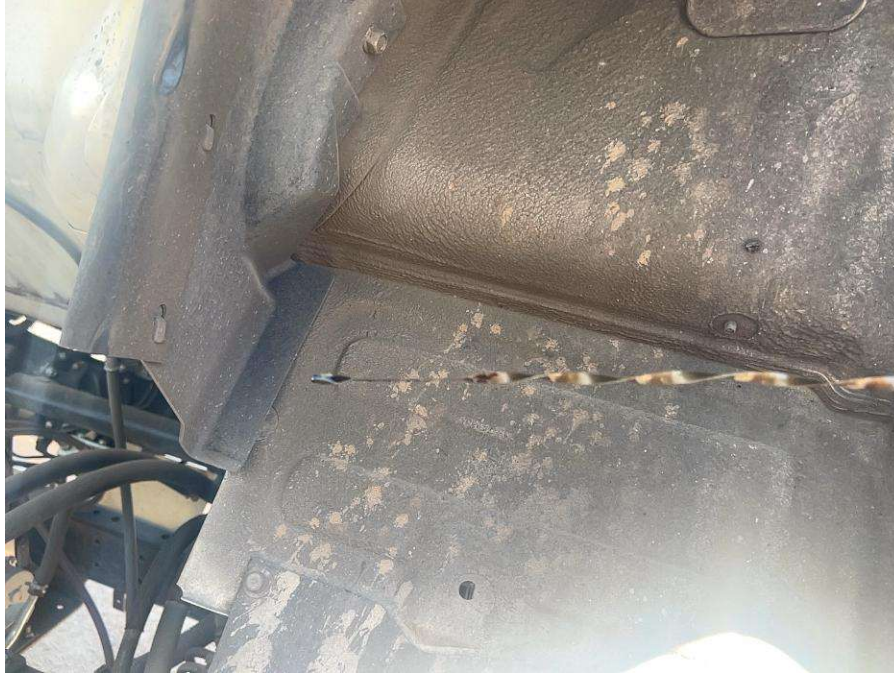
Oil Dipstick

Engine Compartment:	No Damages Observed	Oil Dipstick:	Low Level / Dark in Color	Coolant Level:	Low Level
Engine Serial Plate:	Obstructed
