Inspection Detail			
<p>Click to watch the video</p>

Client:		Isuzu Finance
	Inspected by:		
	Location of Inspection:		2201 W Bell Rd, Phoenix, AZ 85023, USA
	Phone No / Email:		+1 602 881 9525 / tfraser@vtaig.com
	Date of Inspection:	Job#:	9/2/2025 868fcqemn
	Year:	Make:	2021 Isuzu
	Model:	VIN:	NQR JALE5J16XM7901159

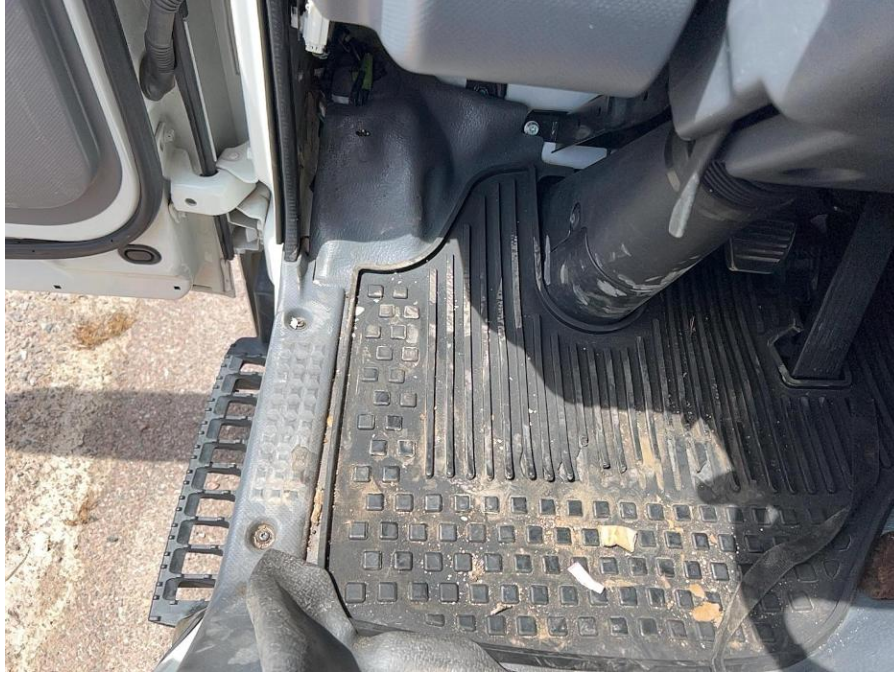
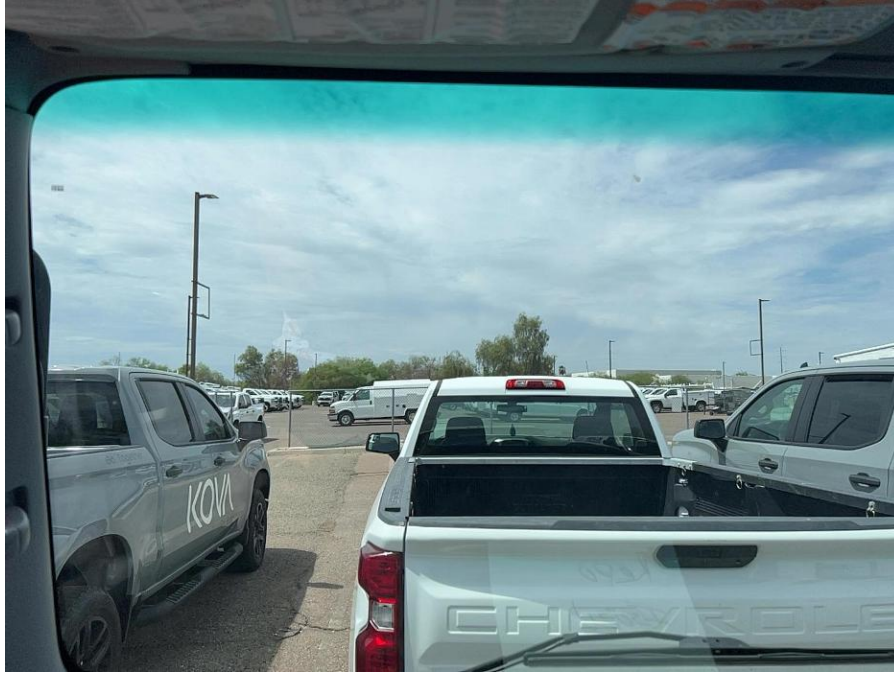
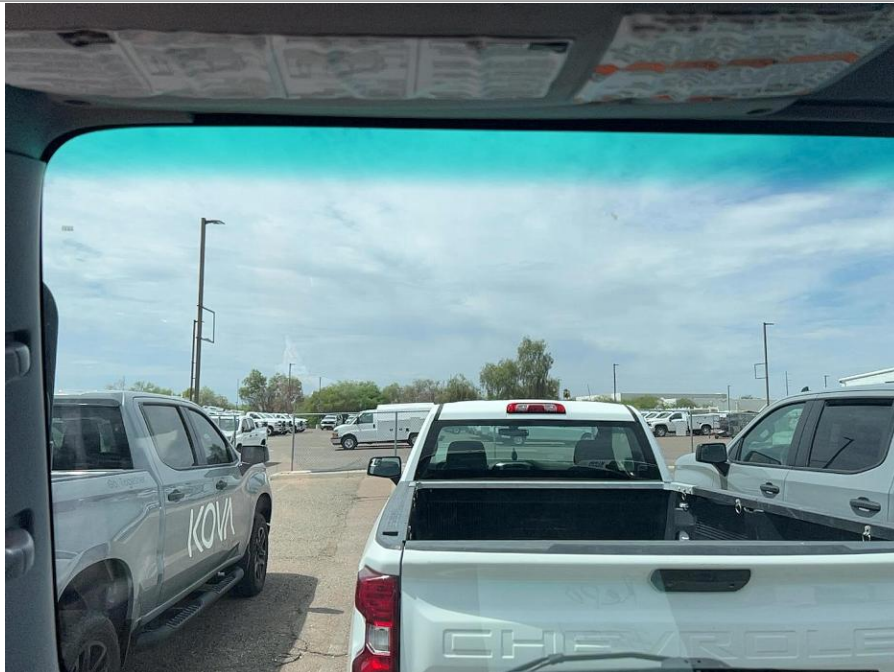
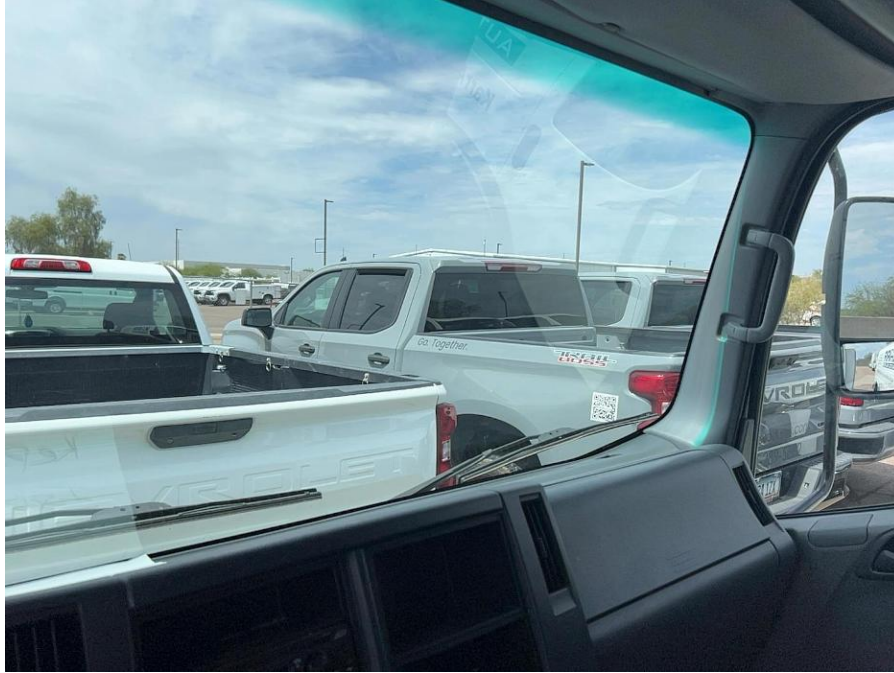
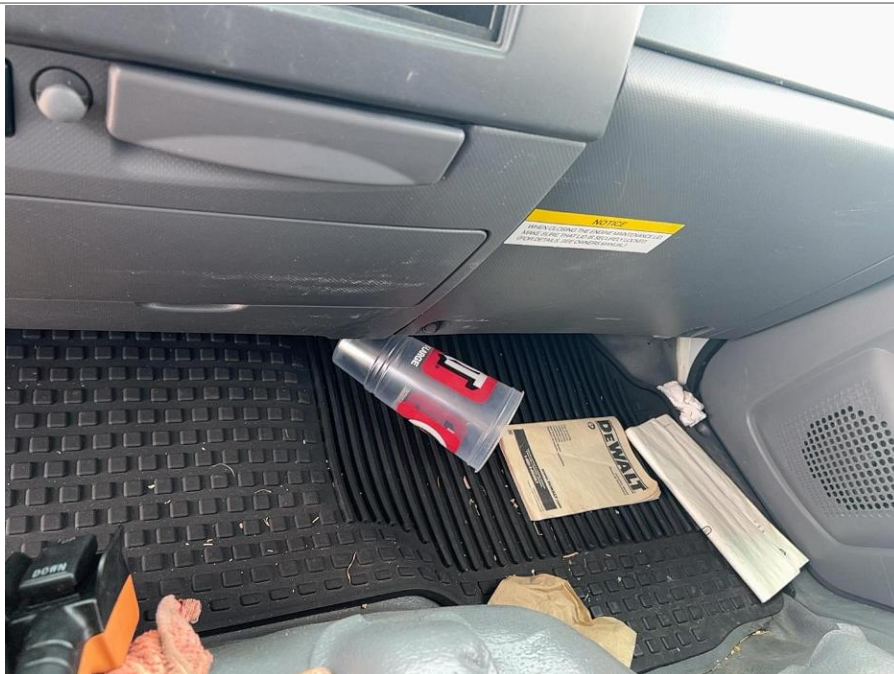
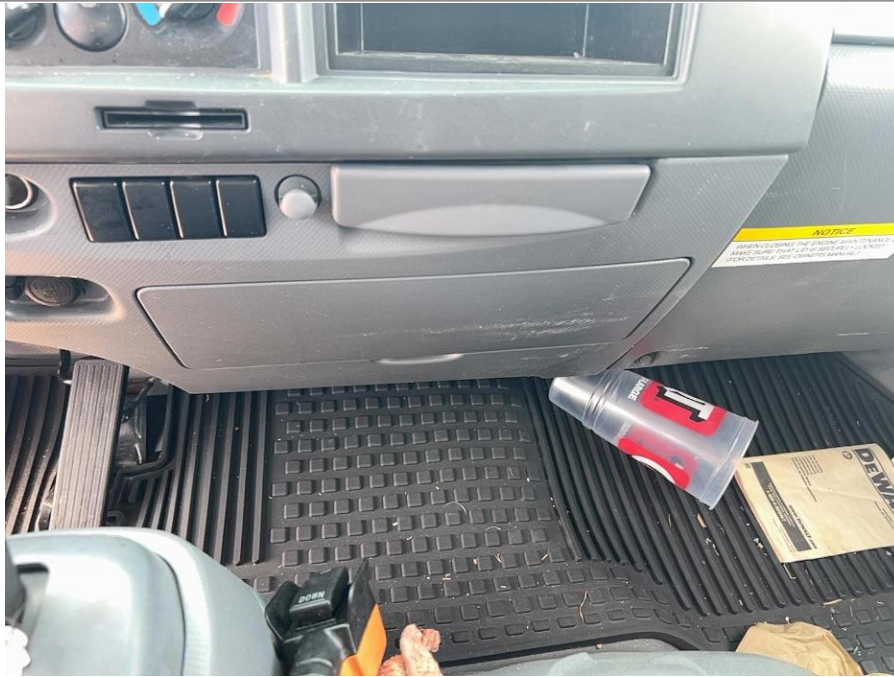
Passenger's Seat Cover	The seat cover is stained and faded.
Driver's Seat Cover	The seat cover is stained and faded.
Box Side Panel	There are small dents on both side panels.
Floor Mat	The floor mat is torn.

Repair Items			
Item Name	Item Labor Cost	Item Part Cost	Total Cost
Floor Mat	\$150.00	\$492.00	\$642.00
First Right Steer Tire	\$150.00	\$555.00	\$705.00
First Left Steer Tire	\$150.00	\$555.00	\$705.00
First Left Outer Tire	\$150.00	\$555.00	\$705.00
Total Repairs:			\$2,757.00

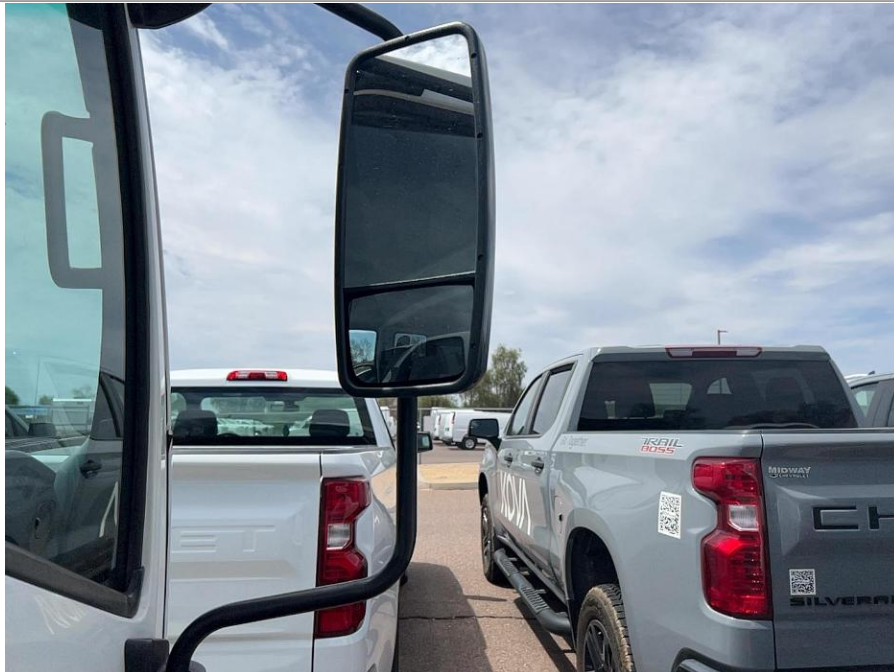
**Mirrors**

Wear and Tear Items	
Item Name	Item Comments
First Left Inner Tire	The tire is worn and regroovable.
First Left Outer Tire	The tire is bald and regroovable.
First Left Steer Tire	The tire is regroovable and nearly bald.
First Right Inner Tire	The tire is regroovable.
First Right Outer Tire	The tire is regroovable.
First Right Steer Tire	The tire is worn on the right side, which may indicate an alignment issue.
Box Storage Door Seal	The door seal is damaged and loose.
Box Storage Condition	The interior of the box has a bent shelf, and the paint is damaged.
Rear Mud Flap	The rear left mud flap is damaged.
Skirt Flap	The skirt flap below the radiator is damaged.
Coolant	The coolant reservoir is empty and needs to be topped up.
Hood	The front hood frame has small dents.
Driver's Door Seal	The door seal is loose.
Mirror Trim	The mirror trim cover is damaged.
Back Seat Cover	The seat cover is stained and faded.
