Inspection Detail

Client:	Isuzu Finance		
Inspected by:			
Location of Inspection:	2201 W Bell Rd, Phoenix, AZ 85023, USA		
Phone No / Email:	+1 602 881 9525 / tfraser@vtaig.com		
Date of Inspection:	9/2/2025	Job#:	868fcp6h2
Year:	2015	Make:	Isuzu
Model:	NQR/NRR	VIN:	JALE5W168F7301238

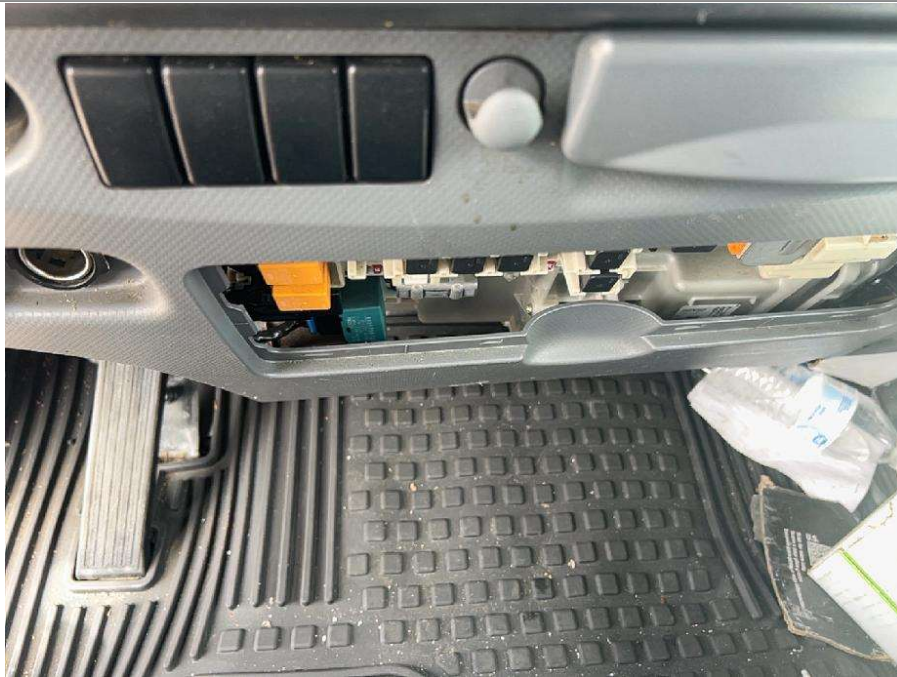
Pedals / Floorboard

Floor Mat	The floor mat is torn.
Warning Lights	The engine check light is on and needs to be diagnosed.
Box Side Panels	The side panels on both sides are dented.

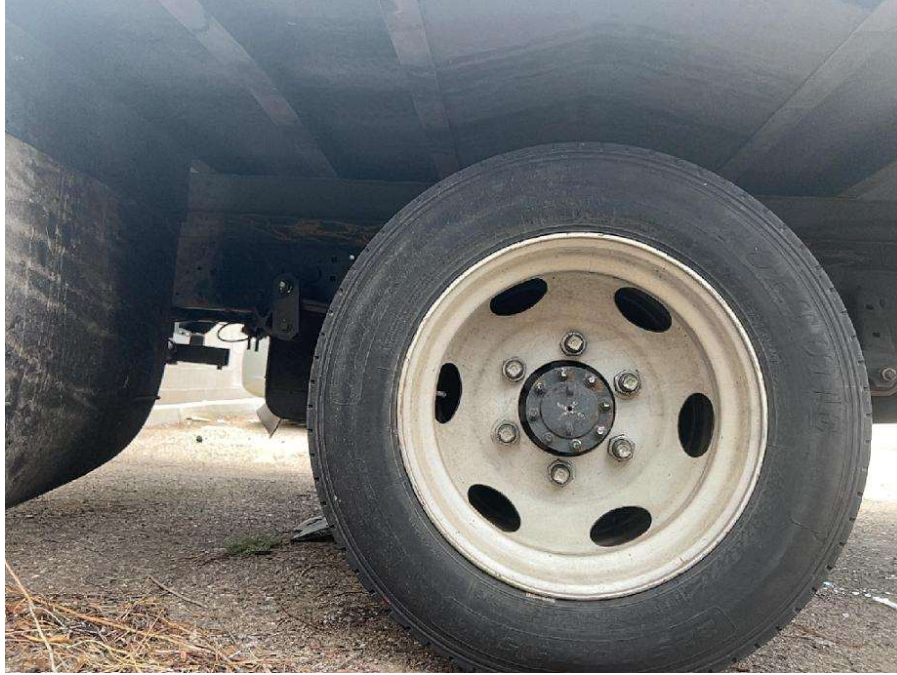
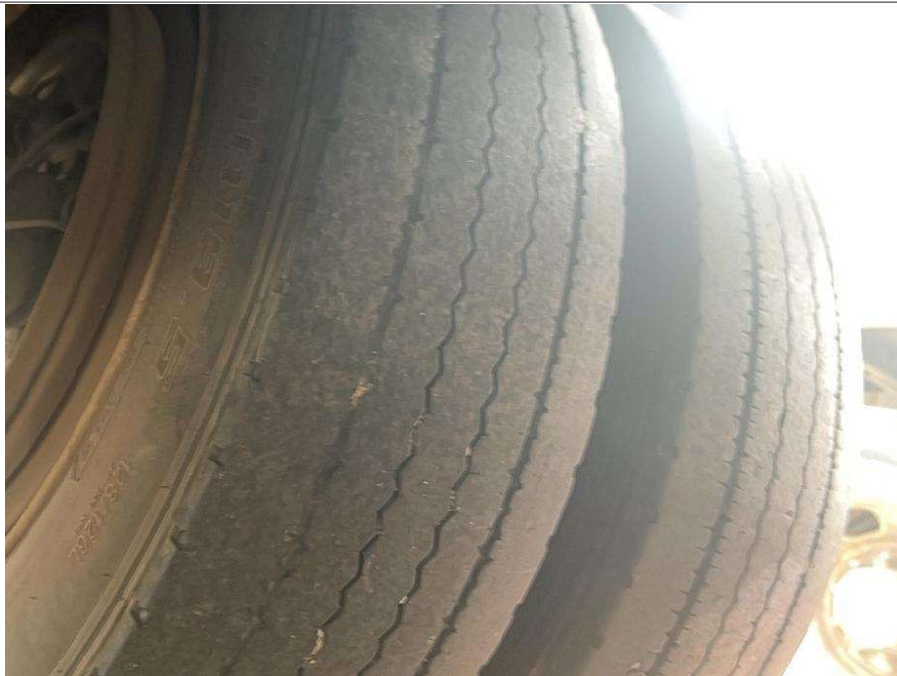
First Right Outer Drive Tire Condition

Wear and Tear Items	
Item Name	Item Comments
Right Steer Tire	The tire has small gouges and is worn.
Box Metal Panel	The metal panel is dented.
First Right Outer Tire	The tire is regroovable and worn.
First Right Inner Tire	The tire is bald and regroovable.
First Left Inner Tire	The tire is regroovable and worn.
First Left Outer Tire	The tire is regroovable and worn.
Left Steer Tire	The tire is regroovable.
Toolbox	The toolbox is held in place with a zip tie. The toolbox latches are damaged and broken.
Coolant	The coolant reservoir is empty and needs to be topped up.
Driver Door Panel	The driver's door panel is scratched.
Cab Interior	There are some items in the cab interior.
Dash Cover	The fuse cover on the dash is missing.
Driver's Seat	The seat cover is stained, has small holes, and is fraying.
Steering Column Cover	The cover is misaligned, possibly due to damaged latches.
Windshield	The windshield is cracked.

Repair Items			
Item Name	Item Labor Cost	Item Part Cost	Total Cost
Box Side Panels	\$900.00	\$2,500.00	\$3,400.00
Warning Lights	\$450.00	\$1,000.00	\$1,450.00
Floor Mat	\$150.00	\$492.00	\$642.00
Windshield	\$450.00	\$852.00	\$1,302.00
Driver Door Panel	\$150.00	\$487.00	\$637.00
Left Steer Tire	\$150.00	\$555.00	\$705.00
First Left Outer Tire	\$150.00	\$555.00	\$705.00
First Left Inner Tire	\$150.00	\$555.00	\$705.00
First Right Inner Tire	\$150.00	\$555.00	\$705.00
First Right Outer Tire	\$150.00	\$555.00	\$705.00
Box Metal Panel	\$300.00	\$400.00	\$700.00
Right Steer Tire	\$150.00	\$555.00	\$705.00
Total Repairs:			\$12,361.00
