Inspection Detail

Client: Isuzu Finance		
Inspected by:	Rayfield (Ray) Wyatt II		
Location of Inspection:	6225 State Rd., Philadelphia, PA 19135, USA		
Phone No / Email:	+1 267 255 0956 / jwallick@bentleytruckservices.com		
Date of Inspection:	5/12/2025	Job#:	868dvrvgl
Year:	2021	Make:	ISUZU
Model:	NRR	VIN:	JALE5W168M7300412

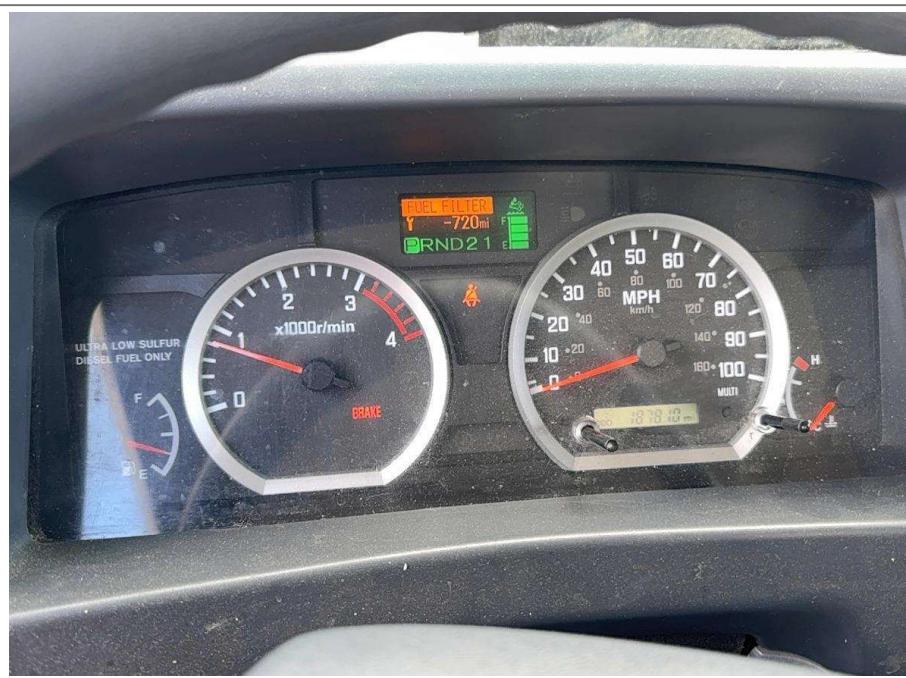
**EMS Warning Lights**

GVWR:	19,500	Odometer:	187,810	Engine Hours:	7,672
EMS Warning Lights:	Yes

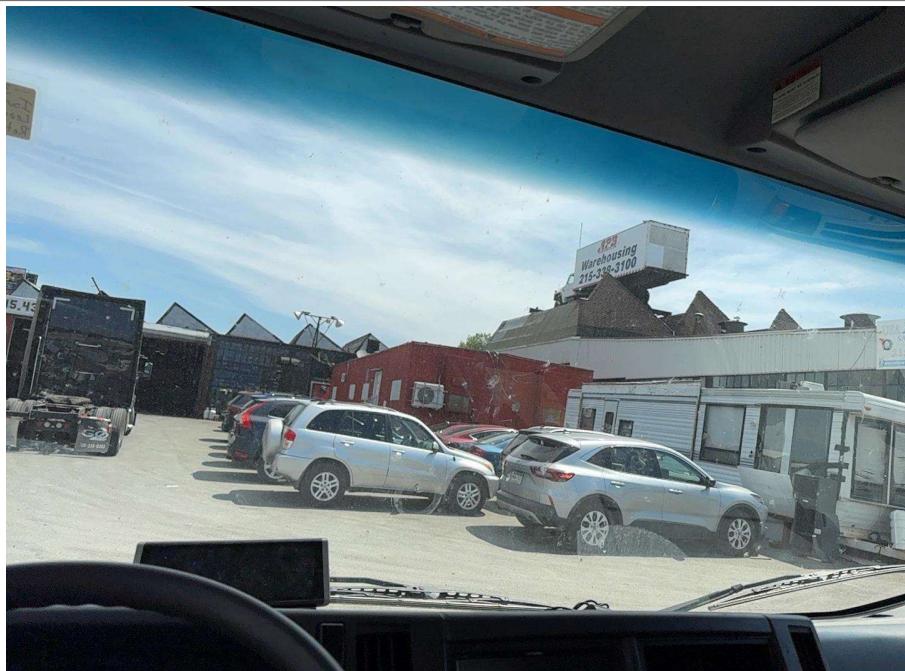
**Cab Interior**

Cab Interior:	See Notes	Driver's Seat:	No Damages Observed	Passenger's Seat:	No Damages Observed
Transmission Type:	Automatic	Pedals:	No Damages Observed	Floorboard:	No Damages Observed
Radio:	Yes	A/C:	Yes	Switches and Controls:	No Damages Observed
Power Mirrors:	No	Heated Mirrors:	No	Steering Wheel:	No Damages Observed
Cab Mirror:	N/A	Box Condition:	See Notes

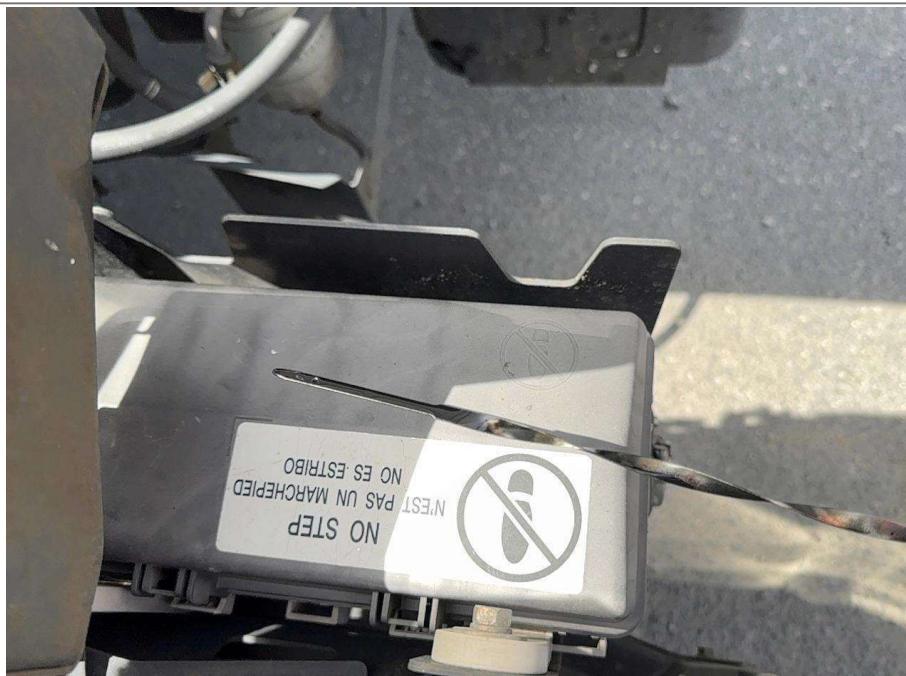
Oil Dipstick

Engine Compartment:	No Damages Observed	Oil Dipstick:	See Notes	Coolant Level:	Low Level
Engine Serial Plate:	Obstructed

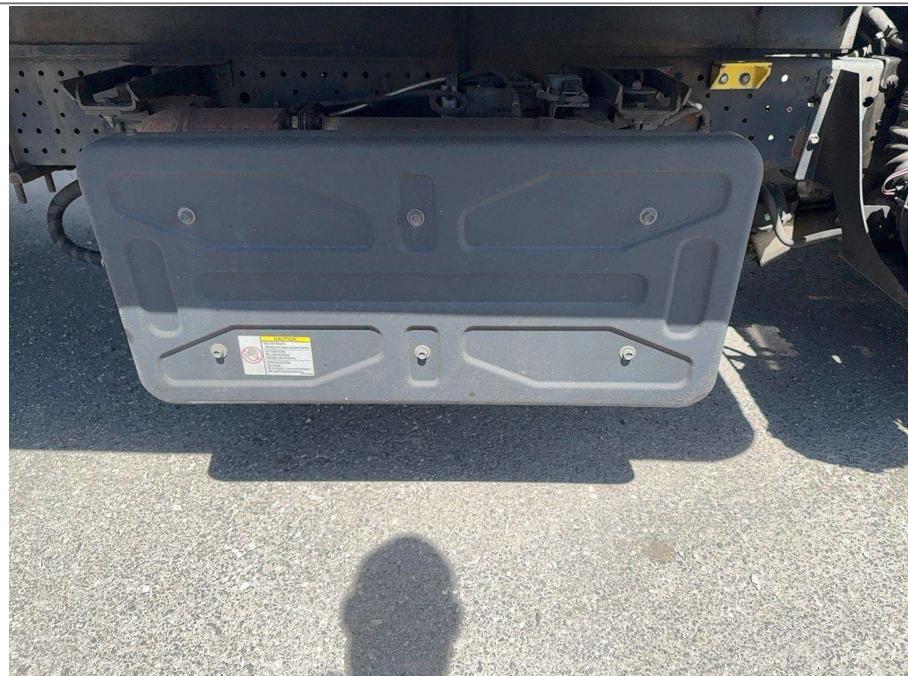
Exhaust System

Mirrors:	No Damages Observed	Steps:	No Damages Observed	Handrails:	No Damages Observed
Exhaust System:	See Notes	Front Lights:	No Damages Observed	Rear Lights:	No Damages Observed
Suspension:	No Damages Observed	Axles:	No Damages Observed
