Isuzu Vehicle HEALTH REPORT

Beginning Report Date: Vehicle Production Date  
 Ending Report Date: 2020-12-28 17:02:31  
 VIN: JALC4J167H7003084  
 Current Mileage: 79425 Miles  
 Rear Body Type: Dry Box  
 Freight Type: Agricultural Products  
 Customer Name: Pressure Pro's  
 Customer Email: .  
 Customer Address: .

Case Number: 7774243 - Repair Order Number: 110846  
 Purchase Order Number: n/a  
 Service Writer: , - Case Date: 12/21/20 11:50 am EST

**Unit #:**  
**Asset:** 2017 Isuzu Nprhd **Miles** 79,425  
**Serial #:** 7H7003084  
**VIN:** JALC4J167H7003084  
**Engine:** 4HK1-TC  
**Engine Hours:**

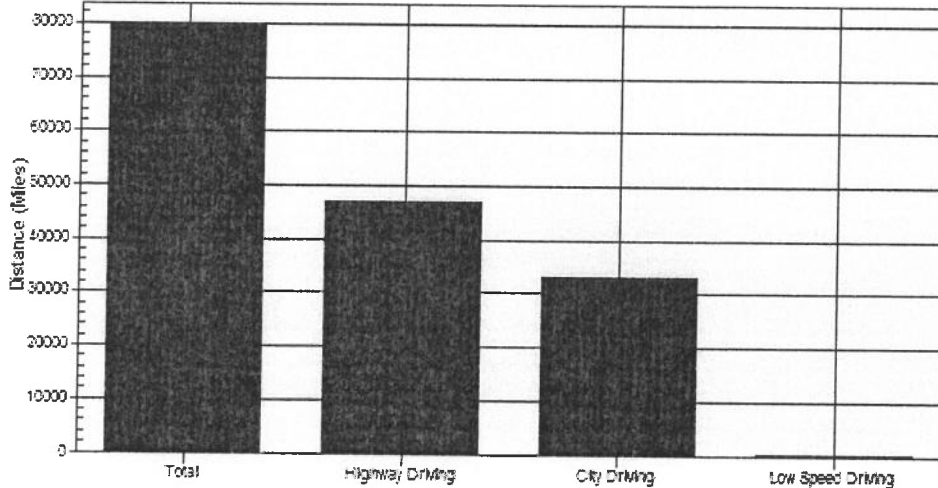
### Distance Traveled (Miles)

Total: 79,866.01  
Highway Driving: 46,881.4  
City Driving: 32,965.5  
Low Speed Driving: 149.64

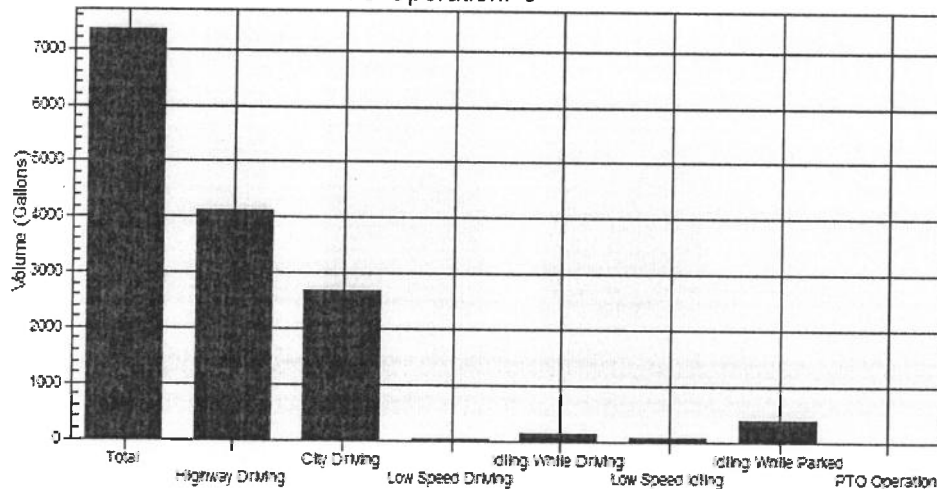
### Fuel Consumption (Gallons)

Total: 7,361.35  
Highway Driving: 4,112.53  
City Driving: 2,671.9  
Low Speed Driving: 16.97  
Idling While Driving: 138.28  
Low Speed Idling: 55.16  
Idling While Parked: 366.51  
PTO Operation: 0

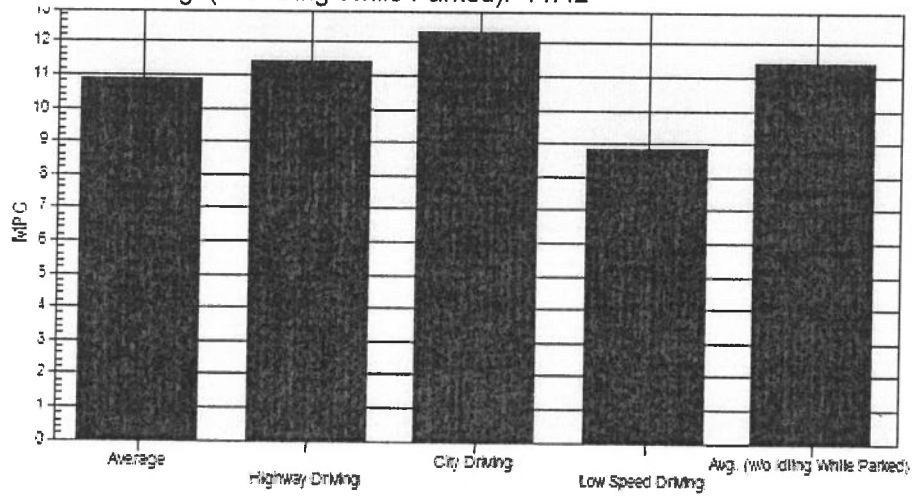
### Fuel Economy (MPG)

Average: 10.85  
 Highway Driving: 11.4  
 City Driving: 12.34  
 Low Speed Driving: 8.82  
 Avg. (w/o Idling While Parked): 11.42

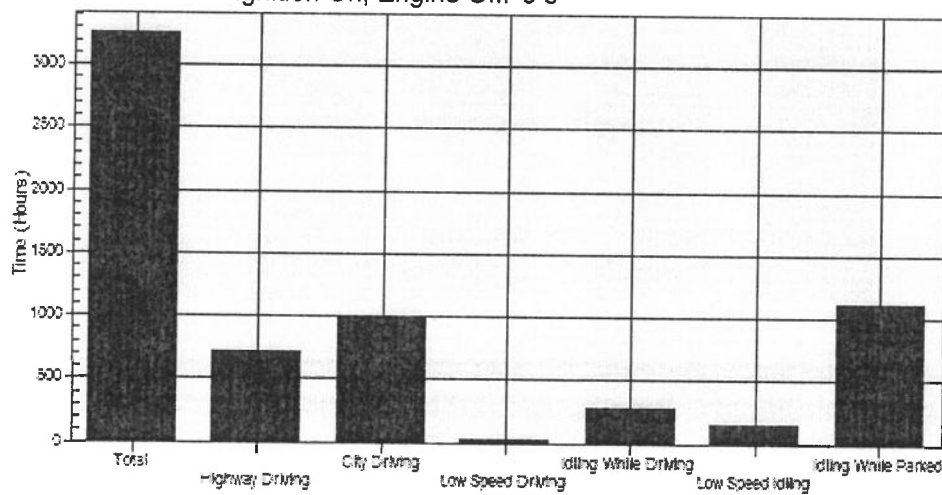
### Collection Time

Total: 3,093 hr, 41 min, 27 s  
 Highway Driving: 708 hr, 49 min, 24 s  
 City Driving: 985 hr, 1 min, 51 s  
 Low Speed Driving: 27 hr, 48 min, 30 s  
 Idling While Driving: 281 hr, 11 min, 12 s  
 Low Speed Idling: 154 hr, 31 min, 19 s  
 Idling While Parked: 1,106 hr, 51 min, 39 s  
 Ignition On, Engine Off: 0 s
