Job #: 59775 /

VIN: 54DC4W1BXJS804800

# 16' SUPREME DRY VAN, GAS 2018 - ISUZU NPR-HD - LA126721 / LA126721

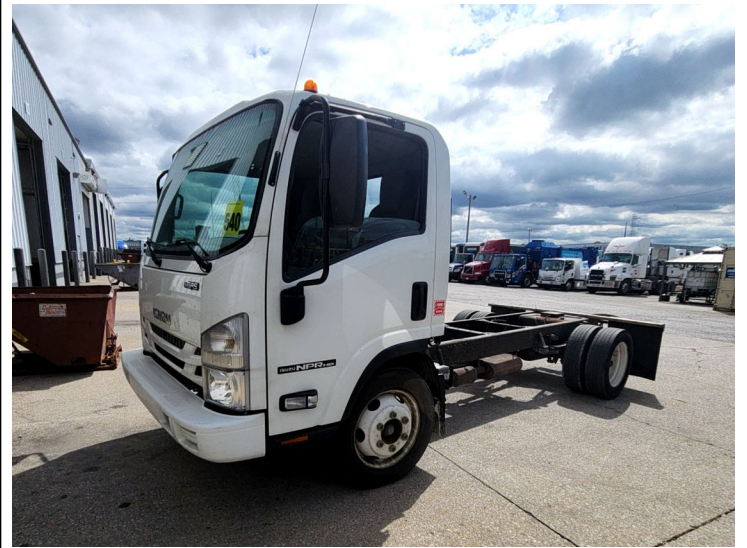
## Equipment Photo

The truck was confirmed to be fully operational. The rear of the frame rails has been cut to remove the box from the truck, and temporary mud flaps are zip-tied to the frame.

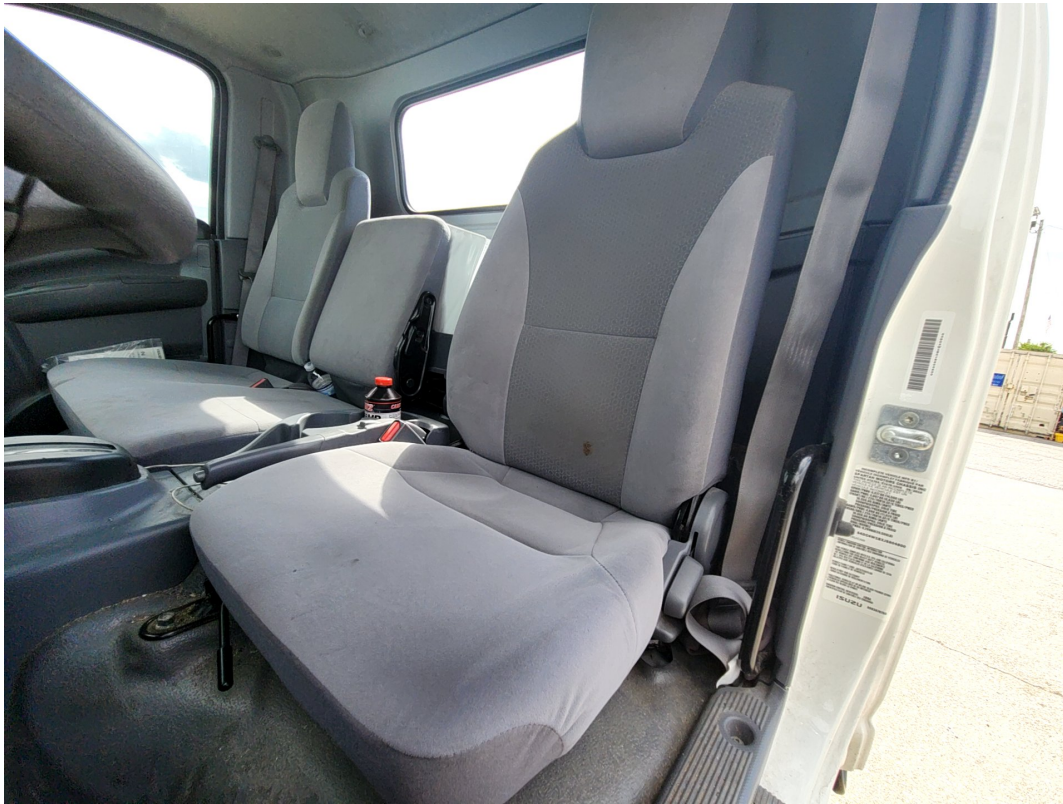
Driver's Seat / 09-08-2023

Visible Damages	
Driver's Seat	The seat has some staining.
Left Outer Drive Tire	The tire tread looks to be worn.
Coolant	The coolant is low in the reservoir.
Engine Oil	The oil is dark in color and low level.
Frame Rails	The frame rails are rusty and need to be cleaned and repainted.
Rear Lights	The rear tail lights are not operational.
